HOME INSPECTION REPORT

13431-69 Hwy 8 Business
El Cajon, CA 92021

Kroon Family Trust c/o Ann and Ray Petta
07/25/2023

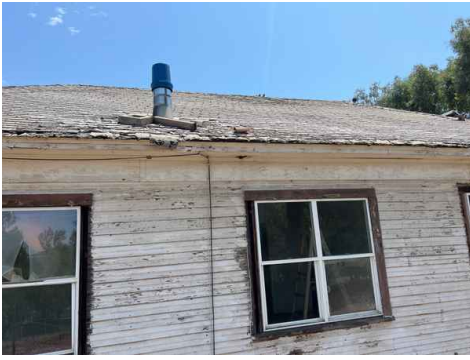
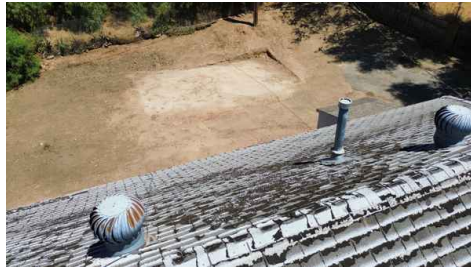
The roof shows extensive wear and deterioration and is in need of replacement. We advise consulting a licensed roofing contractor for estimates prior to the end of your contingency period.

Contact a qualified roofing professional.

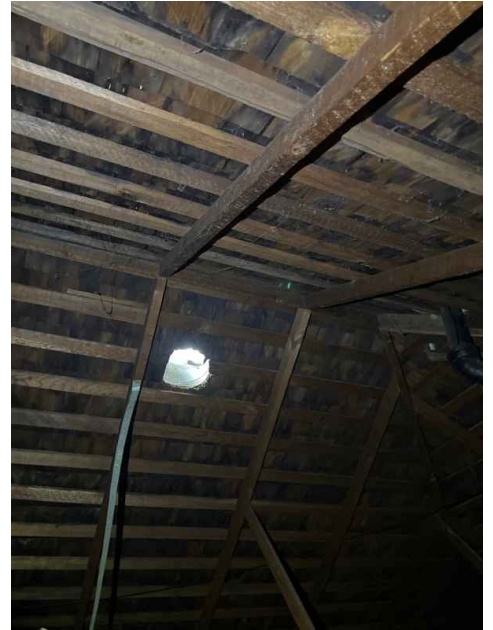
The roof has composition asphalt shingles installed over a layer of wood shakes. This condition will result in the following: Reduced asphalt shingle service-life compared to similar shingles installed over a proper substrate. Any warranty which may have been in effect will be void. Proper installation of new shingles will require removal of all roof-covering materials and installation of solid sheathing over the existing spaced sheathing. This will be relatively expensive. We recommend that before the close of your contingency period, you consult with a licensed roofing contractor to discuss options and costs for any eventual roof-covering material replacement.

Contact a qualified roofing professional.

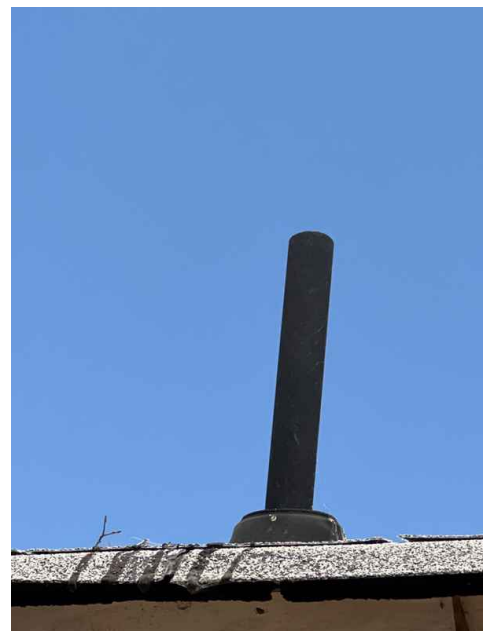
Sheet metal flashings and ABS plumbing vents were not painted. Paint is required at the ABS vents and recommended at exterior sheet metal. We advise corrections with qualified painter.

Contact a qualified painting contractor.

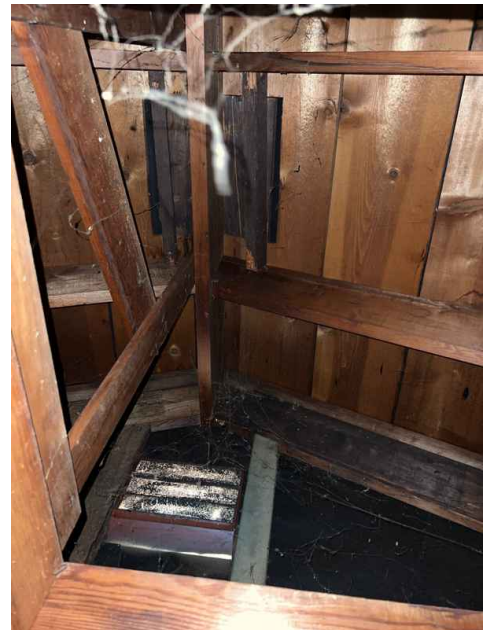
REPAIRS

Repairs were observed to the roof sheathing. We recommend further review with a Qualified roofer.

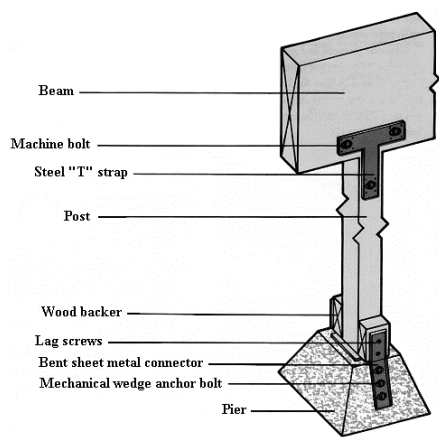
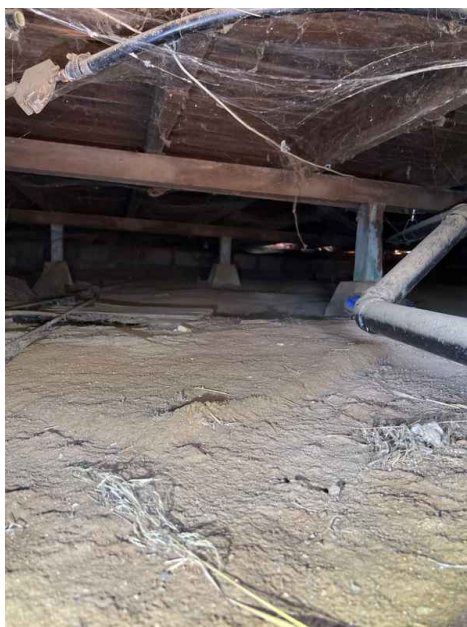
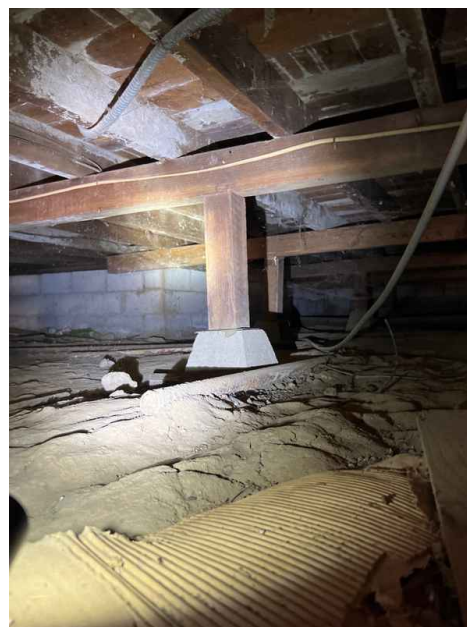
COLUMNS OR PIERS: POSTS - TIES

The wood posts are not strapped/bolted to the floor beams/concrete piers. At time of construction, and until 1994 this was acceptable. You may wish to upgrade the post and pier system for stability and seismic resilience. We advise obtaining a quotation for the scope of work required and cost from a licensed foundation contractor.

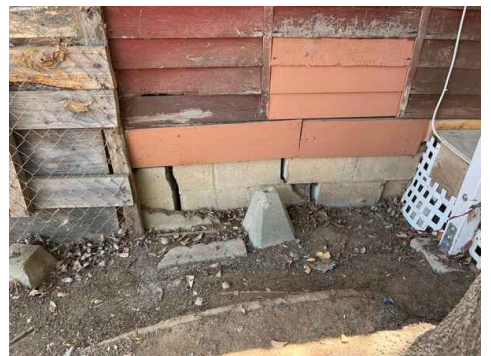
13469

STEM WALL - LARGE CRACKS - ENGINEER

Cracks 1/2" or larger in width were observed in the foundation wall(s). The cracking implies that foundation movement has occurred. The exact evaluation of the suggested condition is not within the scope of our inspection. A qualified engineer or foundation specialist should be consulted to determine if these conditions are reasonable or if they warrant further investigation or repair.

Contact a qualified professional engineer

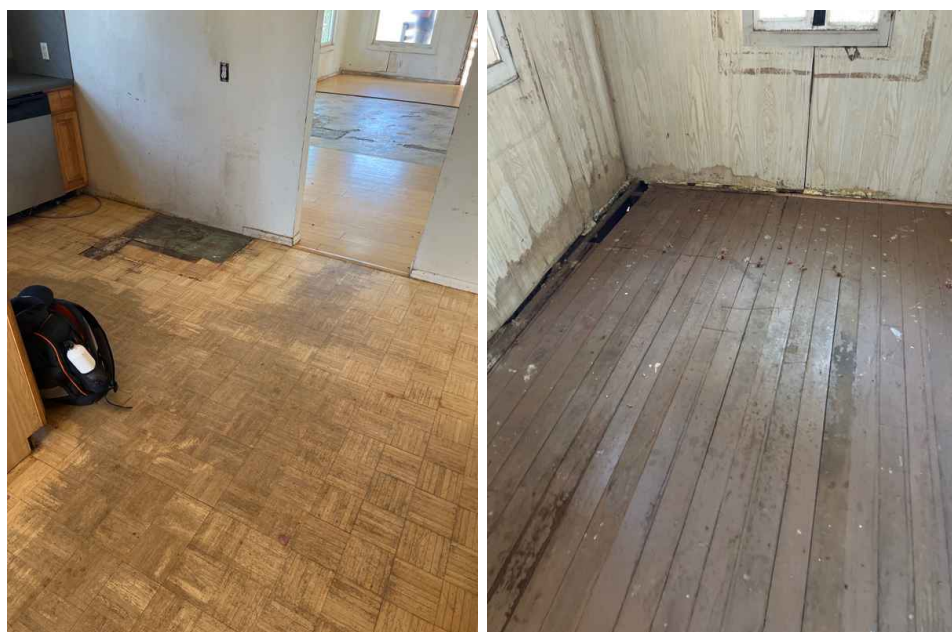
The floor appears to be sloping or not level. The exact evaluation is beyond the scope of our inspection. We advise further evaluation by a structural engineer or qualified licensed contractor before the end of your contingency period to evaluate the structure and advise you on possible required repairs.

Contact a foundation contractor.

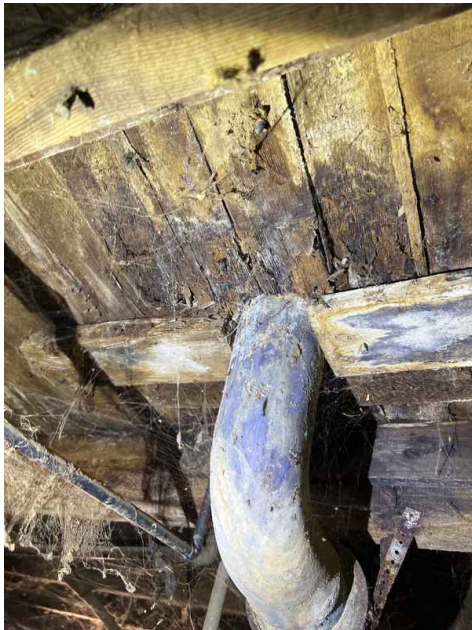
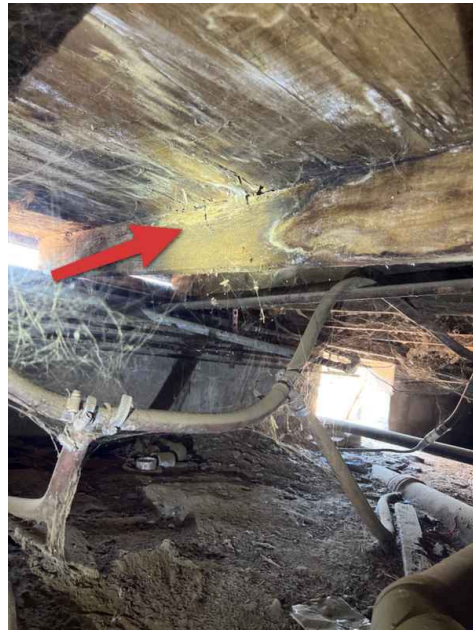
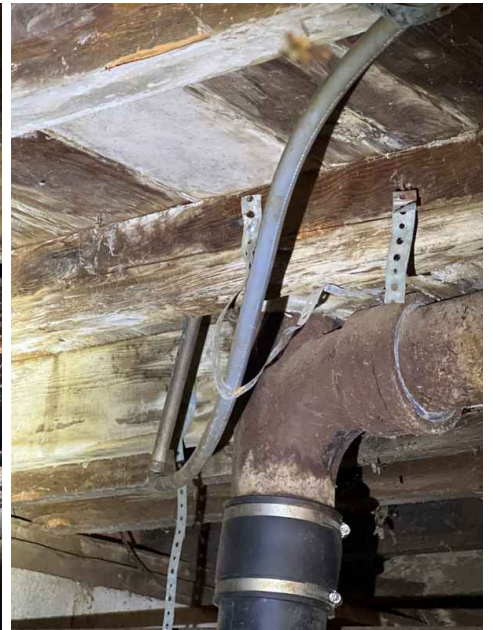
13429

Action Item or Further Review
WOOD DAMAGE UNDER PLUMBING

Damaged wood and water staining were observed on the sub-flooring and floor structure in the crawlspace. This may indicate that a leak did or still does exist. Damage may exist in the walls or at framing members which are not observable. Due to the limited scope of a home inspection, it is important that you have this area inspected by a licensed pest inspector and licensed plumber prior to the end of your contingency period to determine the condition of the wood, and if/what repairs are necessary.

Contact a qualified professional.

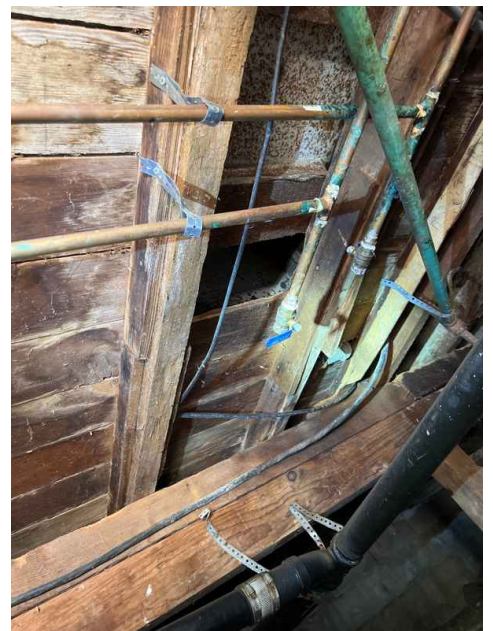
Recommendation or Safety Upgrade
OPENINGS - POOR FRAMING

An opening has been cut into the floor framing. The floor joists were not properly framed to support the cut joist(s). This causes the floors to sag over time. We recommend consulting with a licensed general contractor for repair options and costs prior to the end of your contingency period.

Contact a qualified professional.

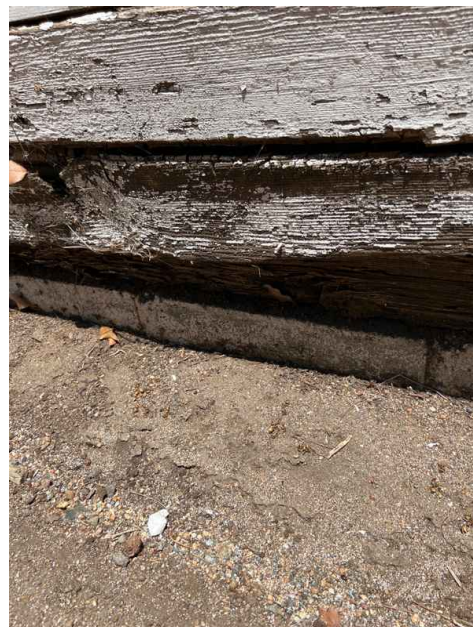
13431

SOLE PLATE DETERIORATED

The exterior wall sill plate visible in the crawlspace was not pressure-treated to resist wood decay or of a type of wood species that has a natural resistance to wood decay (rot). Probing revealed widespread advanced wood decay which may affect the structural integrity of the home. We recommend that an evaluation and any necessary corrections or repairs be performed by a qualified contractor. The source of moisture intrusion causing decay should be located and corrected.

Contact a qualified professional.

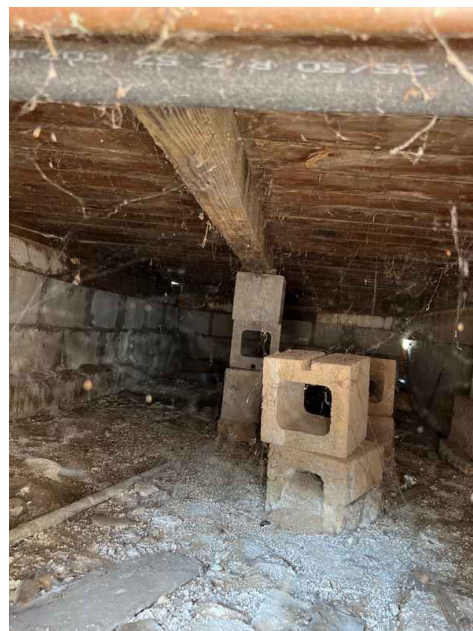
INADEQUATE BEARING (BEAM/GIRDER)

Beam/girder(s) visible in the crawlspace had inadequate bearing at their ends. Generally-accepted current standards dictate that beams or girders with this type of bearing have a minimum of 3 inches of bearing where they rest upon supporting structures unless additional adequate support is provided. We recommend further review and correction by a qualified contractor.

Contact a qualified professional.

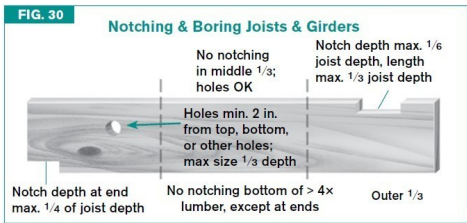
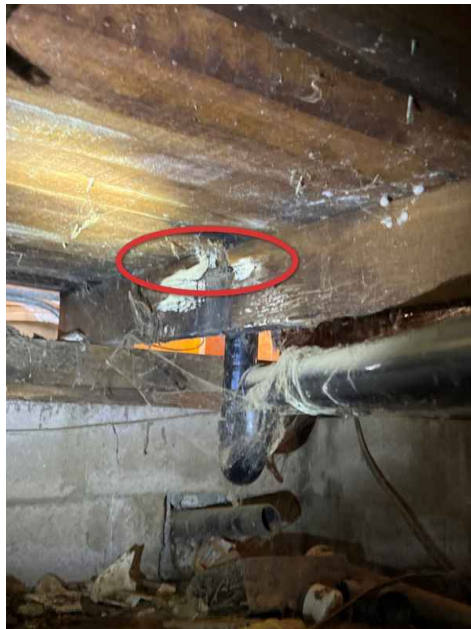
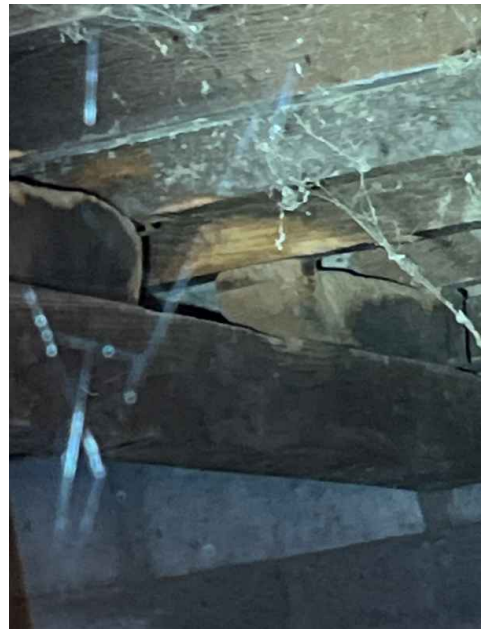
13429

Whereas it is permissible to pierce intermediate floor framing, the holes should be no larger than one-third of the depth of the material and drilled no closer than two inches from the upper or lower edges. Also, although the framing may be notched, the notch should be no deeper than one-sixth the girder depth, and never in the middle of the span. One or more areas observed did not meet this standard. We advise consulting with a licensed general contractor for an estimate of repair prior to the close of your contingency period.

Contact a qualified professional.

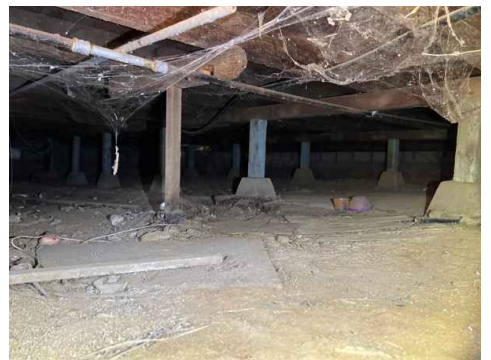
This home appears to have had past foundation repairs performed. The concrete piers were replaced or added in areas without the use of a concrete footing under the pier. Current building standards require a 12-inch square with a 12-inch deep footing, a precast pier with a metal strap should be embedded in the pier placed in the footing when the concrete is wet. The pier should extend a minimum of 8" above grade. The post must be pressure treated, and strapped to the beam. The footing needs to have reinforcing steel in the poured concrete. The minimum spacing is 4 feet apart, as well as supporting each split where the beam-ends touch, and usually start approximately 12" from the exterior wall. Piers that are placed without footings or poorly installed are more likely to move/settle over time. We advise review of this installation with a licensed foundation repair contractor.

Contact a foundation contractor.

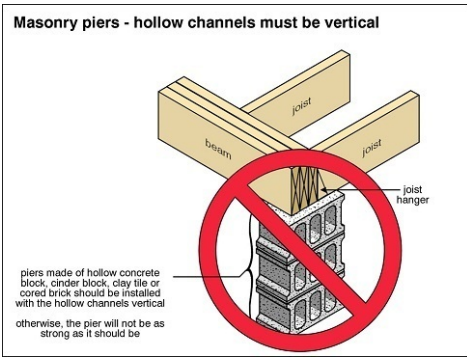
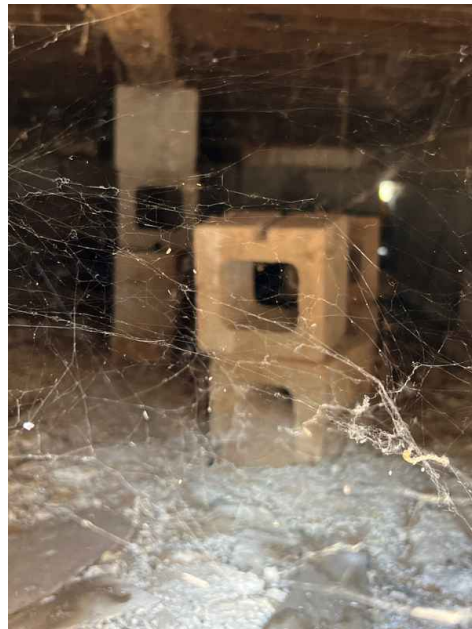
13431

CINDER BLOCKS - SIDWAYS

Masonry blocks are being used as piers under the house. The masonry blocks are installed improperly. They may not be turned on their sides. The hollow channels must be vertical. We recommend correction by a licensed contractor.

Contact a foundation contractor.

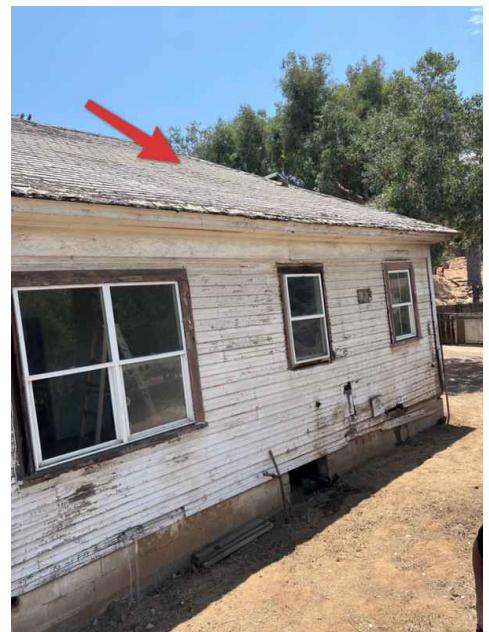
12.7.1 ROOF STRUCTURE AND ATTIC
ROOF STRUCTURE -SAGGING

Visible sagging of the roof was observed. This can be caused by over-spanning of rafter in the roof structure and/or deterioration due to moisture from roof leaks. Minimal mid-span support was noted in the attic. We recommend that before the expiration of your contingency period you consult with a qualified engineer for an estimate to repair.

Contact a qualified professional engineer

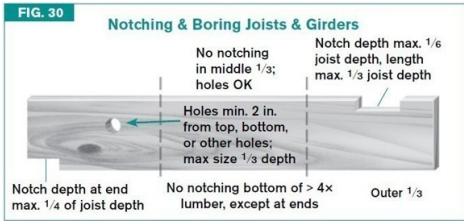
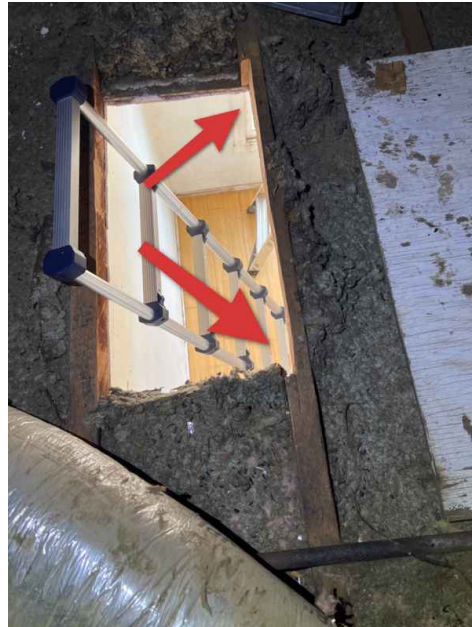
13429

12.7.2 ROOF STRUCTURE AND ATTIC
NOTCHED RAFTER/CEILING JOIST

A ceiling joist has been notched to allow for air return placement. Although the framing may be notched, the notch should be no deeper than one-sixth the girder depth, and never in the middle of the span. One or more areas observed did not meet this standard. We advise consulting with a licensed general contractor for an estimate of repair prior to the close of your contingency period.

Contact a qualified carpenter.

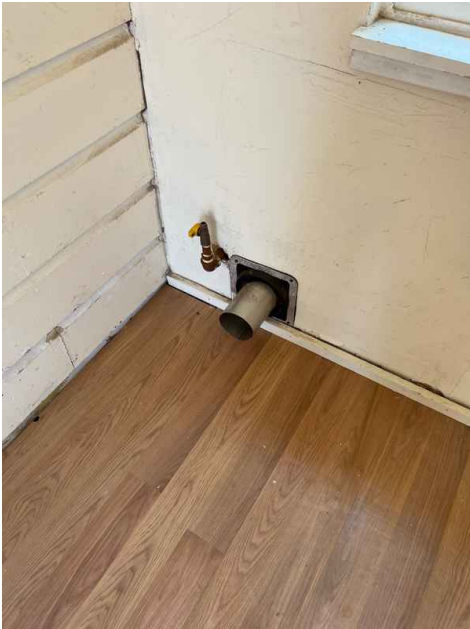
13431,13469

No clothes dryer vent connection was present.

Repair or replace

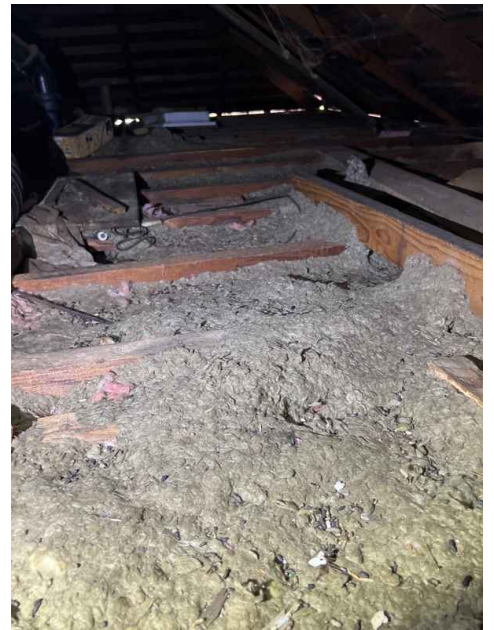
The insulation in the attic is compressed. We recommend increasing the amount of insulation to improve the thermal efficiency of the house.

Contact a qualified insulation contractor.

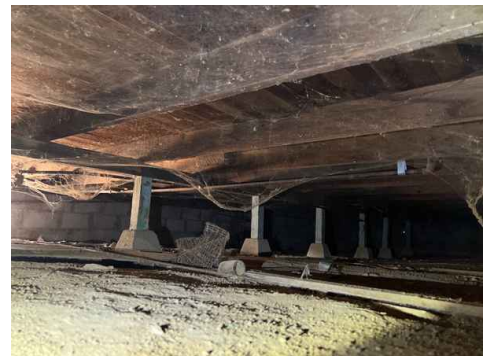
INSULATION MISSING - FLOOR

The floor system is not insulated. Heat loss can occur more on this home than one that is properly insulated. We recommend adding insulation to the floor system in the crawlspace by a qualified person.

Contact a qualified insulation contractor.

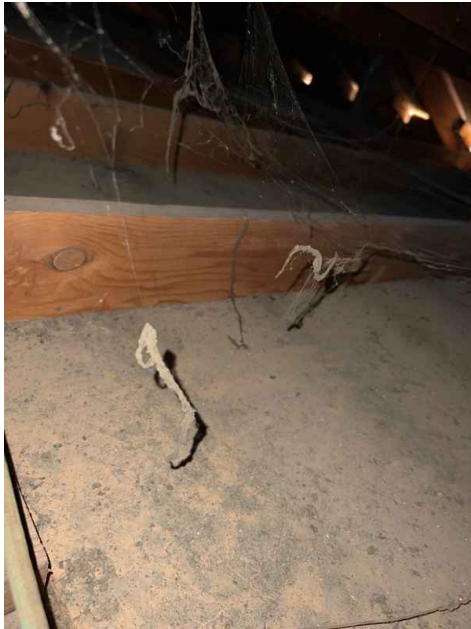
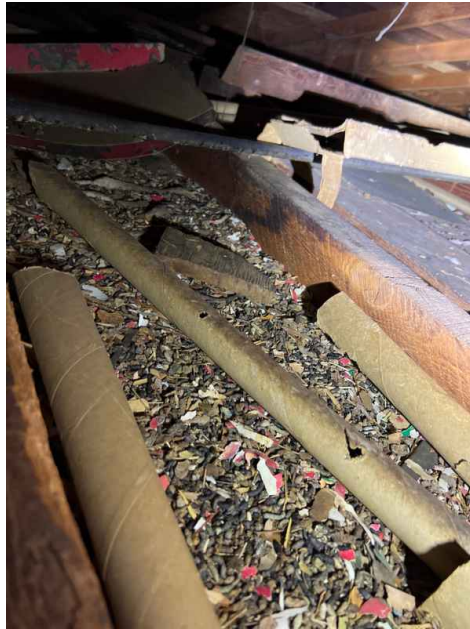
13431

INSULATION - NONE IN ATTIC

No insulation is present in the attic. We recommend having insulation installed to increase the comfort level of the house, and to improve the thermal efficiency of the heating/cooling system.

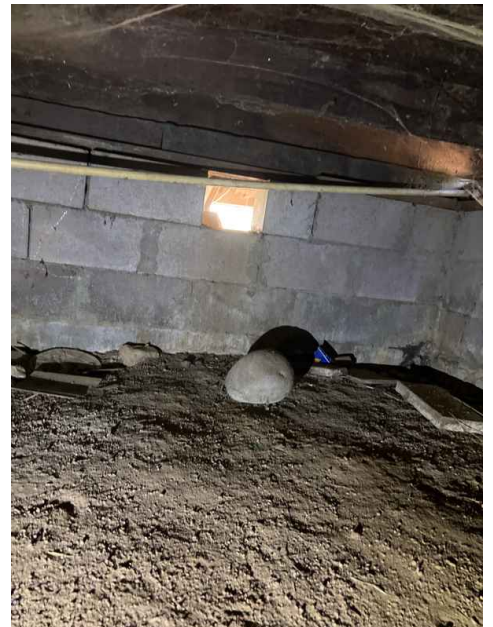
13.7.1 CRAWLSPACE
VENTILATION**VENT SCREENS - TORN**

Torn vent screens are noted. We advise repair to prevent pest intrusion.
