REAL ESTATE INSPECTION REPORT

Property Address:
72325 Roxbury Dr
Rancho Mirage, CA 92270

Prepared and Written by Bruce Carmichael , Inspector - Exclusively for
Mark Stine

Inspection Date
Thursday, August 4, 2022 at 8:30 AM

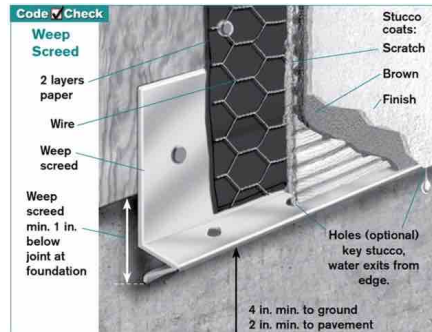
NR Soil grade is blocking the stucco weep screed at bottom of stucco wall at rear exterior . There should be a minimum 3 " maximum 6 " inches between the soil and the bottom of the weep screed. This will allow the wall to ventilate and drain properly.

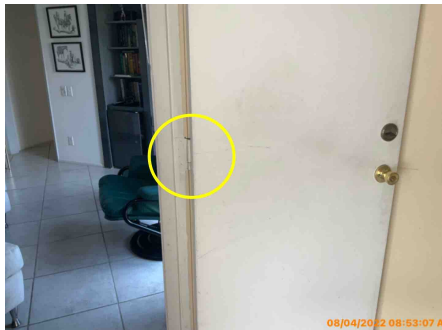
SC Self latching door is not operational, repair needed ,door should close and latch for safety. Adjustment needed to self closing spring(s)

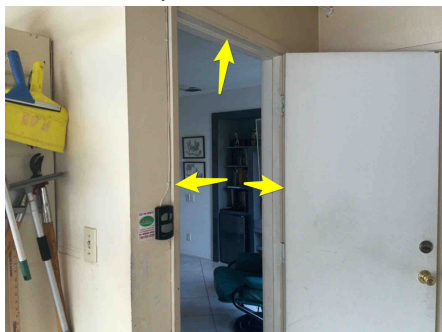
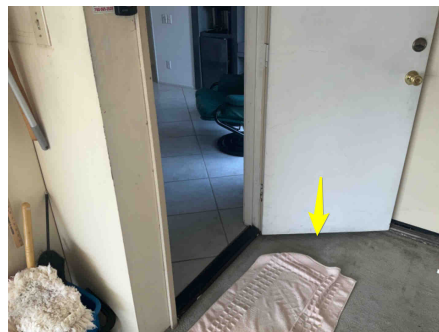
SC Door from garage to interior of the house is required to be weather stripped and have proper threshold and a bottom sweep installed

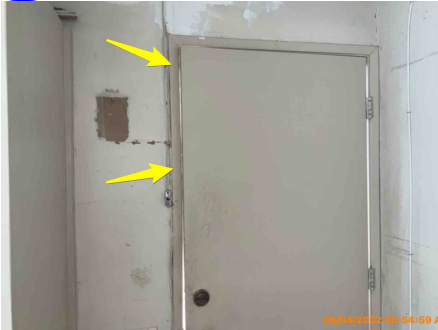
NR Garage exterior door rubbing on frame.

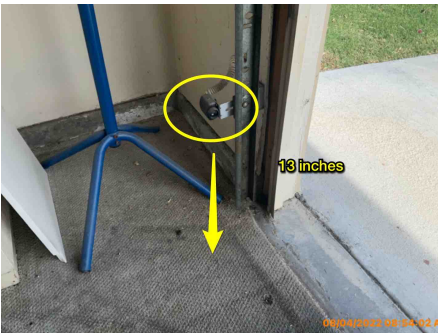
SC The electric eye beams are installed over 6" off the ground. The electric eye beams are designed to be installed 4" to 6" off the ground as per the manufacturer's recommendations = Readjust the height of the eye beams is recommended for safety.

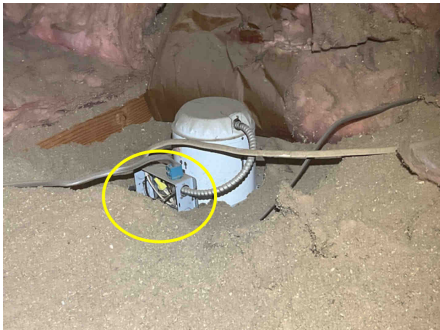
SC Junction box cover(s) missing in attic area, this is a fire hazard, all attic electrical be reviewed. Recommend further review and repair by qualified Electrical Contractor.

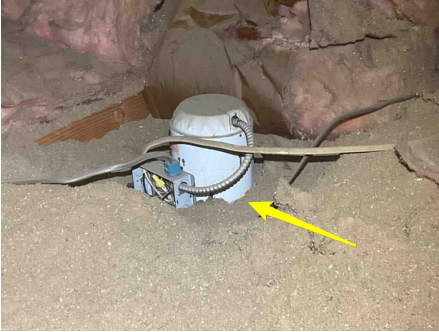
SC Recessed lights in attic are covered with insulation, inspector could not verify if lights are non-IC rated, recommend verifying if lights are IC rated for contact with insulation. Non-IC rated lights require at least 3 inches clearance to combustibles

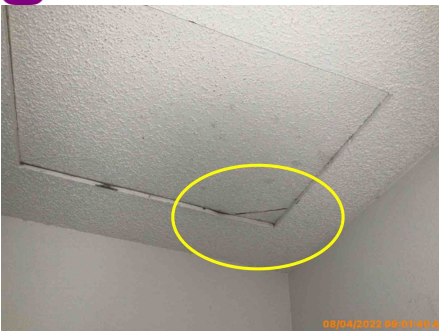
RM Attic hatch is damaged, recommend new hatch cover be installed.

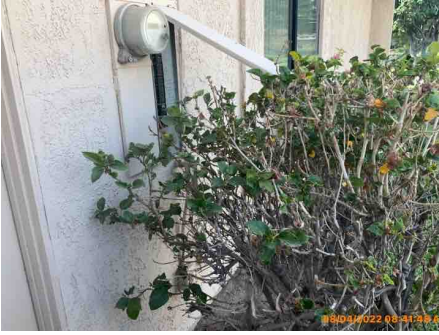
NR Trimming is needed to plants to allow for access to electrical panel.

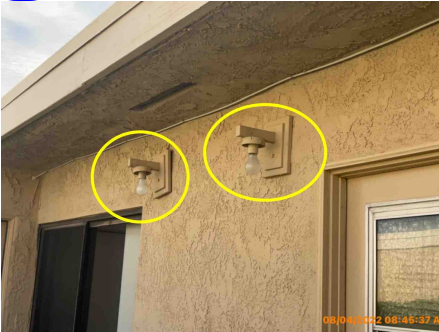
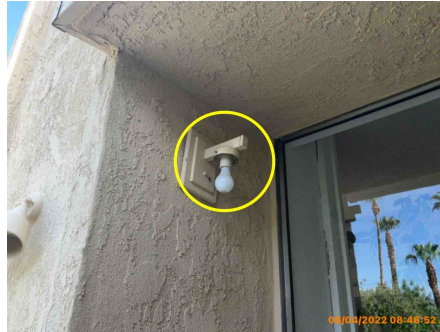
NR Weather proof cover missing at right side light fixtures .

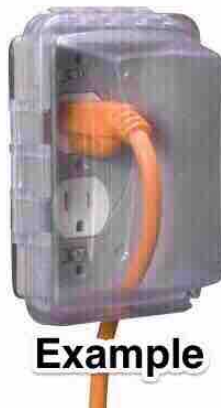
RM Recommend installation of listed outdoor cover for unattended cords to protected receptacles from moisture damage at exterior of house.

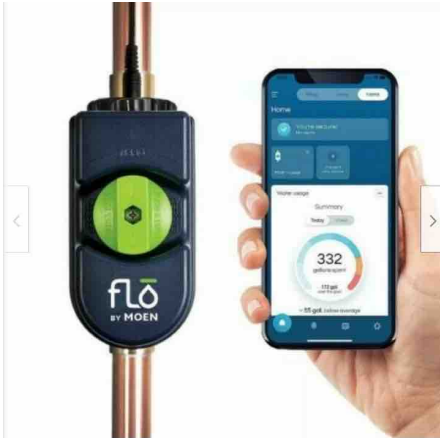
UG Recommend installing a FLOW by MOEN smart water shut off valve. Recommend the advice and services of a qualified Plumbing Contractor

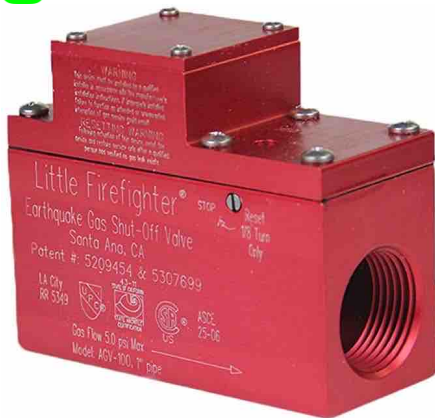
UG Recommend that an automatic Earthquake Gas Shut Off Valve be installed near the gas meter.

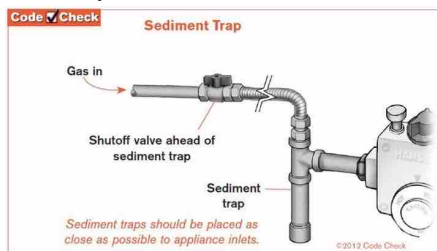
GAS LINE SEDIMENT TRAP(S)

UG Sediment traps missing on gas line for older type furnace(s) and water heater(s). Sediment traps may have not been required when house was built, recommend installation to prevent voiding manufacturers and or home warranty. Recommend the advice and services of a qualified Plumbing Contractor

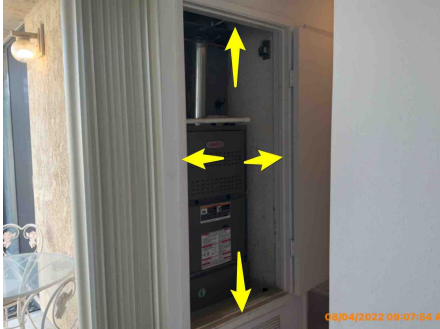
RM Heater access door lacks weather stripping, recommend installation to prevent combustion air and return air from mixing since return vent is less than 10 feet from heater unit.

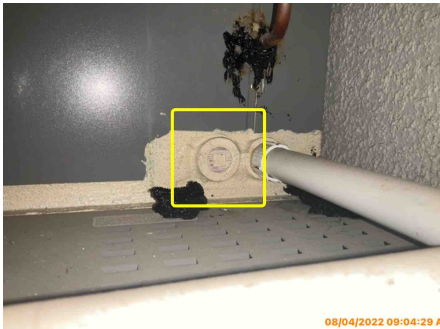
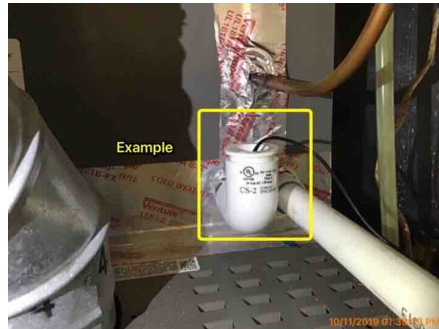
COILS SECONDARY CONDENSATION LINE

UG Recommend Micro switch be installed on secondary condensation line to prevent moisture damage if primary condensation line becomes blocked.

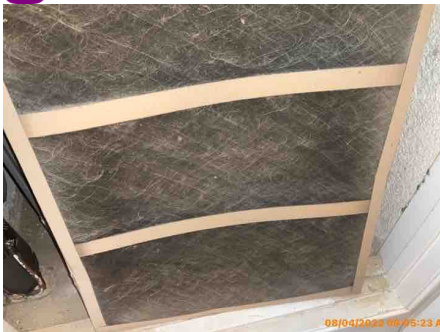
RM Heater filter is dirty, new filter is needed, suggest cleaning/changing filter regularly

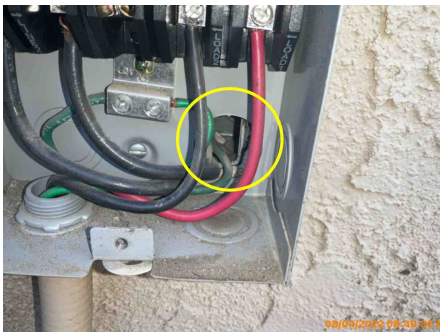
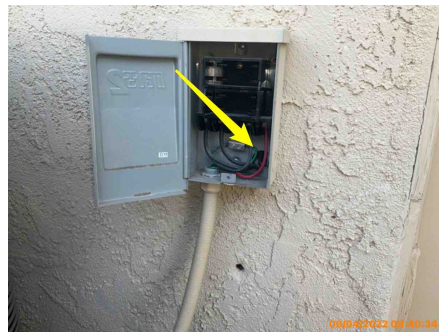
NR Missing protective wire bushing for wires that enter the A/C disconnect panel. All wires that enter the panel should be protected from metal enclosure. Recommend further review and repair by qualified Electrical Contractor.

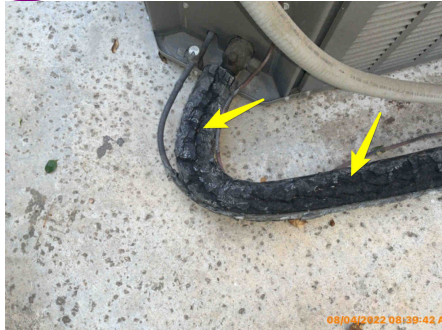
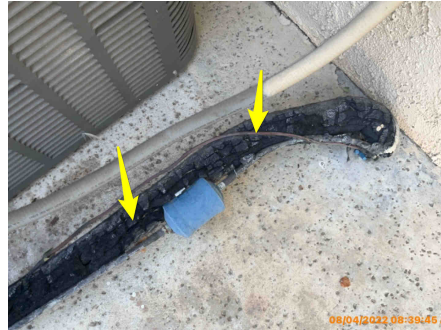
A/C REFRIGERANT LINES

RM Refrigerant insulation is missing on refrigerant line, line should be insulated for better efficiency.

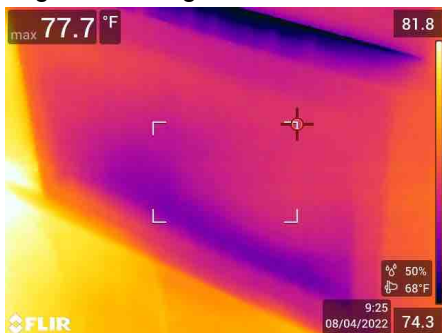
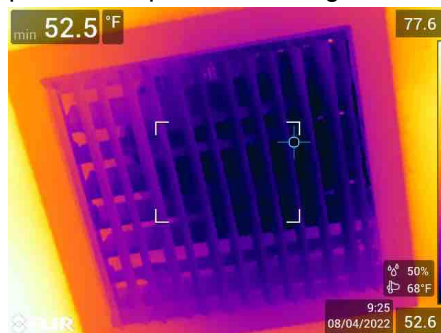
A/C SYSTEM CONDITION

Ambient temp = 77 Supply temp = 52. Temperature split = **25**. Air conditioner was turned on and appeared to be in good working condition at time of inspection. Inspector is testing for a **18** to **22** degree drop in temperature.

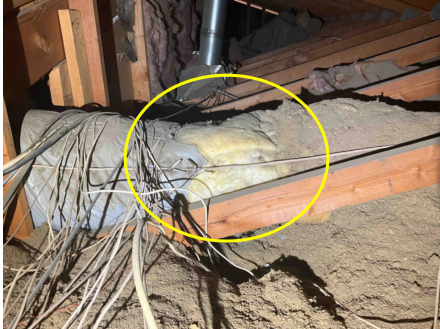
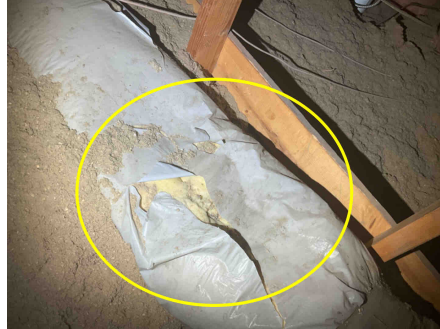
NR Gray flex duct thermal plastic cover is damaged and duct is crushed on heating duct(s) in attic. The loss of the protective plastic covering on flex ducting poses several concerns including loss of the duct insulation, increased air conditioning system operating cost due to air leaks and also indoor air quality concerns. Replacement is costly. Damaged ducts need to be replaced when this happens from end to end. We recommend the ducts be evaluated and replaced as needed by a qualified HVAC Contractor

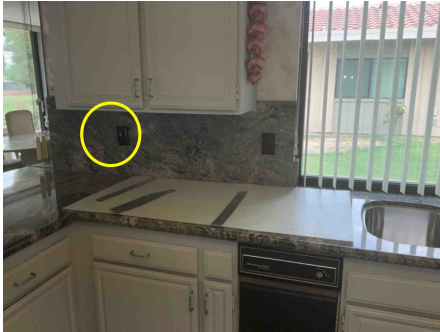
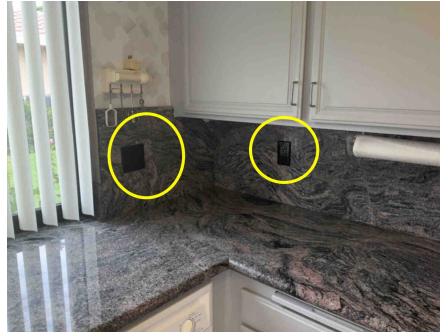
RECEPTACLE(S) CONDITION

SC All Kitchen receptacles are required to be GFCI protected when a kitchen is remodeled, electrical is required to be updated. GFCI receptacles need to be installed at all receptacles serving all counters, Recommend further review and repairs as needed by a Qualified Electrical Contractor.

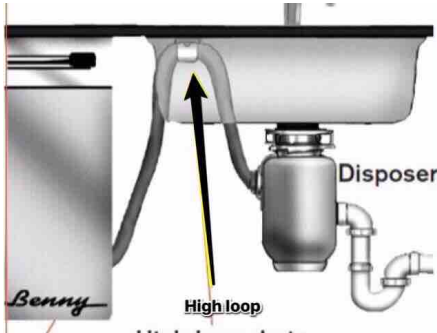
DISHWASHER AIR GAP CONDITION

RM High loop dishwasher drain line not high enough to prevent siphoning. We recommend further review and repairs by a qualified specialist in the appropriate trade.

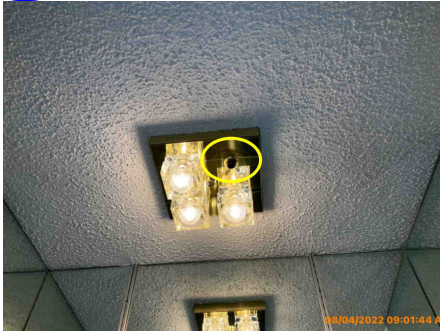
NR Light bulb missing at time of inspection, replace bulb and re test.

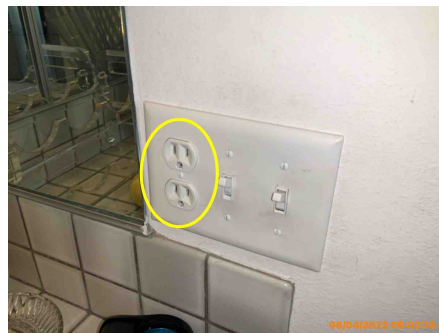
UG GFCI Protected receptacles missing at bar. Recommend further review and repair by qualified Electrical Contractor.

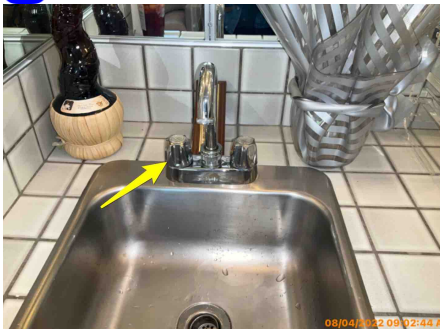
NR Faucet handles difficult to turn

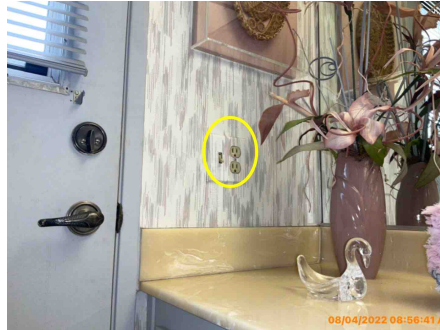
SC Bathroom receptacle(s) is/are not Ground Fault Circuit Interrupter (GFCI) protected, ground fault circuit interrupters are required in bathrooms. Recommend further review and repair by qualified Electrical Contractor.

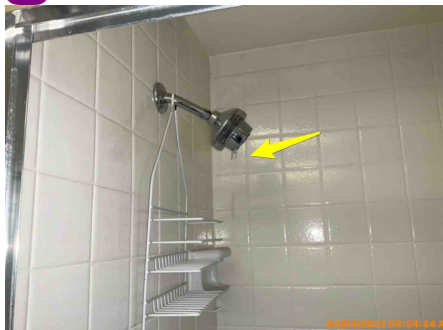
RM Leaking is noted at shower head connection

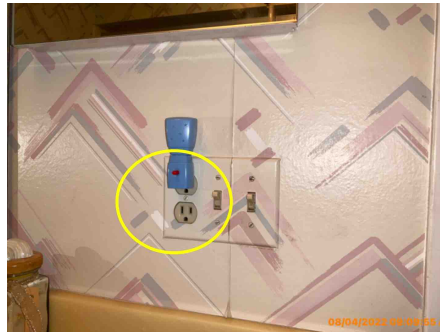
SC Bathroom receptacle(s) is/are not Ground Fault Circuit Interrupter (GFCI) protected, ground fault circuit interrupters are required in bathrooms. Recommend further review and repair by qualified Electrical Contractor.

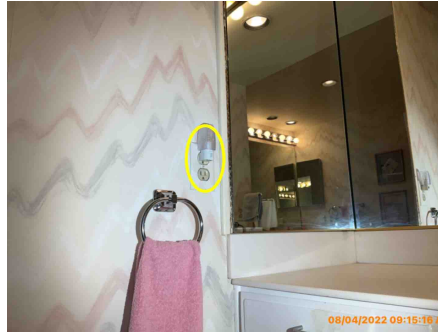
SC Bathroom receptacle(s) is/are not Ground Fault Circuit Interrupter (GFCI) protected, ground fault circuit interrupters are required in bathrooms. Recommend further review and repair by qualified Electrical Contractor.
