**BPG Inspection, LLC**

**1015 Rachelle Way  
El Cajon CA 92019**

Client(s): Camberos  
Inspection Date: 4/22/2026  
Inspector: Mark Kirkland ,

| <b>Property:</b> 1015 Rachelle Way, El Cajon, CA 92019 | | <b>Prepared By:</b> Mark Kirkland |

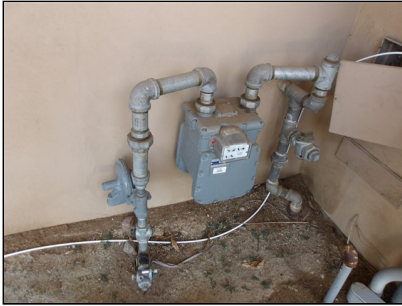
Gas front exterior

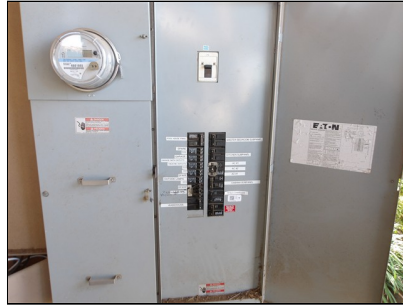
Electric front exterior

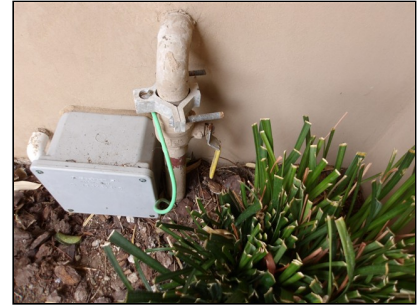
Multiple water shut off valves

♦ In an emergency, the locations of the various shut-offs for the utilities should be readily accessible and well known. We strongly recommend familiarizing yourself and other occupants of this building with their exact locations and their operation. You can find information about their locations under this section or in the Plumbing and Electrical systems. We observed several water disconcert valves at the exterior of the home. We recommend labeling the water shut off valves.

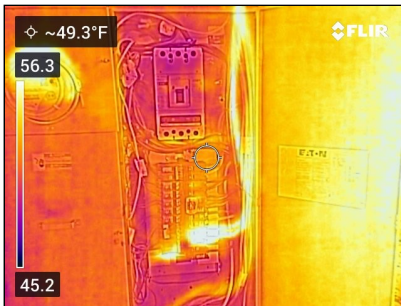
No abnormal heat in electric panels

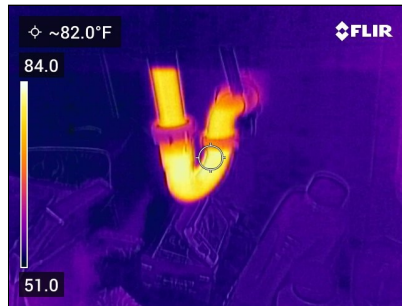
No visible leaks under sinks

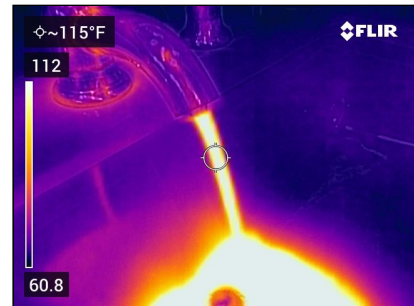
Hot water noted all fixtures

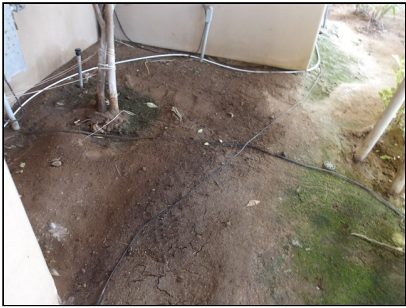
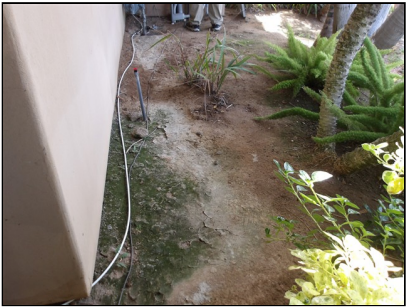
- ◆ The grading around the exterior is flat by modern standards in several areas. The soil should fall away 6" in 10' for proper grade. Have a technician correct as needed.

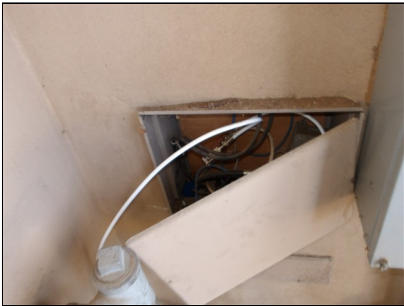
♦ A low voltage access panel cover is loose and not fully attached at the front of the home near the electric panel. This can allow moisture into the walls. A qualified technician should repair the access panel.

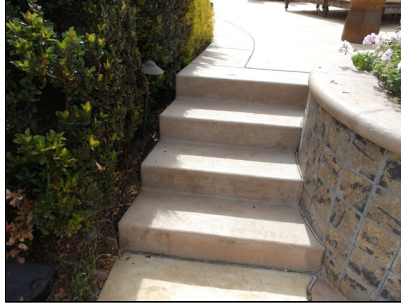
♦ A proper handrail is needed on the exterior steps on the rear of the building near the pool. No rail is installed.  
- Handrailings should be installed, to reduce the potential for personal injury at this location.

The steps are narrow and not standard width. This can cause possible injury. A licensed contractor and/or specialist should repair the steps to meet current standards.

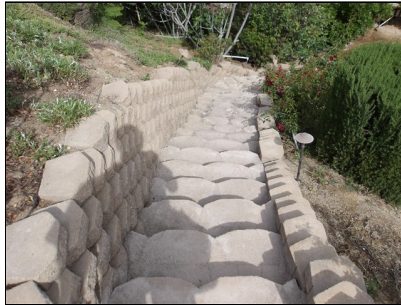
- ❌ ♦ A proper handrail is needed on the exterior steps on the rear of the building. No rail is installed.  
- Handrailings should be installed, to reduce the potential for personal injury at this location.

The steps are uneven in rise and run. The current industry standards require the maximum riser height of 7 3/4 inches with a maximum variation between steps of 3/8 an inch. An excessive variation could pose a trip hazard. We recommend upgrading your steps to current industry standards and having a qualified technician perform repairs as needed.

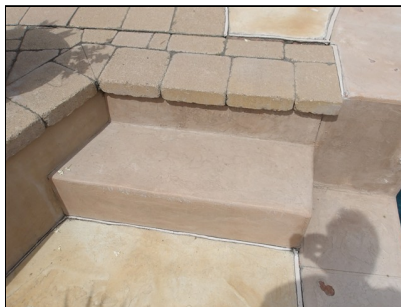
Pool area

- ❌ ♦ The steps are uneven in rise and run. The current industry standards require the maximum riser height of 7 3/4 inches with a maximum variation between steps of 3/8 an inch. An excessive variation could pose a trip hazard. We recommend upgrading your steps to current industry standards and having a qualified technician perform repairs as needed.

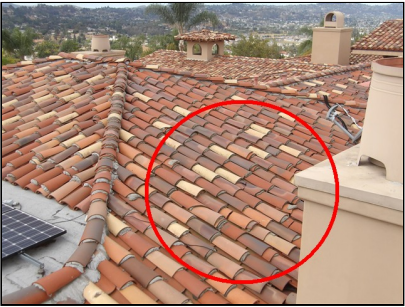
♦ Roof tiles were noted to be cracked, damaged, or displaced. Further evaluation and repairs/replacement is needed. Since inspectors do not walk on concrete/clay/composite roof tiles, there could be additional tile defects. Have the roofing technician who corrects this/these reported conditions, check the rest of the roof.

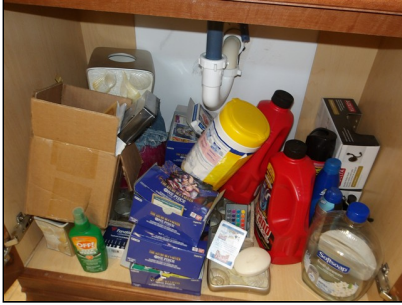
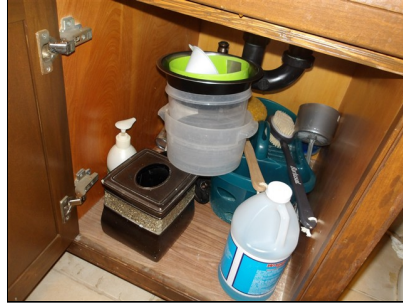
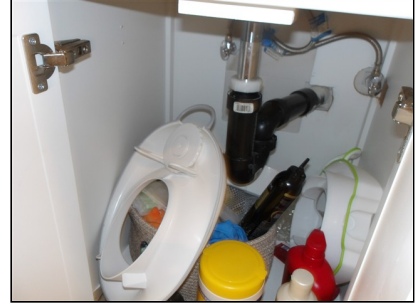
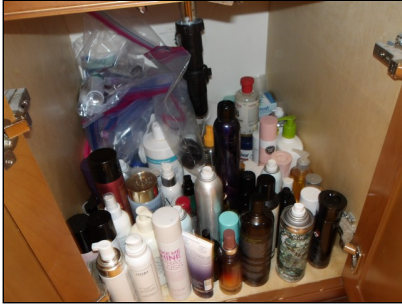
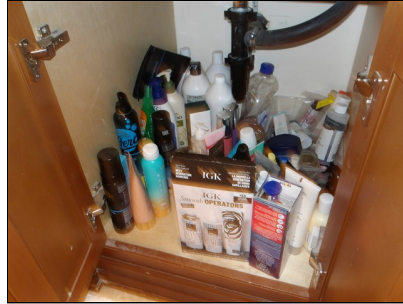
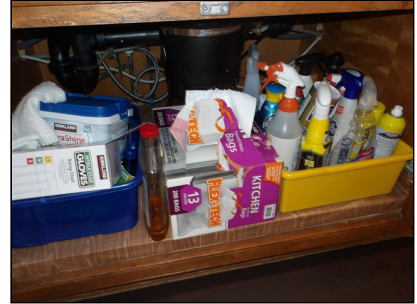
- ◆ Storage under the sink prevented access to inspection of all features contained there in several rooms. Removal of the items may expose other non-reported conditions. The cabinets and walls under the sinks should be evaluated for leaks and damage prior to close of escrow.

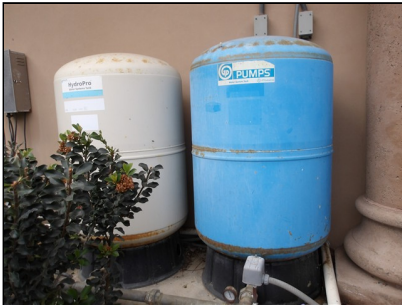
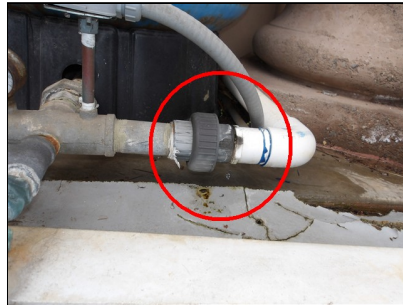
- ◆ There is a water softener or filtration system on the property. Testing the function of this device is not within the scope of this inspection.
- ✗ ◆ Inspection of the well water system is outside the scope of this inspection. However, we observed active leaking noted at the well pipes. We recommend a licensed plumber perform repairs.

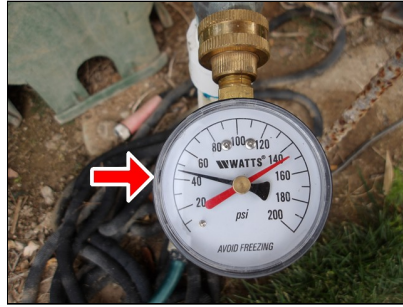
46 psi

- ◆ Water pressure at time of inspection. (The water pressure should be between 40 - 80 psi.) The pressure was within limits.

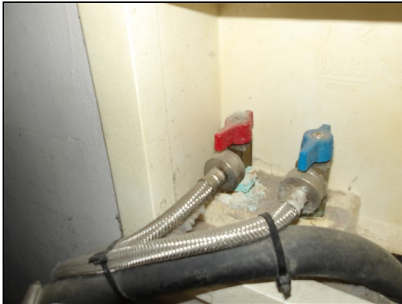
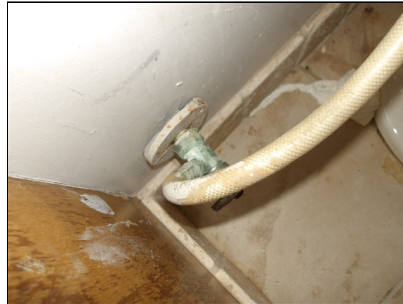
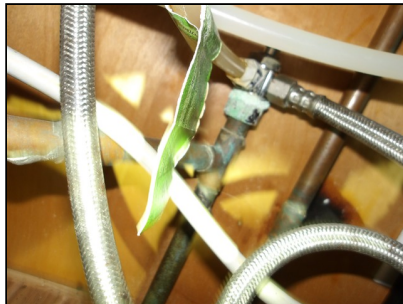
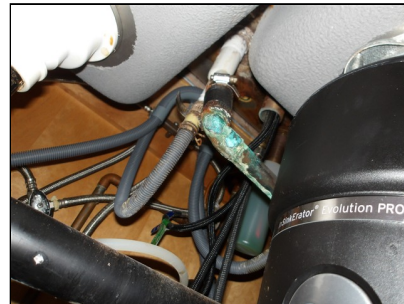
- ◆ Backflow prevention devices are now required on exterior hose bibbs to prevent contamination of the domestic water supply. These devices are inexpensive and available at most hardware stores. Consider upgrading the hose bibbs by installing backflow devices.
- ◆ There is surface corrosion in the visible supply and/or waste piping at several valves, fixture and drains in the home. We observed no signs of active leaks at the time of the inspection but leaks can develop anytime without warning. All valves and fixtures should be evaluated during your final walk through and before close of escrow to verify that no new leaks have developed.
  - This piping should be evaluated for leaks on a regular basis and repaired by a qualified technician when necessary.

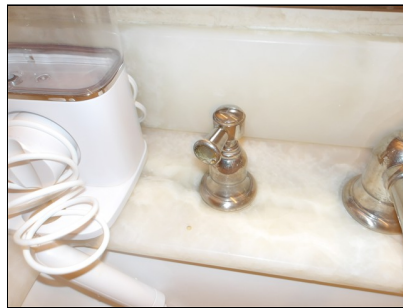
- ◆ One hot water faucet handle in master bathroom is missing. A qualified technician should repair or replace the handle.

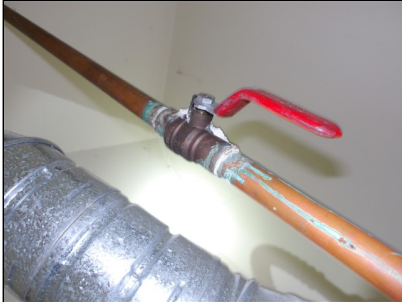
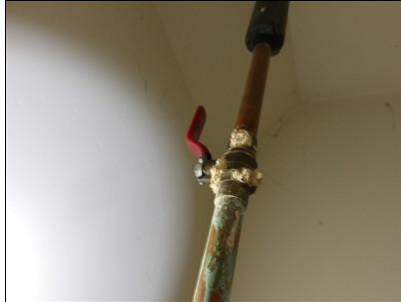
- ◆ The water line connections are corroded at both of the house water heaters.
  - These connections are dry at the time of the inspection and repairs should be made as necessary.

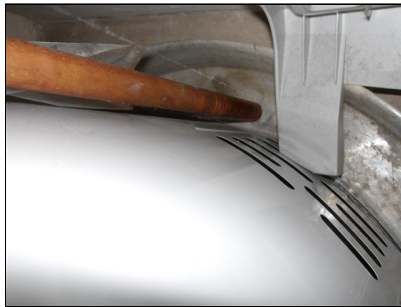
- ✗ ◆ The discharge pipe for the temperature & pressure relief valve on the water heater does not terminate outside the foundation, currently into water pan in laundry room water heater. A qualified technician should make any needed repairs or corrections.

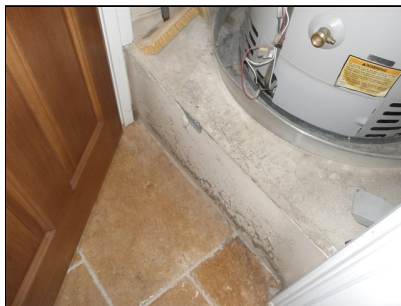
- ◆ The water heater stand and/or surrounding wall is damaged or stained in laundry room. This is often caused by a previous leak. The areas were dry at the time of the inspection. We recommend asking the seller for details regarding the damage and any previous leaks. A qualified technician should perform repairs as needed.

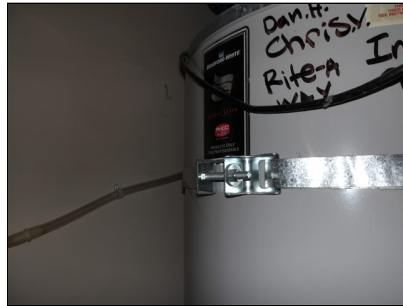
- ✗ ◆ The water heater's capacity is greater than 52 gallons and there are only two seismic straps installed in laundry room. The straps are loose and also allow movement. The California Office of the State Architect has published standards with which all water heater installations in the state must comply when buildings are sold or transferred. These standards require adequate restraint provided by an approved metal strapping, located one third down from

the top and another approximately 4" above the control valve. If the heater is larger than 52 gallons, then approved strapping rated for a larger tank or additional strapping or engineered strapping may be required. A third strap is recommend at times to comply with the California Office of the State Architect standards for seismic strapping of water heaters.

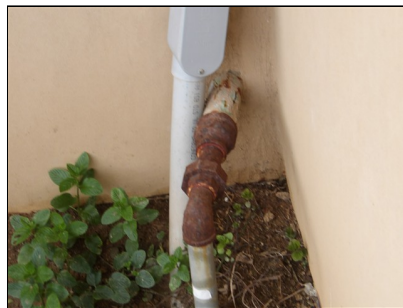
- ◆ There is surface corrosion in some areas of the visible gas piping at the rear exterior. We observed no signs of leaking during the inspection. This piping should be regularly evaluated for leaks and repaired if necessary .

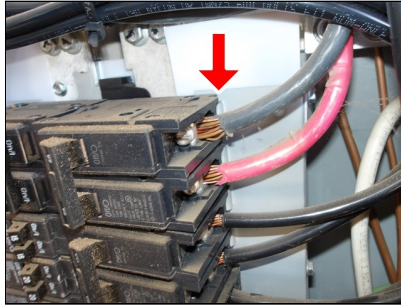
- ◆ The main electric panel at the front exterior have one or more wires with excessive sheathing removed. A licensed contractor and/or specialist should repair the wires.

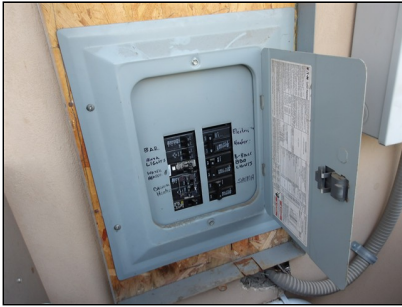
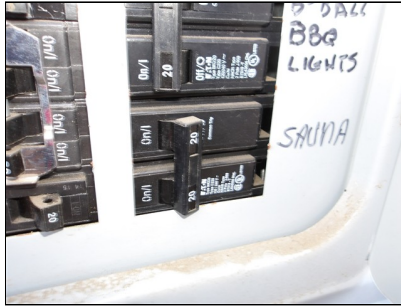
- ◆ One or more breakers in the exterior cabana sub panel are in the off position at the time of this inspection. We did not activate the breakers, or energize the circuits because doing so could create a hazard.
- The owner may have information as to why the breakers are in the OFF position. If it is not functional, a licensed electrician should make appropriate repairs before closing escrow.

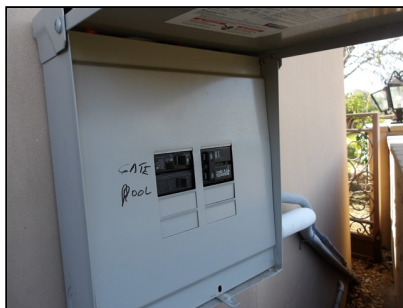
- ◆ The exterior cabana electric panel is missing a cover screw and labels. A qualified technician should install a cover screw and label the circuits.

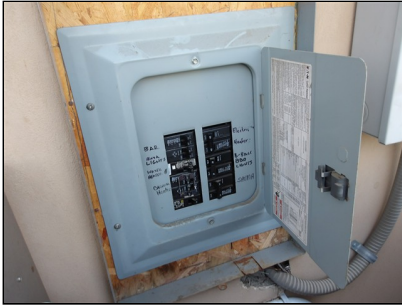
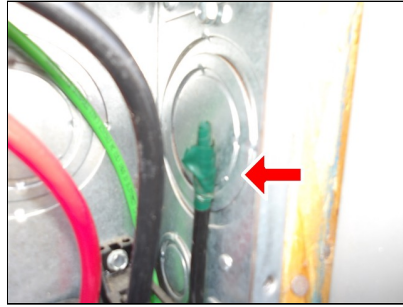
- ◆ The problem(s) discovered in the exterior cabana sub panel such as uncapped abandoned wires, 20 amp breaker on size 14 wire, and any other problems that an electrician may discover while performing repairs need correcting. We recommend a licensed electrician inspect further and correct as needed.

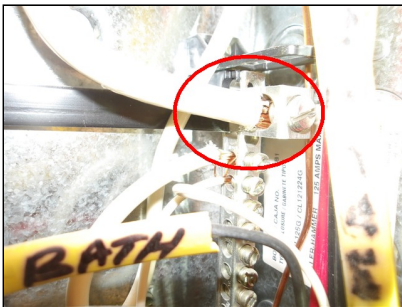
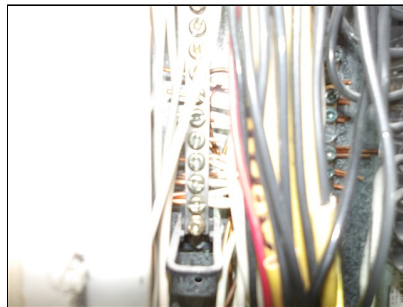
- ❌ ♦ The problem(s) discovered in the master bedroom sub panel such as double lugged neutral wires at buss, frayed wires, knock out missing, and any other problems that an electrician may discover while performing repairs need correcting. We recommend a licensed electrician inspect further and correct as needed.

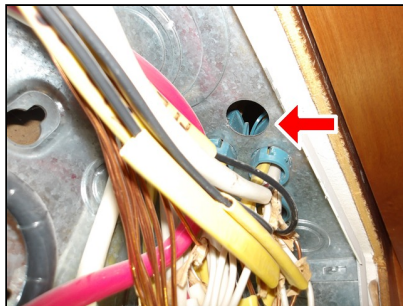
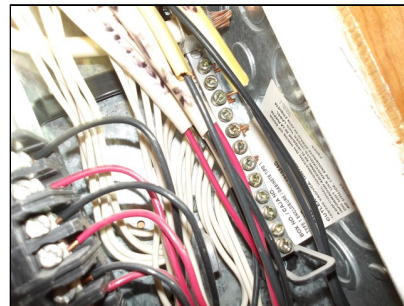
- ❌ ♦ The problem(s) discovered in the kitchen pantry sub panel such as double lugged neutral wires at buss, knock outs missing in panel, and any other problems that an electrician may discover while performing repairs need correcting. We recommend a licensed electrician inspect further and correct as needed.

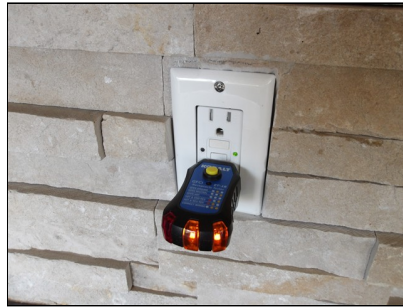
- ✘ ◆ When tested, the GFCI outlet at the exterior cabana did not function properly. It failed to trip. This is an indication of a defective or improperly-wired GFCI. A qualified electrician should make repairs or modifications as necessary.

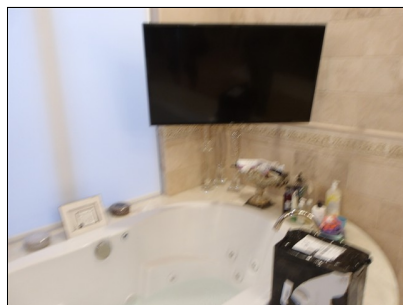
- ✘ ◆ There is a TV directly over the bathtub in the master bathroom. We were unable to find the receptacle or prove that the TV is protected by GFCI. If GFCI protection can't be confirmed then a qualified technician should install proper GFCI protection.

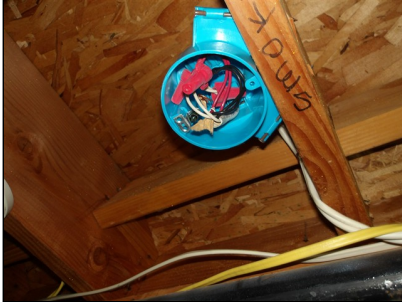
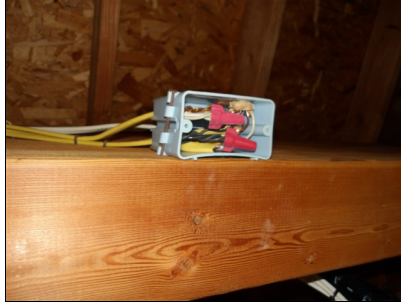
- ❌ ♦ There are several open junction boxes at various locations in the attics. Lack of covers can create a shock or fire hazard.
- A qualified technician should check the system and install proper covers on all junction boxes.

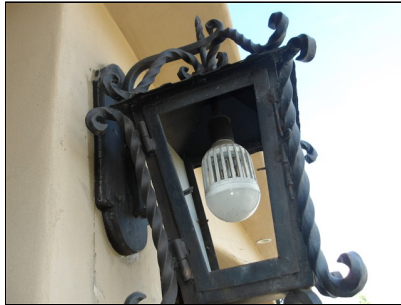
- ⚠️ ♦ Several light fixtures are loose and/or not sealed at the exterior walls. A qualified licensed electrician should make any needed corrections.
- ⚠️ ♦ Several exterior lights are damaged and/or have corrosion. A licensed contractor and/or specialist should repair or replace all damaged lights.

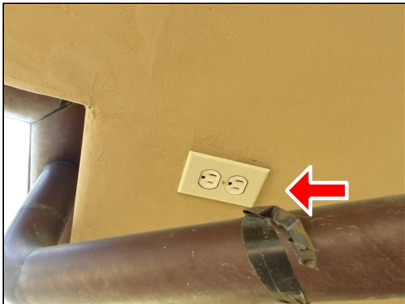
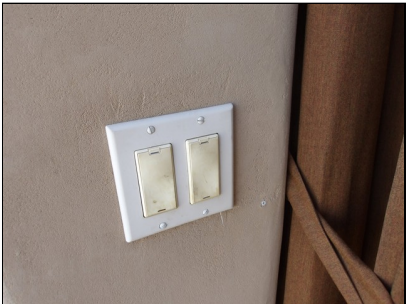
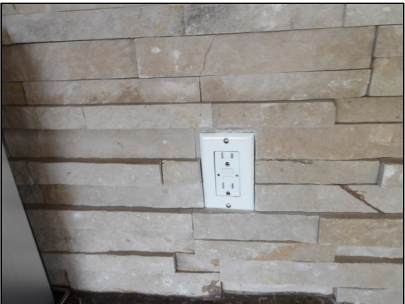
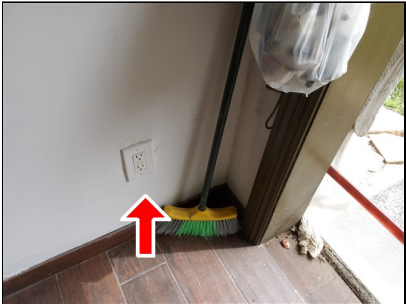
- ❌ ♦ Several exterior outlet and switches at the front exterior, left side cabana, prayer house entryway, does not have an exterior rated cover installed. A qualified technician should install exterior rated covers at all exterior locations.

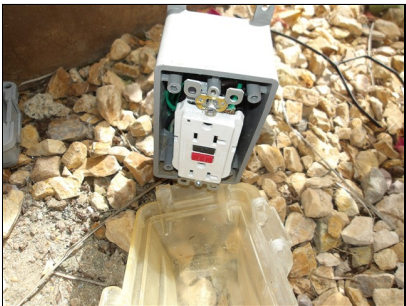
✗ ♦ The outside outlet cover at the exterior prayer house is damaged and needs repaired or replaced.

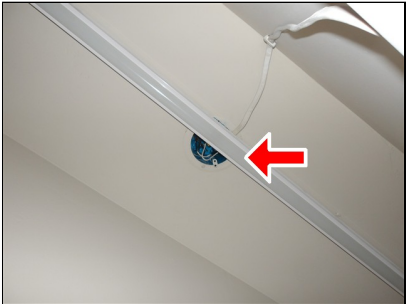
✗ ♦ The light fixture has an improper junction box for the light at the bedroom closet in middle bedroom. Their are exposed wires. A qualified technician should make any needed repairs.

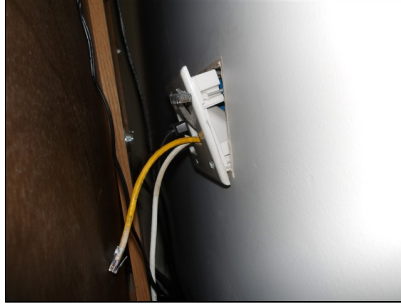
✗ ♦ One or more receptacles is loose in the wall at master bedroom. A qualified electrician should make any needed repairs.

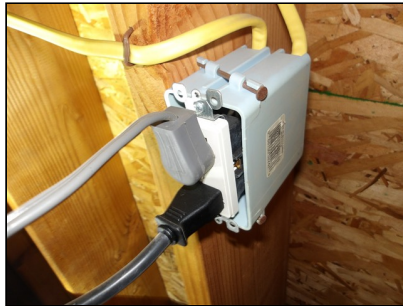
attic

- ❌ ♦ One or more cover plates for receptacles and switches are missing or damaged in the building. This can be a shock hazard. All missing or damaged cover plates should be replaced with new cover plates.

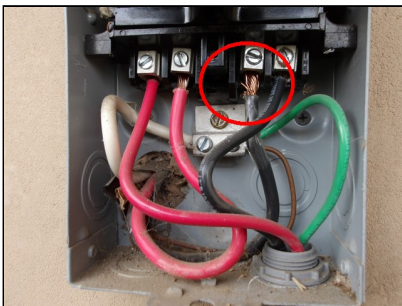
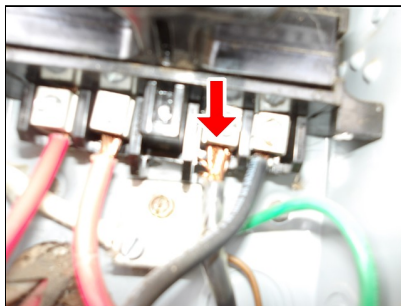
- ❌ ♦ Two of the AC electric disconnects has frayed wire connections at the rear exterior of the home. A licensed electrician should perform repairs.

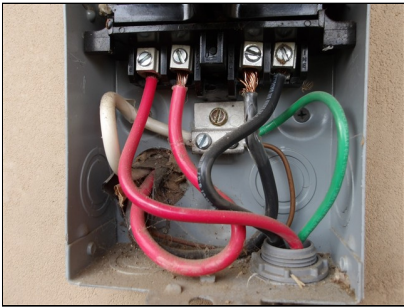
- ❌ ♦ The protective "deadfront" cover for the local HVAC disconnect, which helps prevent hazardous shocks, is missing at rear exterior.  
- A properly fitting deadfront cover should be installed for safety purposes.

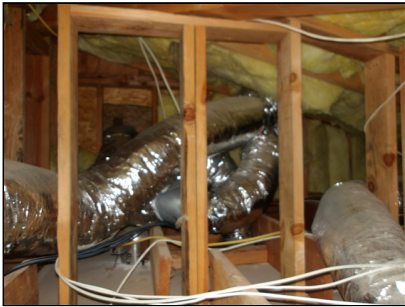
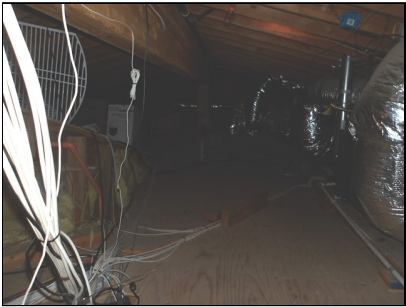
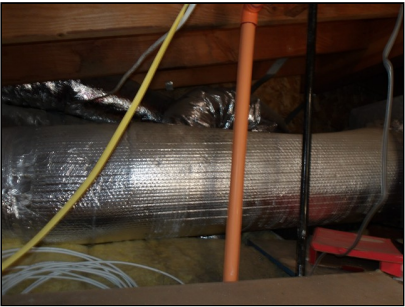
♦ We could not access one or more attic areas due to one or all of: no access, low headroom, vaulted ceilings, insulation concealing the rafters, duct work, temperature, unsafe conditions, storage, etc. Further evaluation is advised if the client has concerns about these areas.

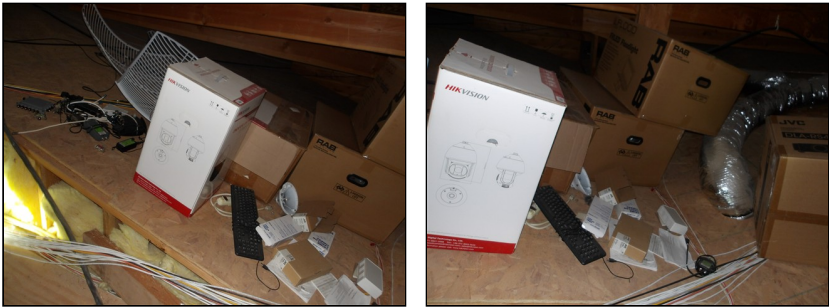
♦ This attic space has abandoned items that should be removed. A technician can do the work.

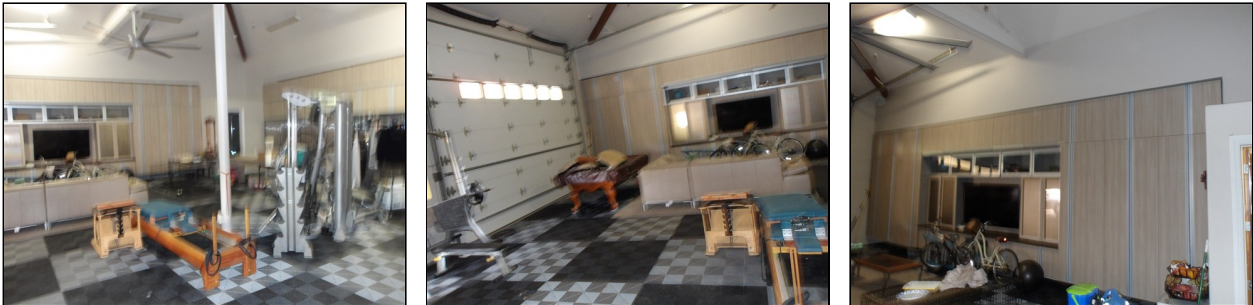
- ◆ The presence of personal items limited access to the garage at the time of this inspection.
- A "walk through" is recommended when the areas is cleared and accessible, prior to the close of escrow.

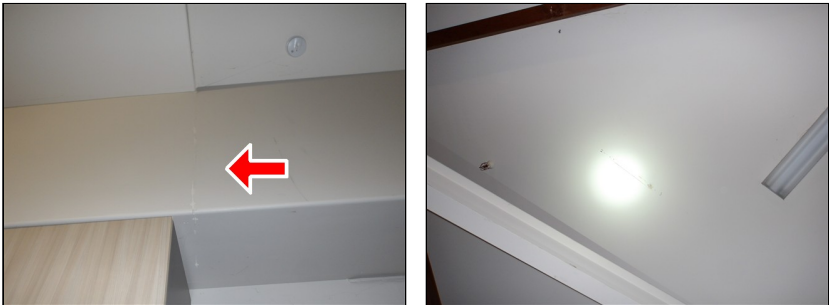
- ◆ The ceiling has small holes and cracks at the garage. A qualified technician should make any needed repairs.

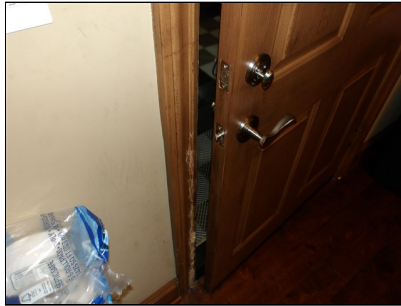
- ✗ ♦ The passage door from the garage bedroom to the garage needs the self closer adjusted. Failed to close and latch. A qualified technician should make repairs or modifications as necessary to restore the fire separation.

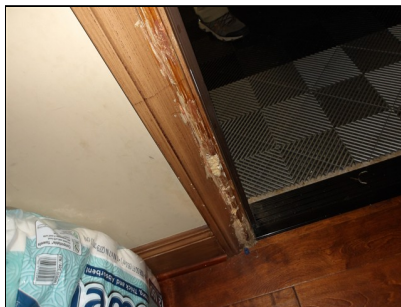
- ⬆ ♦ The door trim is damaged in the garage bedroom. A qualified technician should repair the damaged areas.

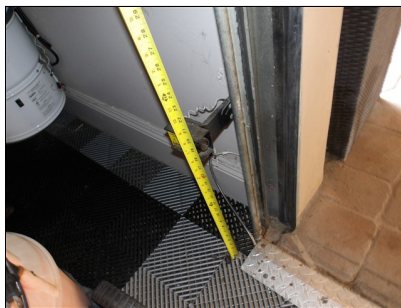
- ♦ The garage door opener raises and lowers the door properly and it stopped and reversed when the light beam was interrupted. We did not test the auto-reversing or stop function of the opener by physical force because of the potential to damage the door or the opener.
- ✗ ♦ The optical sensor or track beam installed on the garage door opener (which activates the reversing eye system) is installed at an incorrect height. This could allow small children or animals to move under the beam without activating the safety feature. This is a safety concern.
  - The optical sensor or track beam should be installed six inches above the floor of the garage or in accordance with the manufacturer's specifications.

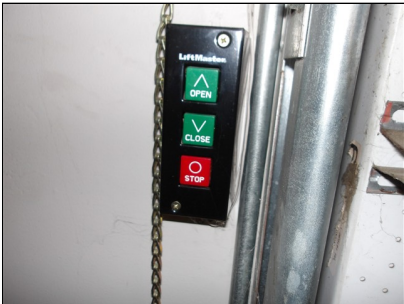
- ⬆ ♦ The garage door controls near the doors failed to stop when the buttons were pushed. The doors stopped when the wall controls near the garage pedestrian door was pushed but not when these buttons were pushed. A qualified technician should repair as needed.

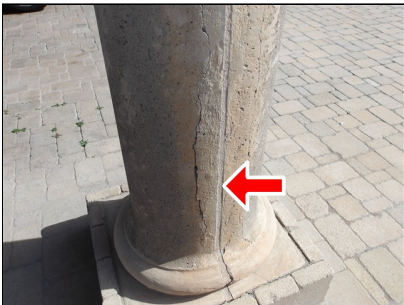
♦ Several exterior front carport cover post are cracked. We observed no signs of structural movement. A qualified technician should repair the cracked areas

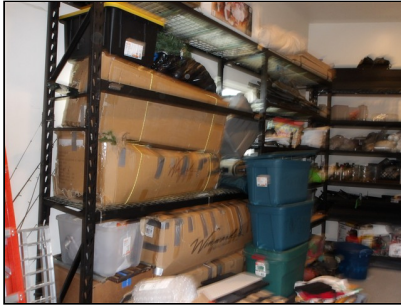
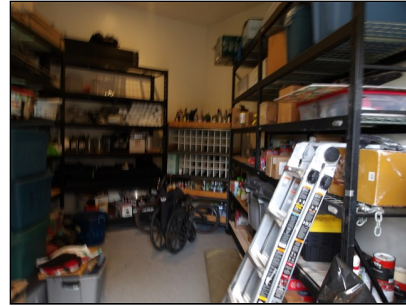
♦ The presence of many personal items limited access to the detached storage room at the time of this inspection.  
- A "walk through" is recommended when the areas is cleared and accessible, prior to the close of escrow.

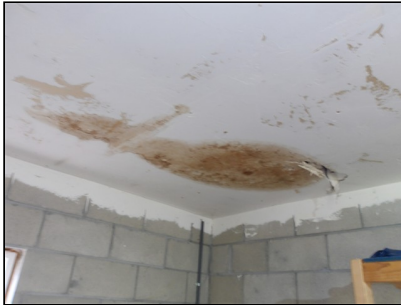
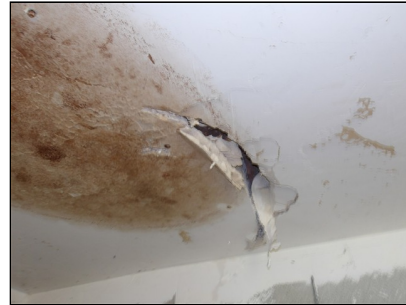
- ❌ ♦ Water stain/damage is present in the detached pool equipment storage room ceiling. The source of the leak should be identified and necessary repairs performed before any attempt is made to restore surface appearance. A licensed roofer should evaluate the roof and make repairs.

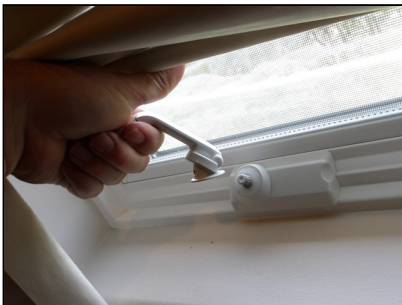
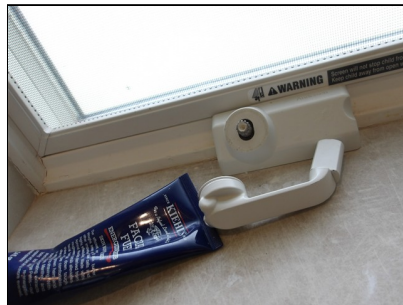
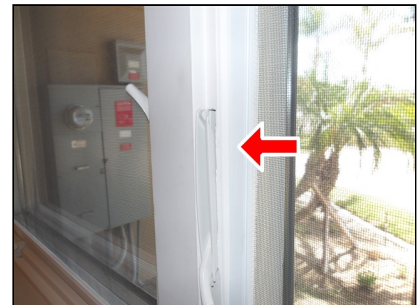
- ♦ We operated a representative sample of the windows, but did not open, close, and latch every window. Windows were found to be generally functioning.
- ⬆ ♦ Several windows do not operate smoothly, are difficult to latch or are in need of adjustment. All poorly or non-operating windows and their associated hardware should be cleaned, lubricated, and adjusted for smoother operation. Where needed, essential hardware, such as operator cranks, sash balances and latches should be replaced with compatible components.

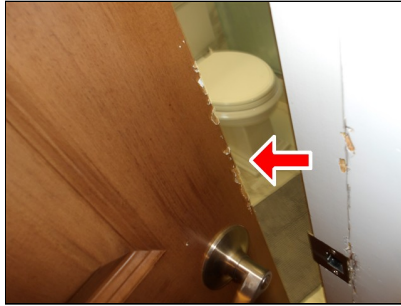
- ◆ The interior door to the bathroom in the far right rear bathroom is damaged in several areas. The door is still functional but should be repaired by a qualified technician.

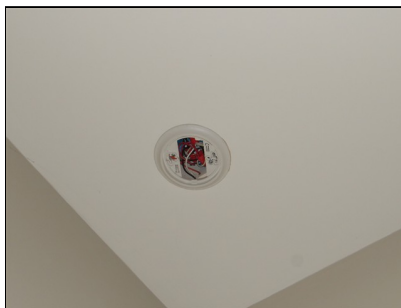
- ✗ ◆ The number of carbon monoxide detectors is less than would be required by modern standards. We did not locate any CO detectors. One carbon monoxide detector is required on each level of a multi level home. CO desecrators should also be installed in all bedrooms with fireplaces. CO detectors should be installed as needed according to manufacturers recommendations and the local building and state safety requirements.
- ✗ ◆ The number of smoke detectors is less than would be required by modern standards. Missing in one bedroom right side of home. Most cities want the detectors in each bedroom, hallway leading to the bedrooms and if multi-storied, at the top and bottom of the staircase at each level. Smoke detectors should be installed as needed according to manufacturers recommendations and the local building and state safety requirements.

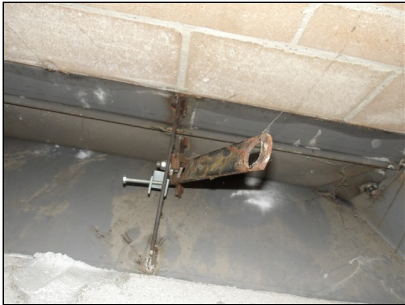
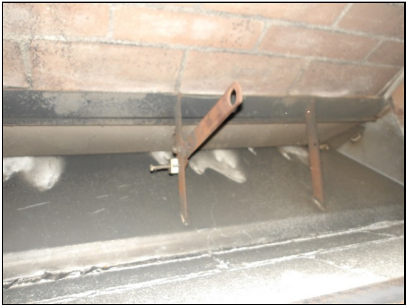
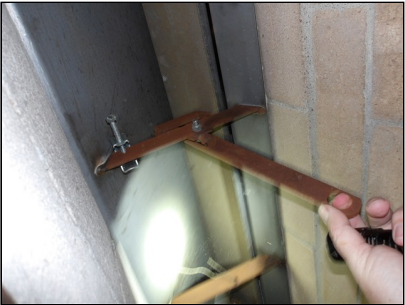
- ✘ ♦ All of the gas log fireplaces have a damper clamp installed but they are incorrectly installed and fail to stop the damper from fully closing. This is an important safety feature that ensures toxic gases go up the chimney, instead of escaping to the interior. - An approved damper clamp should be installed. (This is a very small "C" clamp attached to the damper door.)

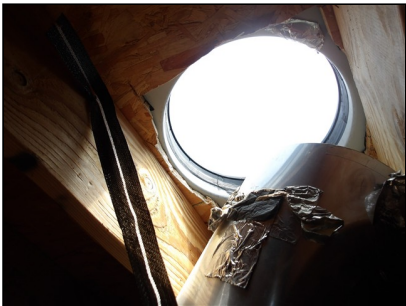
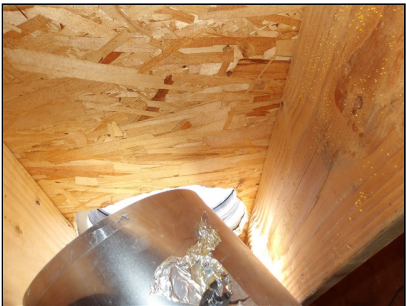
- ♦ Skylights are common leak sources. Monitor the area around the skylight(s) for any moisture intrusion and have repairs made if necessary.
- ⬆ ♦ The solar tub is disconnected in the master bedroom attic. It does not divert the light down the tube and into the room. A qualified technician should repair as desired.

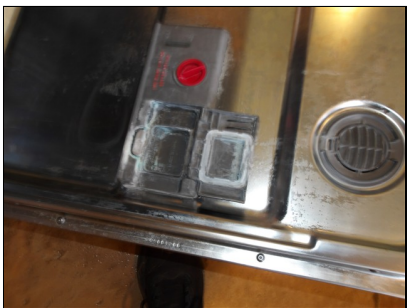
◆ The large dishwasher soap dispenser is stuck open and does not latch. A qualified technician should repair.

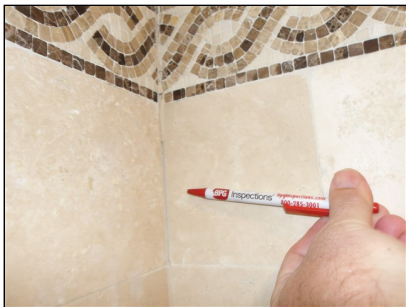
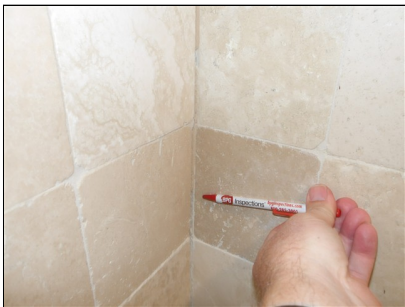
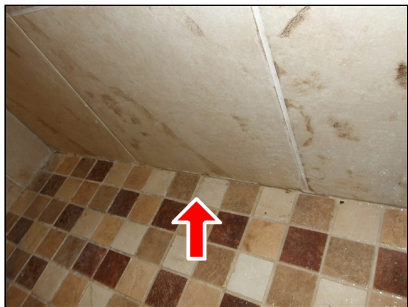
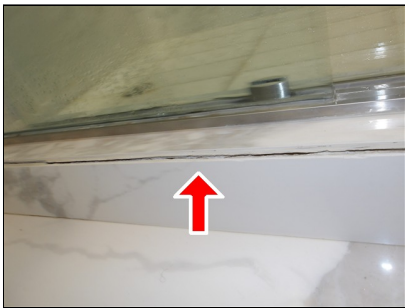
- ⬆ ◆ The grout is cracked, deteriorated and/or missing in several areas at the cabana, garage, far right side bathroom. Damaged or missing grout can cause leaks and moisture damage. A licensed contractor and/or specialist should perform repairs.

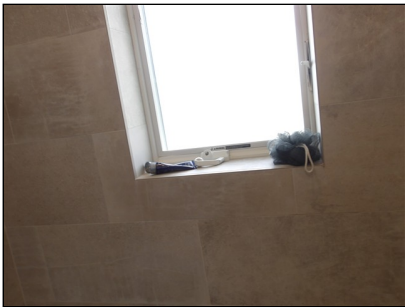
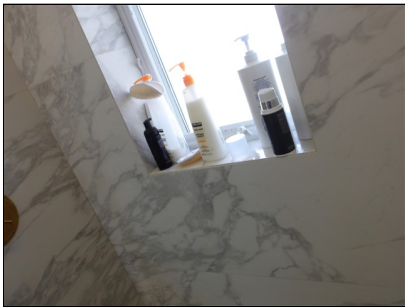
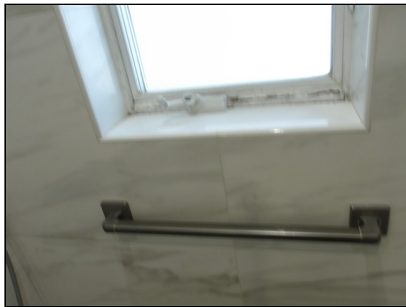
♦ The shower wall window was low enough where it was subject to oversplash from the shower in several bathrooms. The window framing and the shower wall are subject to possible water damage. Keeping the window and sill properly sealed is recommended.

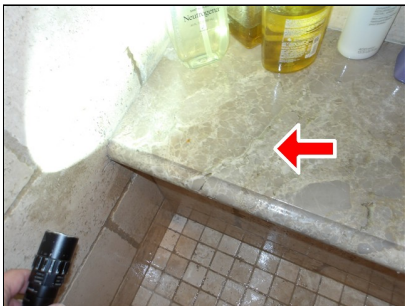
♦ Deterioration and a possible crack was noted on the shelf in the master bathroom shower. A qualified technician should repair the damaged areas.

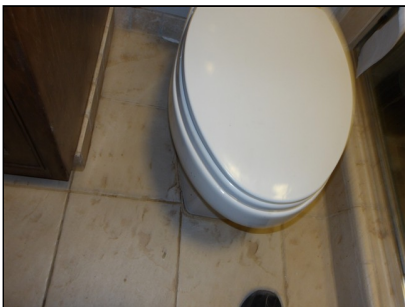
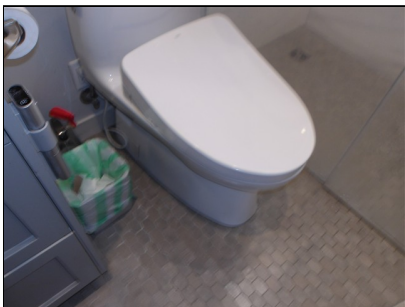
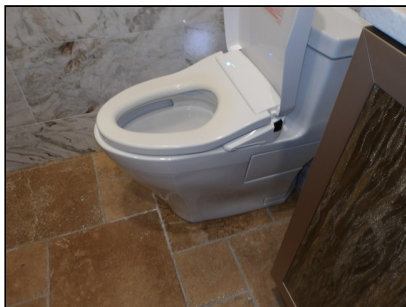
♦ The garage, half bathroom and front right bedroom toilets are not securely attached at the floor. This could allow leaks at or into the floor. A qualified technician should make repairs or modifications as necessary.

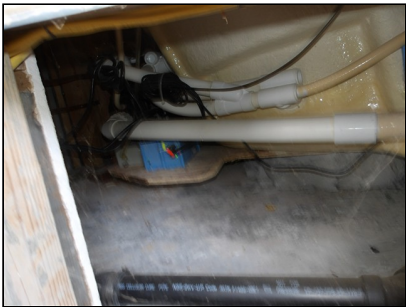
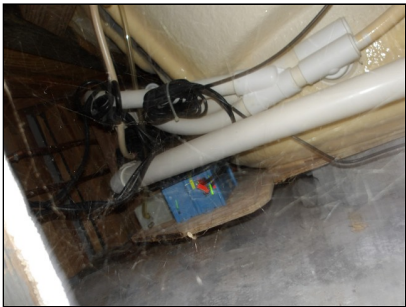
- ⚠ ◆ There is an access panel for the jet tub at the rear exterior of the home. There is limited access inside the panel to inspect the jet tub and its components. We were unable to verify if the jet tub is properly bonded. We saw no GFCI for the jet tub. We recommend having the seller identify the GFCI location for the jet tub. A licensed contractor and/or specialist should gain access and verify pump is properly bonded and perform additional repairs as needed.

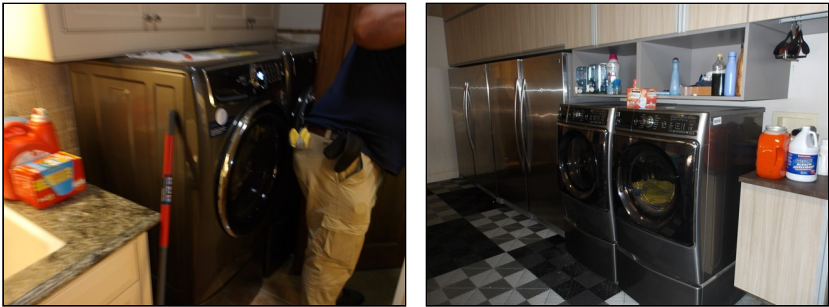
- ◆ The washer and dryer were not operated nor inspected, and are beyond the scope of the inspection. This is FYI.
- ⚠ ◆ Due to limited clearances around the laundry equipment, we could not identify the type of utility sources provided for the dryer, nor could we verify the washer connections and drain lines. Ask the owner whether gas or electricity (or both) are available at the dryer location and review the washer hookups when access is available.

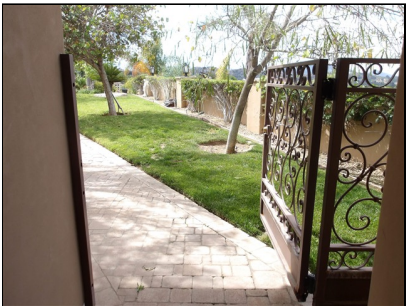
- ⚠ ◆ **As of January 1, 2018 Pool Safety Act (Senate Bill 442)**, California law requires new or remodeled pools and spas to have 2 of 7 child protective safety barriers. **While existing pools and spas are not required to add additional safety barriers, we suggest when it comes to protecting our young and vulnerable , all pools and spas should have 2 of 7 appropriate safety barriers identified in the Pool Safety Act.** Conformance of several of the items cannot be determined by a visual inspection. We recommend that the current owner or their representative provide any and all documentation to ensure compliance or have a qualified pool contractor further evaluate and perform any needed repairs.

**The exterior fences and gates do not meet current industry standards. The gate stays open, no gate other than car gate on other side of the house and no secondary barrier device. We recommend adding additional safety features to comply with Senate Bill 442.**

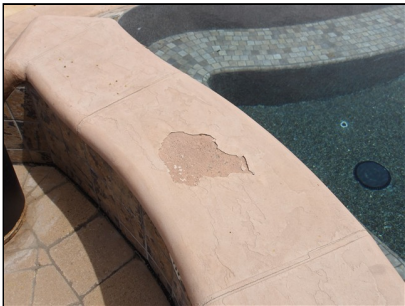
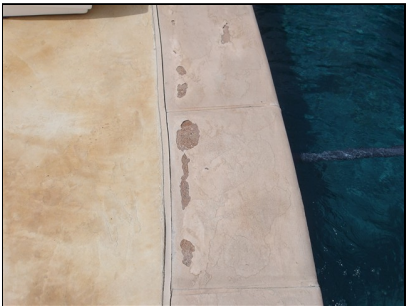
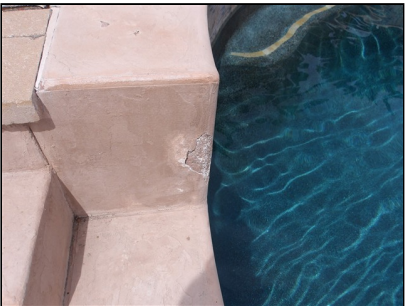
♦ The pool and spa patio surface is damaged, deteriorated and peeling paint in several areas. A qualified contractor should make any needed repairs or modifications.

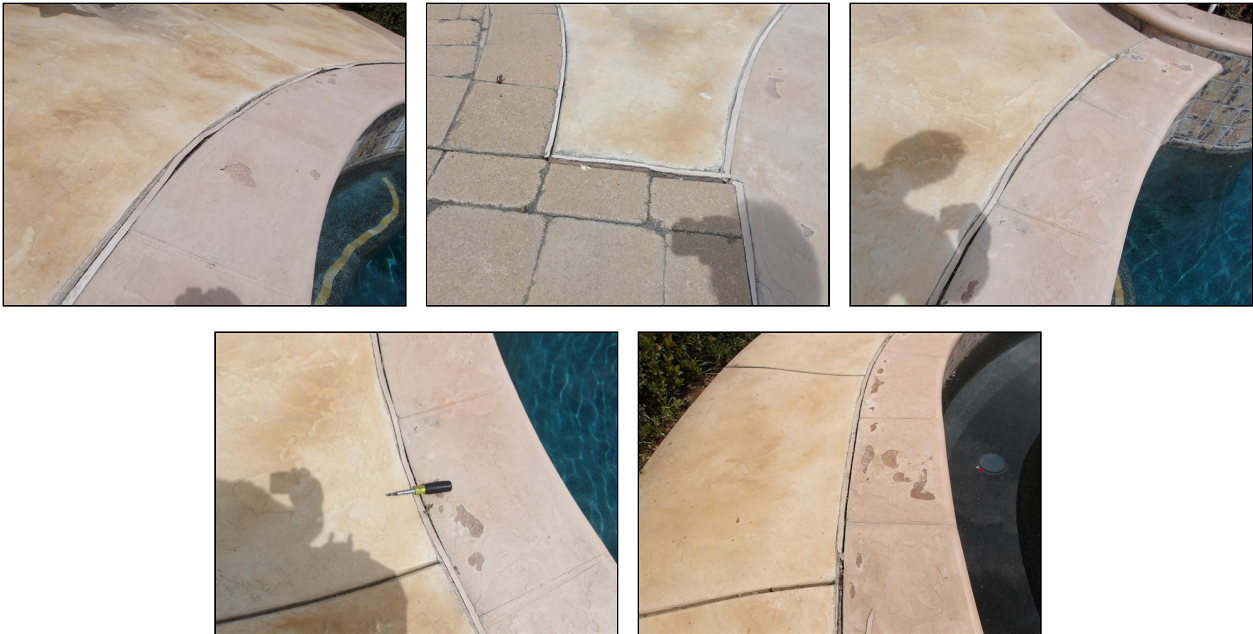
♦ The flexible expansion joint separating the pool coping from the surrounding flatwork is deteriorated. This may lead to water penetration under the concrete. Over time, this could damage the concrete and pool. There is currently an uneven walking surface, signs of separation and possible movement. A qualified pool contractor should evaluate the area and perform repairs.

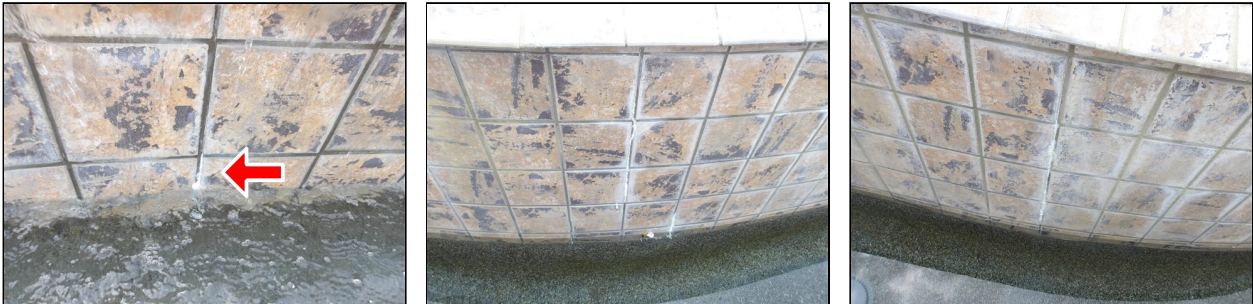
- ◆ Calcium build up/spots was noted at the spa and/or pool surface. Have the pool water tested ( take a water bottle sample to a pool supply store for free testing ) and follow the pool technician's recommendations for correction/ removal and prevention of surface calcium, if calcium is present.

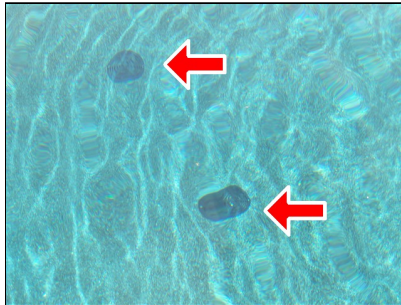
We recommend upgrading these components to meet present industry standards. The present industry standard is to have two drains at the pool and two at the spa with proper drain covers manufactured after December 19, 2008. In Addition, every suction drain on a pool must have a split (dual) drain or be equipped with a safety vacuum release system or an automatic pump shut off system. The existing drain cover/s do not appear to meet industry standards and we were unable to identify the required safety devices. We recommend further evaluation and repair by a qualified pool contractor.

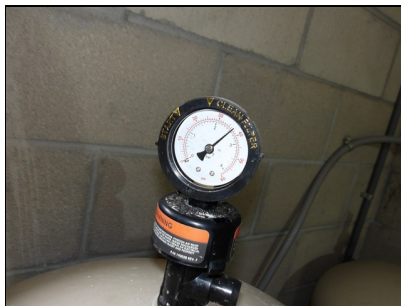
- ♦ A pressure gauge is used to determine the need for filter servicing and cleaning. Consult a pool specialist to get guidelines for the proper operating pressure.

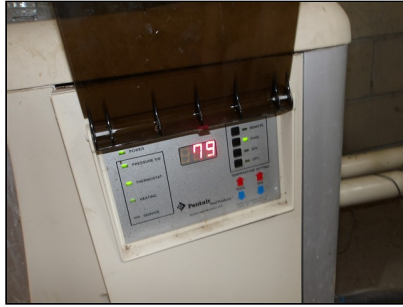
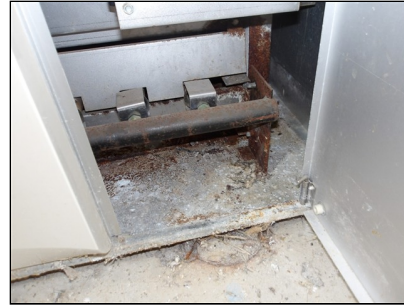
- ☑ ♦ The heating system, which is an older system, responds to normal operating controls. The system is dirty and shows normal wear and tear for a system this age. We recommend review and servicing by a qualified pool contractor prior to close of escrow.

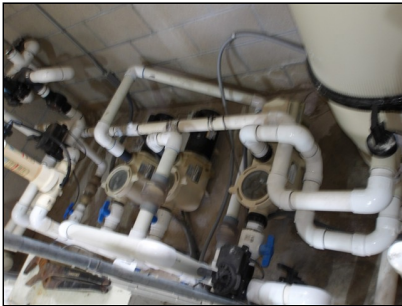
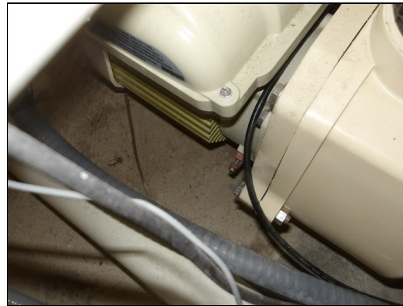
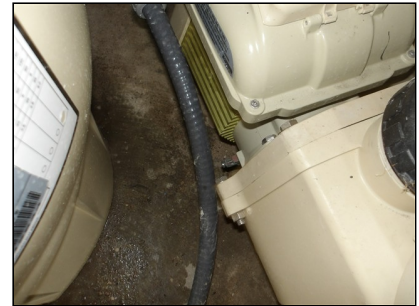
- ◆ Two pool pumps lack proper bonding to ground. Equipment that is not bonded can be a shock hazard. A qualified licensed electrician should make any needed modifications.

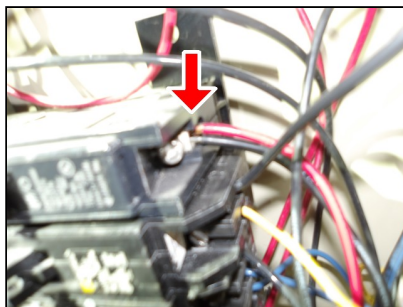
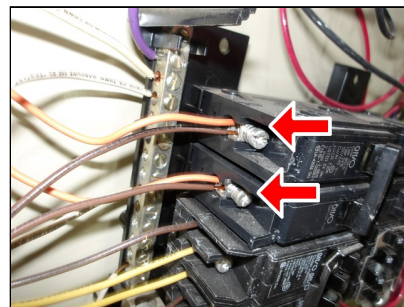
- ◆ The pool pumps are not protected by GFCI (ground fault circuit interrupter) protection. This may not have been required at the time of construction but current industry standards require all pool pumps to be protected by GFCI. As a safety upgrade, consider installing GFCI protection at all recommended locations.
- ◆ The problem(s) discovered in the pool sub panel such as double wired circuits, and any other problems that an electrician may discover while performing repairs need correcting. We recommend a licensed electrician inspect further and correct as needed.

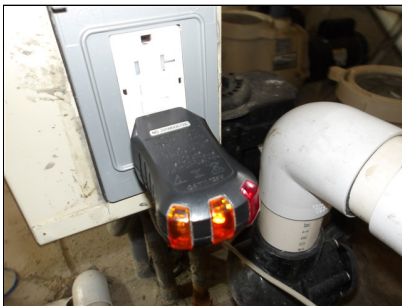
- ◆ When tested, the GFCI outlet at the pool and spa area did not function properly. The receptacle is improperly wired hot and neutral reverse. This is an indication of a defective or improperly-wired GFCI. A qualified electrician should make repairs or modifications as necessary.
