WOOD DESTROYING PESTS AND ORGANISMS INSPECTION REPORT

Building No. 528	Street Dawson St.	City Morro Bay	Zip 93442	Date of Inspection 05/25/17	Page 1 of 5

Mojoe Termite 1445 Grand Ave., Suite H Grover Beach, CA 93433 Phone: 805-574-1990 Fax: 805-574-1991 Mojoetermite.com Registration # PR5493 Report # 8667					
Ordered by: Cayucos Realty Dave Stevens Cayucos, CA 93430 W: 710-2316		Property Owner and/or Party of Interest:		Report sent to: Cayucos Realty Dave Stevens Cayucos, CA 93430 Phone: 710-2316	
COMPLETE REPORT <input checked="" type="checkbox"/> LIMITED REPORT <input type="checkbox"/> SUPPLEMENTAL REPORT <input type="checkbox"/> REINSPECTION REPORT <input type="checkbox"/>					
General Description: Two story residence; Stucco and wood siding; Composition roof; Vacant				Inspection Tag Posted: Garage Other Tags Posted:	
An inspection has been made of the structure(s) shown on the diagram in accordance with the Structural Pest Control Act. Detached porches, detached steps, detached decks and any other structures not on the diagram were not inspected. Diagram is not to scale. Locations are only approximate.

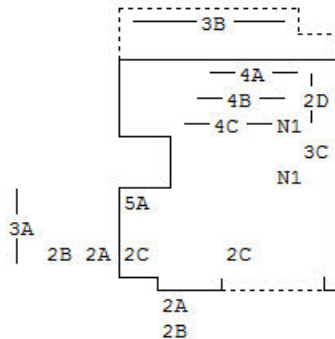
Subterranean Termites <input type="checkbox"/> Drywood Termites <input checked="" type="checkbox"/> Fungus / Dryrot <input checked="" type="checkbox"/> Other Findings <input checked="" type="checkbox"/> Further Inspection <input checked="" type="checkbox"/>					
If any of the above boxes are checked, it indicates that there were visible problems in accessible areas. Read the report for details on checked items.					
KEY: 1 - Subterranean Termites 2 - Drywood Termites 3 - Fungus/Dryrot 4 - Other Findings 5 - Unknown Further Inspection

FINDING: Evidence of drywood termites was noted at the eaves.
