WOOD DESTROYING PESTS AND ORGANISMS INSPECTION REPORT

Building No. Street, City, Zip	Date of Inspection	Number of Pages
23655 SUNCREST AVENUE, MORENO VALLEY, 92553	07/13/2026	9

TERMINIX INTERNATIONAL, BRANCH #2550
649 S WATERMAN AVE
SAN BERNARDINO,CA 92408
PH: 9098900981

Firm Registration No PR 9806
Report No.: 95095-060826220423-8987

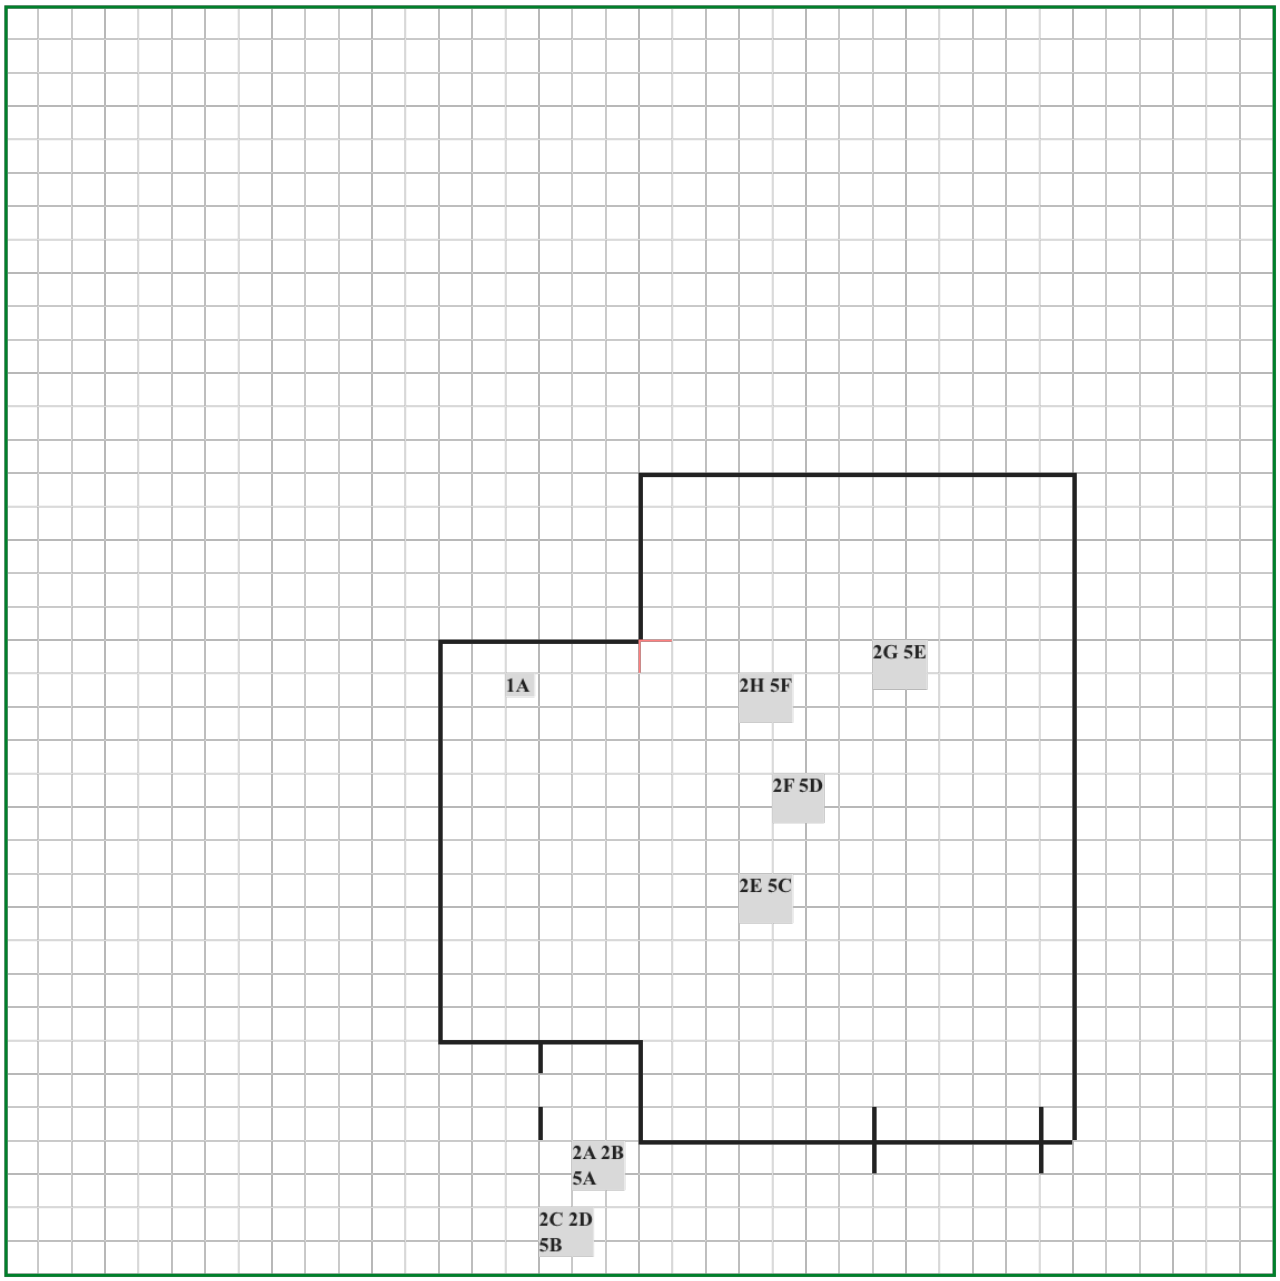
FINDING: Evidence of drywood termites was noted at/in Front entryway beam.

FINDING: Drywood termites have damaged Beam at/in Front entryway beam.

FINDING: Evidence of drywood termites was noted at/in Front yard gable board end near entryway to front door.

FINDING: Drywood termites have damaged Gable board at/in Front yard gable board end near entryway to front door.

FINDING: Evidence of drywood termites was noted at/in Droppings in garage base of wall near door leading into house.

FINDING: Evidence of drywood termites was noted at/in Base of closet door jamb near door going into garage from house.

FINDING: Evidence of drywood termites was noted at/in Droppings on catwalk centrally located with Swarmers same area.

FINDING: Evidence of drywood termites was noted at/in Droppings in attic on insulation center left portion of attic.

RECOMMENDATION: Remove or cover accessible drywood termite fecal pellets.

RECOMMENDATION: Fumigate the structure with an approved fumigant for the eradication of drywood termites.

RECOMMENDATION: Remove the damaged wood member(s). Replace the damaged wood with new material. See recommendations in this report for the control of drywood termites.
