WOOD DESTROYING PESTS AND ORGANISMS INSPECTION REPORT

Building No. 9	Street Sunnyfield Drive	City Rolling Hills Estates	Zip 90274	Date of Inspection 05/18/17	Number of Pages 1 of 6
--------------------------	-----------------------------------	--------------------------------------	---------------------	---------------------------------------	----------------------------------

General Description: One story single family residence, furnished, unoccupied	Inspection Tag Posted: Garage
	Other Tags Posted:

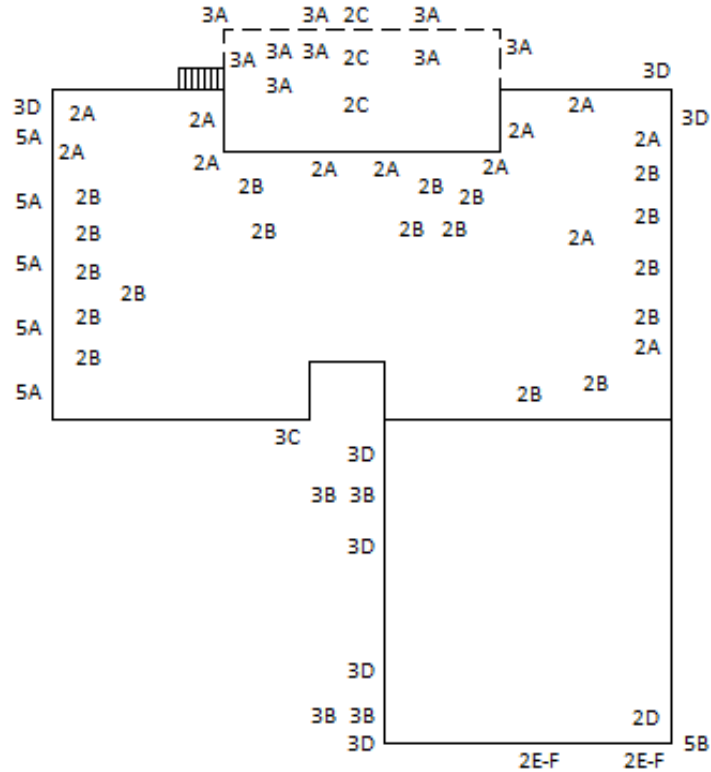
Diagram not to scale

An inspection has been made of the structure(s) shown on the diagram in accordance with the Structural Pest Control Act. Detached porches, detached steps, detached decks and any other structures not on the diagram were not inspected.
