# WOOD DESTROYING PESTS AND ORGANISMS INSPECTION REPORT

BUILDING NO. 5050	STREET, CITY, STATE, ZIP Olmeda, Atascadero CA 93422	Date of Inspection 2/27/2018	No. of Pages 6
----------------------	---	---------------------------------	-------------------

General Description: FURNISHED AND OCCUPIED TWO STORY STUCCO FRAMED/WOOD SIDED RESIDENCE WITH ATTACHED APARTMENT AND TWO CAR GARAGE ON A RAISED FOUNDATION	Inspection Tag Posted: ATTIC
	Other Tags Posted:

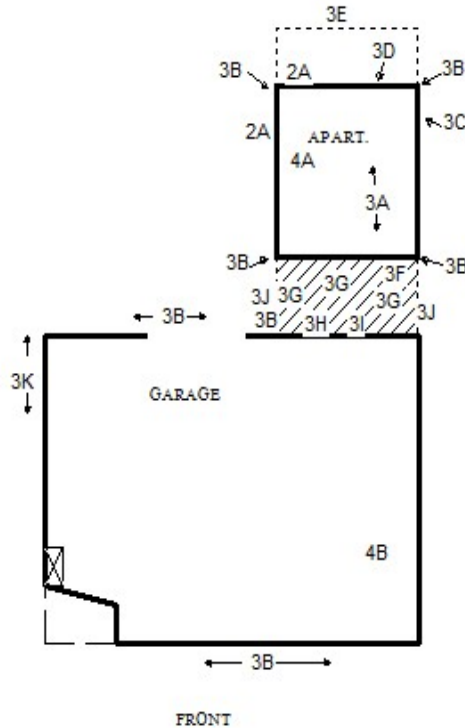
An inspection has been made to the structure(s) shown on the diagram in accordance with the Structural Pest Control Act. Detached porches, detached steps, detached decks and any other structures not on the diagram were not inspected.
