# WOOD DESTROYING PESTS AND ORGANISMS INSPECTION REPORT

BUILDING NO. <b>315</b>	STREET, CITY, STATE, ZIP <b>Fairview Way, Lakeport CA 95453</b>	Date of Inspection <b>5/31/2018</b>	No. of Pages <b>7</b>
----------------------------	--	--	--------------------------

General Description: One story, single family dwelling, stucco exterior, attached garage, deck and patio. Unfurnished and unoccupied.	Inspection Tag Posted: Garage
	Other Tags Posted: None Noted

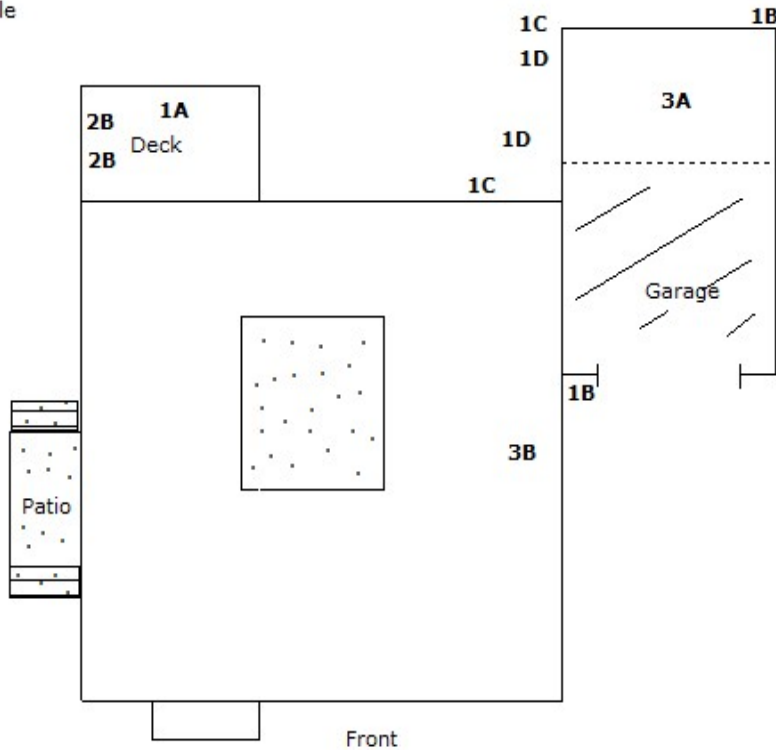
An inspection has been made to the structure(s) shown on the diagram in accordance with the Structural Pest Control Act. Detached porches, detached steps, detached decks and any other structures not on the diagram were not inspected.

This diagram is not to scale
