WOOD DESTROYING PESTS AND ORGANISMS INSPECTION REPORT

BUILDING NO. 2781	STREET, CITY, STATE, ZIP Juniper Ave., Morro Bay CA 93442	Date of Inspection 5/1/2017	No. of Pages 5
<div style="display: flex; justify-content: space-between; align-items: flex-start;"> <div style="width: 30%;">

<p>story TERMITE & PEST P. O. Box 2796 Atascadero, CA 93423</p> </div> <div style="width: 65%;"> <p>Atascadero (805) 460-0650 Morro Bay (805) 772-0712 Arroyo Grande (805) 489-4049 Santa Ynez (805) 688-5950 Lompoc (805) 735-9888 Santa Maria (805) 347-4707</p> </div> </div>			
Firm Registration No. PR 6987		Report No. 23572	Escrow No.
Ordered By: Greg Malik Real Estate Group 7450 Morro Road Atascadero, CA 93422 Attn: Jaime Silveria		Property Owner/Party of Interest	Report Sent To:
COMPLETE REPORT <input checked="" type="checkbox"/> LIMITED REPORT <input type="checkbox"/> SUPPLEMENTAL REPORT <input type="checkbox"/> REINSPECTION REPORT <input type="checkbox"/>			
General Description: FURNISHED AND OCCUPIED TWO STORY STUCCO FRAMED RESIDENCE WITH ATTACHED TWO CAR GARAGE ON A RAISED FOUNDATION.		Inspection Tag Posted: ATTIC

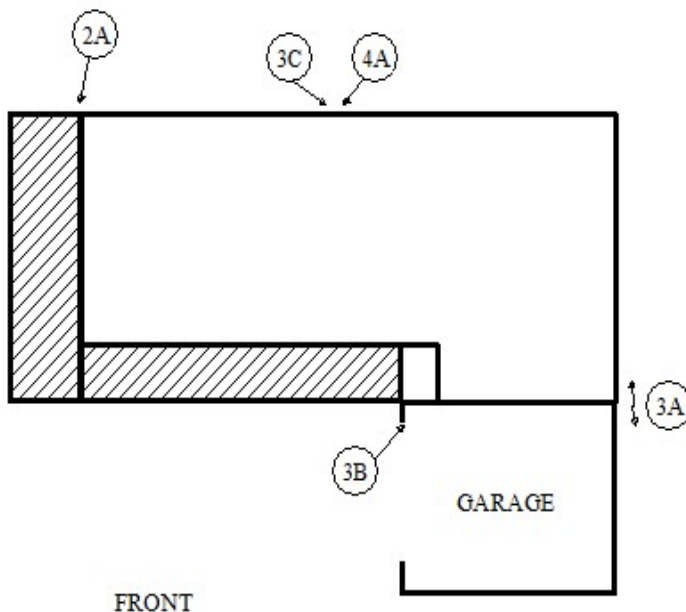
Other Tags Posted:	
An inspection has been made to the structure(s) shown on the diagram in accordance with the Structural Pest Control Act. Detached porches, detached steps, detached decks and any other structures not on the diagram were not inspected.			
Subterranean Termites <input type="checkbox"/> Drywood Termites <input checked="" type="checkbox"/> Fungus/Dryrot <input checked="" type="checkbox"/> Other Findings <input checked="" type="checkbox"/> Further Inspection <input type="checkbox"/>			
If any of above boxes are checked, it indicates that there were visible problems in accessible areas. Read the report for details on checked items.

Drywood termite infestation and damage noted at the 2x4 rafter tail.
SECTION 1 ITEM

Fungus infection and damage noted at the eave framing.
SECTION 1 ITEM
