# WOOD DESTROYING PESTS AND ORGANISMS INSPECTION REPORT

Building No. 1412	Street West 7th Street	City Chico	Zip 95928	Date of Inspection 12-30-21	Number of Pages 4
----------------------	---------------------------	---------------	--------------	--------------------------------	----------------------

General Description: <u>1 story single family dwelling, raised floor and furnished.</u>	Inspection Tag Posted: W.H. Closet  Other Tags Posted:
--	--

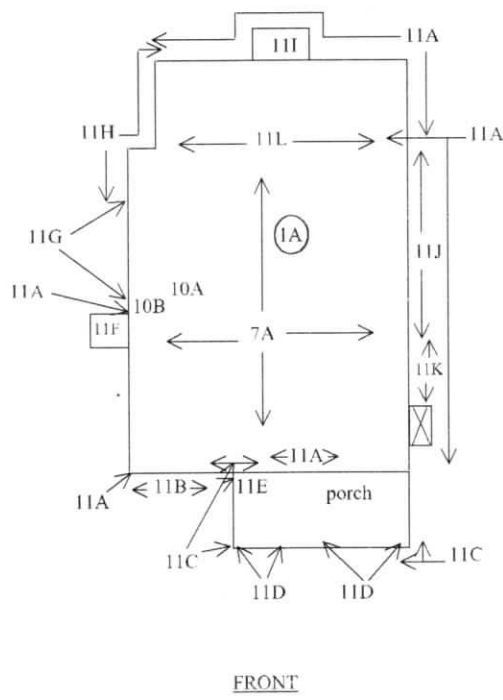
**DIAGRAM NOT TO SCALE**

An inspection has been made of the structure(s) shown on the diagram in accordance with the Structural Pest Control Act. Detached porches, detached steps, detached decks and any other structures not on the diagram were not inspected.
