WOOD DESTROYING PESTS AND ORGANISMS INSPECTION REPORT

Building No. 637-639	Street Harding Ave. Los Angeles CA 90022	City Los Angeles CA 90022	Zip 90022	Date of Inspection 02/16/23	Number of Pages 11
--------------------------------	--	-------------------------------------	---------------------	---------------------------------------	------------------------------

General Description: 1 story, Stucco, Duplex, Composition Roof, Detached Garage, Vacant -	Inspection Tag Posted: Attic
	Other Tags Posted: None

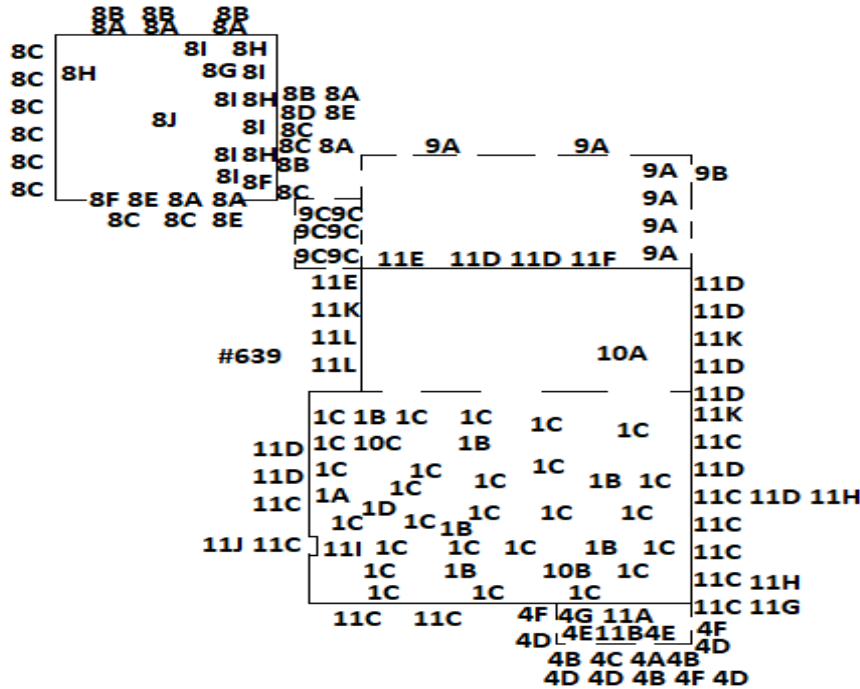
FOUNDATION DIAGRAM (Diagram not to scale)

An inspection has been made of the structure(s) shown on the diagram in accordance with the Structural Pest Control Act. Detached porches, detached steps, detached decks and any other structures not on the diagram were not inspected.

Finding: 1A EVIDENCE OF DRYWOOD TERMITE DAMAGE NOTED AT 2X8 SUBAREA FRAMING ACCESS AS INDICATED ON THE DIAGRAM.

Finding: 1C EVIDENCE OF SUBTERRANEAN TERMITES NOTED IN THE SUB AREA AS INDICATED ON THE DIAGRAM.

Finding: 1D DRY ROT NOTED AT UNDER BATHROOM FLOOR AS INDICATED ON THE DIAGRAM.

Finding: 4A EVIDENCE OF DRYWOOD TERMITES NOTED AT 2X4 RAFTERS AS INDICATED ON THE DIAGRAM.

Finding: 4B EVIDENCE OF DRYWOOD TERMITE DAMAGE NOTED AT 4X4 POST AS INDICATED ON THE DIAGRAM.

Finding: 4C EVIDENCE OF DRYWOOD TERMITE DAMAGE NOTED AT PLYWOOD ROOF SHEATHING AS INDICATED ON THE DIAGRAM.

Finding: 4D EVIDENCE OF DRYWOOD TERMITES NOTED AT POST, RAFTER, PLYWOOD, HEADER BEAM AS INDICATED ON THE DIAGRAM.

Finding: 4E DRY ROT NOTED AT SHEET LATTICE AS INDICATED ON THE DIAGRAM.

Finding: 4F DRY ROT NOTED AT 1X6 FASCIA AS INDICATED ON THE DIAGRAM.

Finding: 4G EVIDENCE OF DRYWOOD TERMITE DAMAGE NOTED AT 4X6 HEADER BEAM AS INDICATED ON THE DIAGRAM.

Finding: 8A EVIDENCE OF DRYWOOD TERMITE DAMAGE NOTED AT 2X4 RAFTER AS INDICATED ON THE DIAGRAM.

Finding: 8B EVIDENCE OF DRYWOOD TERMITES NOTED AT RAFTER, WINDOW SILL, WINDOW FRAMING, STUCCO MOULDING, DOOR JAMB AS INDICATED ON THE DIAGRAM.

Finding: 8C DRY ROT NOTED AT 2X4 RAFTER AS INDICATED ON THE DIAGRAM.
