WOOD DESTROYING PESTS AND ORGANISMS INSPECTION REPORT #: 20122118

BUILDING NO. 201	STREET FIVE CITIES DR. #84	CITY PISMO BEACH	ZIP 93449	Date of Inspection 01/03/2019	NUMBER OF PAGES 1 of 5
---------------------	-------------------------------	---------------------	--------------	----------------------------------	---------------------------

GENERAL DESCRIPTION: This is a double wide, wood sided, single family mobile home. It has an attached carport and an attached cabana. It has a composition roof and was occupied and furnished at the time of inspection.	Inspection Tag Posted: Water Heater Other Tags Posted:
--	---

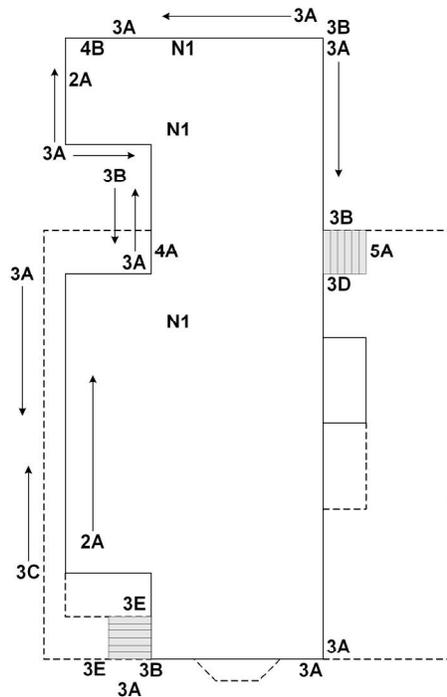
An inspection has been made of the structure(s) on the diagram in accordance with the the Structural Pest Control Act. Detached porches, detached steps, detached decks and any other structures not on the diagram were not inspected.

Key: 1 = Subterranean Termites 2 = Drywood Termites 3 = Fungus/Dryrot 4 = Other Findings 5 = Further Inspection

FINDING AND
RECOMMENDATION: 2A

Evidence of Drywood Termite infestation was found in wood members of the substructure.
