WOOD DESTROYING PESTS AND ORGANISMS INSPECTION REPORT

Building No. 127	Street West Lindo	City Chico	Zip 95926	Date of Inspection 3-22-23	Number of Pages 4
---------------------	----------------------	---------------	--------------	-------------------------------	----------------------

CHICO TERMITE & ROT SPECIALISTS
 PO BOX 7872, CHICO, CA 95927 (530) 893-2999
 E-mail: chicotermite@gmail.com

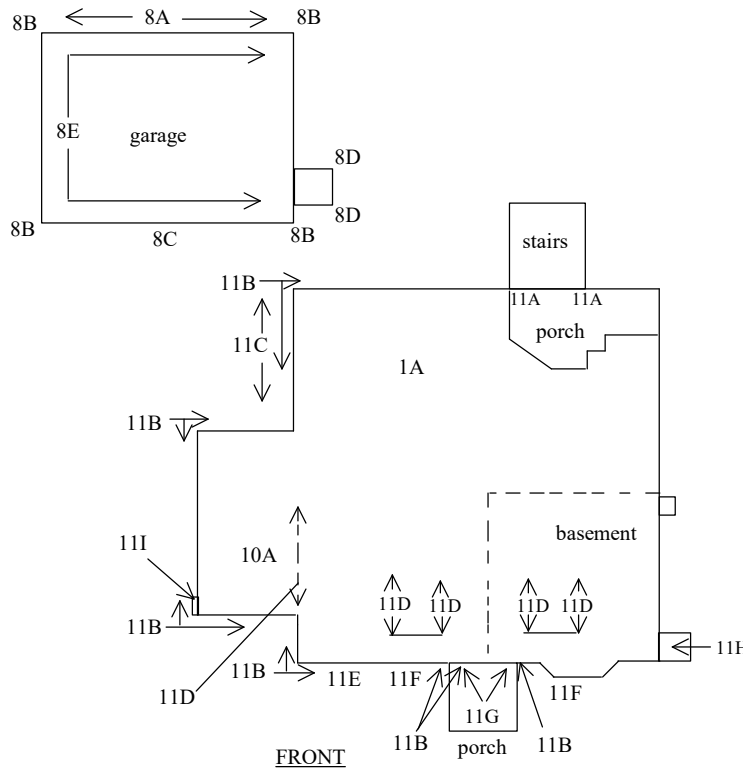
DIAGRAM NOT TO SCALE

Subterranean Termites Drywood Termites Fungus / Dryrot Other Findings Further Inspection
 If any of the above boxes are checked, it indicates that there were visible problems in accessible areas. Read the report for details on checked items.
