WOOD DESTROYING PESTS AND ORGANISMS INSPECTION REPORT

Building No. 246	Street 16th St	City Paso Robles	Zip 93446-2002	Date of Inspection 03/15/2022	Number of Pages 1 of 5
---------------------	-------------------	---------------------	-------------------	----------------------------------	---------------------------

General Description: Single story dwelling, raised foundation, comp roof, stucco siding, 2 unit detached garage, occupied and furnished	Inspection Tag Posted: Other Tags Posted:
--	--

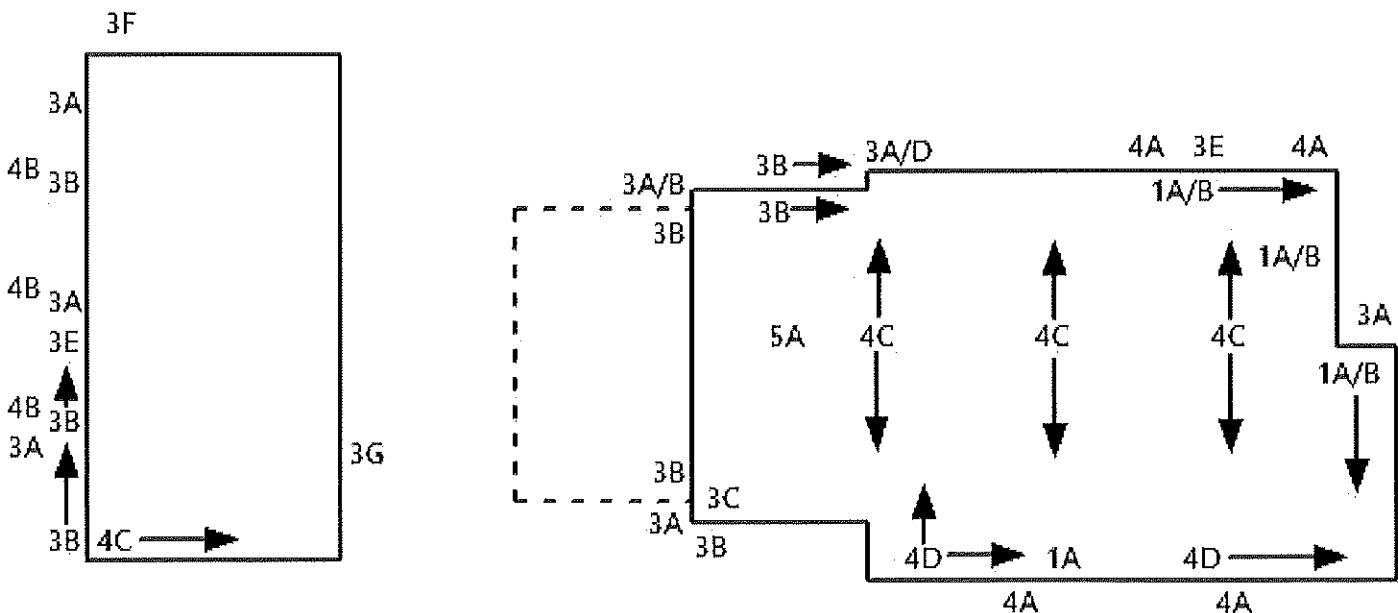
An inspection has been made of the structure(s) shown on the diagram in accordance with the Structural Pest Control Act. Detached porches, detached steps, detached decks and any other structures not on the diagram were not inspected.

Key: 1 = Subterranean Termites
 2 = Drywood Termites
 3 = Fungus/Dryrot
 4 = Other Findings
 5 = Unknown Further Inspection

- Finding: 1A Evidence of Subterranean Termite infestation found at the sub structure framing. This indicates a Subterranean infestation in the adjacent soil below.

- Finding: 1B Subterranean Termite damage was noted at the floor joists and beam.
- Recommendation: Remove, replace and/or resupport damaged wood member(s). Our firm will apply one coat of primer paint to all appropriate wood members installed. Additional painting will be performed upon request at an additional cost.

- Finding: 3A Fungus damage and infection noted to the fascia board(s).
- Recommendation: Remove and replace or resupport damaged and infected wood members. Our firm will apply one coat of primer paint to all appropriate wood members installed. Additional painting will be performed upon request at an additional cost.

- Finding: 3B Fungus damage and infection noted to the siding.
- Recommendation: Remove and replace or resupport damaged and infected wood members. Our firm will apply one coat of primer paint to all appropriate wood members installed. Additional painting will be performed upon request at an additional cost.
