# WOOD DESTROYING PESTS AND ORGANISMS INSPECTION REPORT

BUILDING NO. <b>14264</b>	STREET, CITY, STATE, ZIP <b>Memory Lane, Clearlake CA 95422</b>	Date of Inspection <b>3/29/2022</b>	No. of Pages <b>7</b>
------------------------------	--	--	--------------------------

General Description: One story, single family dwelling, brick & wood exterior, attached garage, porch & patio, furnished/occupied.

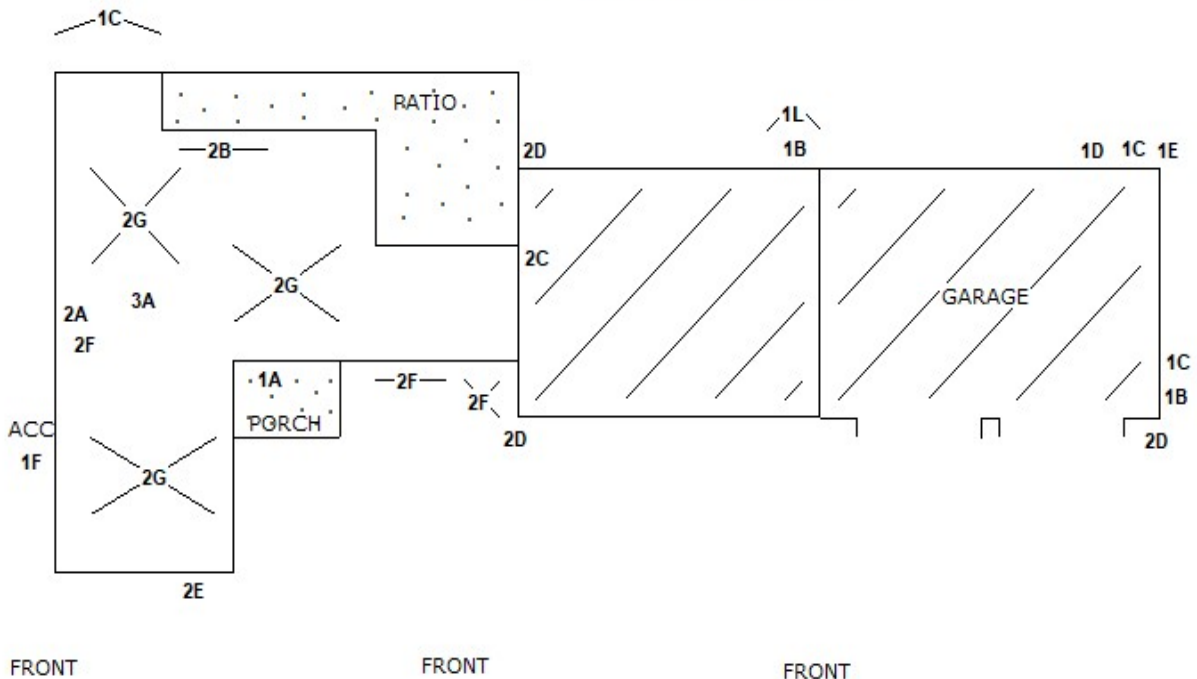
THIS DIAGRAM IS NOT TO SCALE

An inspection has been made to the structure(s) shown on the diagram in accordance with the Structural Pest Control Act. Detached porches, detached steps, detached decks and any other structures not on the diagram were not inspected.
