# WOOD DESTROYING PESTS AND ORGANISMS INSPECTION REPORT

Building No. 69	Street Dossi Wy.	City Sonora	ZIP 95370	Date of Inspection 04/30/2026	Number of Pages 6
--------------------	---------------------	----------------	--------------	----------------------------------	----------------------

GENERAL DESCRIPTION: Two story, multi-family dwelling, wood frame and siding, composition roof, slab foundation, and furnished.	Inspection Tag Posted: Water Heater Closet  Other Tags Posted:
--	---

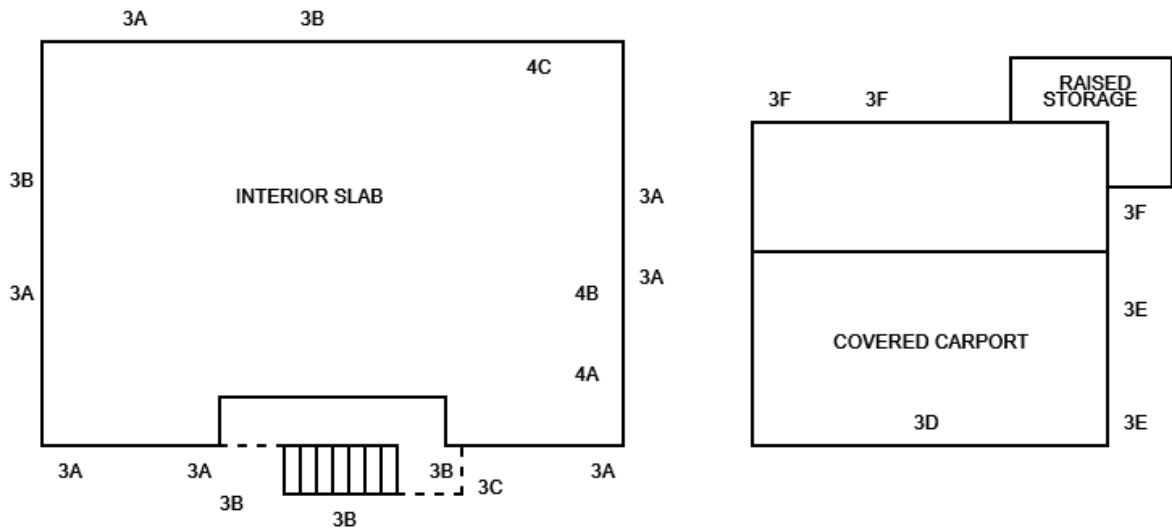
### Diagram Not To Scale

An inspection has been made of the structure(s) shown on the diagram in accordance with the Structural Pest Control Act. Detached porches, detached steps, detached decks and any other structures not on the diagram were not inspected.
