# WOOD DESTROYING PESTS AND ORGANISMS INSPECTION REPORT

Building No. 12800	Street Honey Locust Ct. #14	City Sonora	ZIP 95370	Date of Inspection 01/09/2026	Number of Pages 6

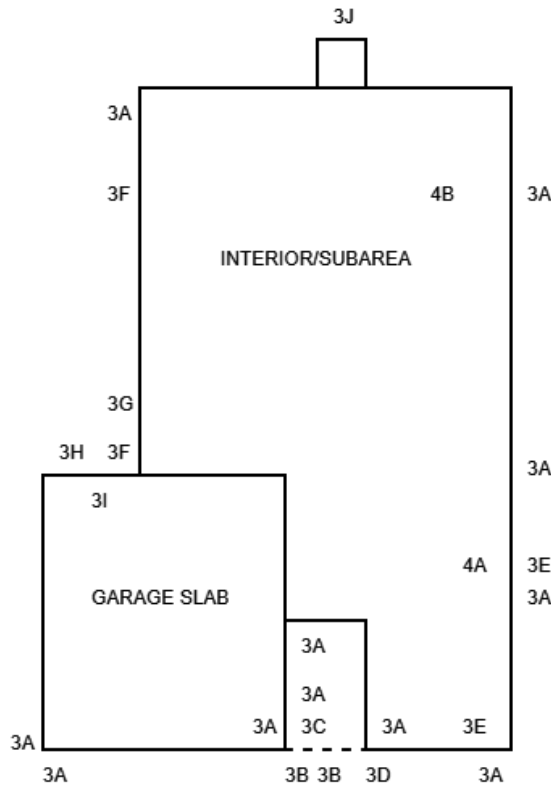
**Diagram Not To Scale**

<b>Lawson Home Services</b> 11185 Racetrack Rd Sonora CA 95370 (209) 770-5980 Jlawson37@outlook.com		Report # : 12399 Registration # : PR8529 Escrow # : <input type="checkbox"/> CORRECTED REPORT	
Ordered by: Jenny Arnold Berkshire Hathaway		Property Owner and Party of Interest: Sue Niebaum 12800 Honey Locust Ct. Sonora CA 95370 United States		Report sent to:	
COMPLETE REPORT <input checked="" type="checkbox"/>		LIMITED REPORT <input type="checkbox"/>		SUPPLEMENTAL REPORT <input type="checkbox"/>	
REINSPECTION REPORT <input type="checkbox"/>		GENERAL DESCRIPTION: Single story, single family residence, modular home, composition roof, raised and slab foundation, carpeted, and vacant.		Inspection Tag Posted: Water Heater Closet Other Tags Posted:	
An inspection has been made of the structure(s) shown on the diagram in accordance with the Structural Pest Control Act. Detached porches, detached steps, detached decks and any other structures not on the diagram were not inspected.
