WOOD DESTROYING PESTS AND ORGANISMS INSPECTION REPORT

BUILDING NO. 136	STREET, CITY, STATE, ZIP Corte Del Encino, Sonora CA 95370	Date of Inspection 5/5/2026	No. of Pages 8
----------------------------	--	---------------------------------------	--------------------------

General Description: ONE STORY SINGLE FAMILY RESIDENCE FURNISHED	Inspection Tag Posted: SUBSTRUCTURE AREA
Other Tags Posted:

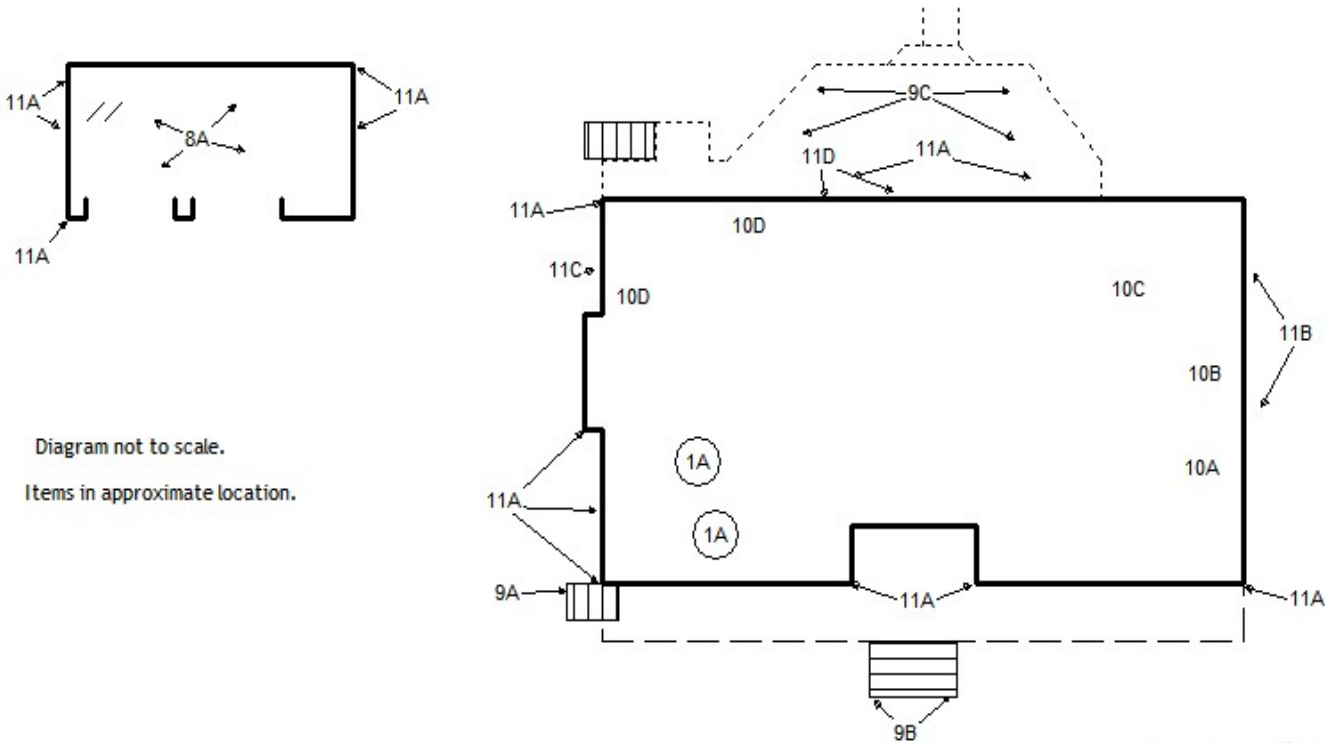
An inspection has been made to the structure(s) shown on the diagram in accordance with the Structural Pest Control Act. Detached porches, detached steps, detached decks and any other structures not on the diagram were not inspected.
