GEOLOGY AND SOILS REPORT APPROVAL LETTER

TRACT: 13404
LOT: 3
LOCATION: 1805 Nichols Canyon Road

The referenced reports concerning remedial slope restoration proposed to remove retaining walls and associated backfill (construction without permits on the vacant, adjacent, up-slope, off-site property), and the removal of wood retaining walls on the slope within the property (also constructed without permits), have been reviewed by the Grading Division of the Department of Building and Safety. An order was issued by the code enforcement bureau of the department.

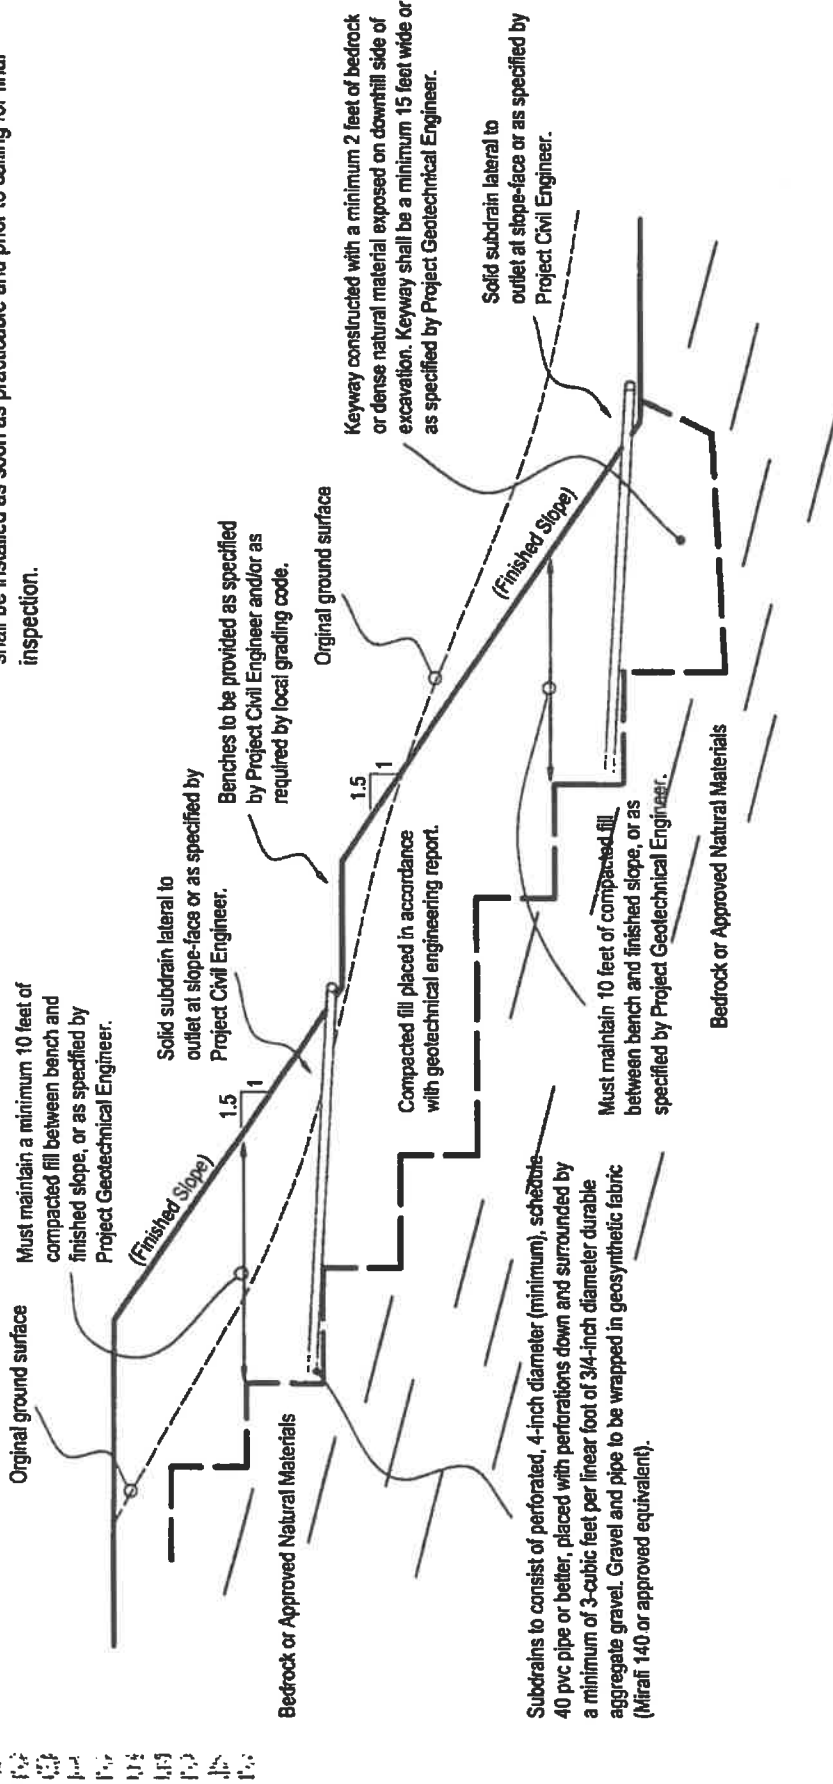
Typical 1.5(H): 1(V) Buttress Fill-Slope, Keyway, Benching, and Subdrain Detail

(Section J110, 2010 CBC) The faces of cut- and fill-slopes shall be prepared and maintained to control against erosion. This control shall be permitted to consist of effective planting. Erosion control for the slopes shall be installed as soon as practicable and prior to calling for final inspection.

SUBDRAIN RUN LENGTH	MINIMUM PIPE DIAMETER
0 - 200 ft	4 inches
200 - 400 ft	6 inches
400 - 800 ft	8 inches
