# WOOD DESTROYING PESTS AND ORGANISMS INSPECTION REPORT

| Building Address:<br><b>25293 Rebekah Rd., Long Barn, CA 95335</b> | | Date of Inspection<br><b>07/23/2026</b> | Number of Pages<br><b>8</b> |
| General Description:<br>Single Family Two Story Wood Frame Wood Siding Composition Roof<br>Occupied Furnished | | Inspection Tag Posted:    Sub Area | |

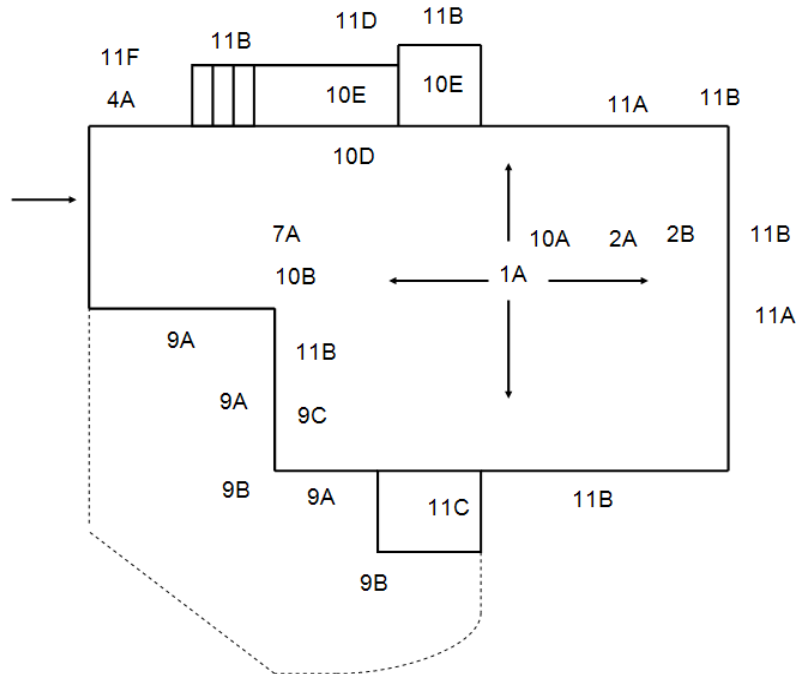
This Diagram is not to scale

| An inspection has been made of the structure(s) shown on the diagram in accordance with the Structural Pest Control Act. Detached porches, detached steps, detached decks and any other structures not on the diagram were not inspected. | | | |
