<u> </u>		
Building No. Street 457 N. 16t	h st	City Grover Beach	Zip 93433	Date of Inspection 07/14/17	Page 1 of 5		
C e e e e e e e e e e e e e e e e e e e	Mojoe Termite 1445 Grand Ave. Grover Beach, C Phone: 805-574- Mojoetermite.co Registration # Pl	A 93433 1990 Fax: 805-574-1991 m		F	 Report # 8860		
Ordered by:		Property Owner and/or Party of Interest:	Report	sent to:			
Hunstad Realty Cayse Hunstad Melero CA H: 441-6938			Hunstad Cayse H CA	l Realty lunstad Melero			
COMPLETE REPOR	RT 🕱 🛛 LIMITED R	EPORT SUPPLEMENTAL REP		REINSPECTION F	REPORT		
General Description:				ion Tag Posted:			
Two story residen Vacant	e ags Posted:						
An inspection has been made of the structure(s) shown on the diagram in accordance with the Structural Pest Control Act. Detached porches, detached steps, detached decks and any other structures not on the diagram were not inspected. Diagram is not to scale. Locations are only approximate.

Building No.	Street	City	Zip	Date of Inspection	Report #	Page
457	N. 16th st	Grover Beach	93433	07/14/17	8860	2 of 5

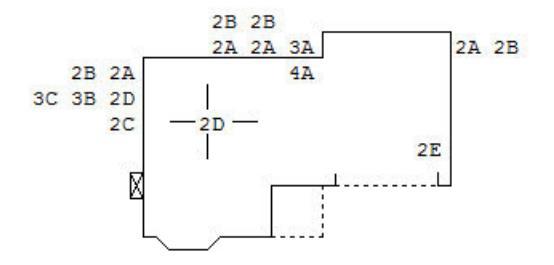
,	oxes are checked, it indica	Termites X Fungus / Dryrot X tes that there were visible problems in accessible a	areas. Read th	e report for details on c			
KEY: 1 - Subterra	KEY: 1 - Subterranean Termites 2 - Drywood Termites 3 - Fungus/Dryrot 4 - Other Findings 5 - Unknown Further Inspection
