RESIDENTIAL INSPECTION - R/R

2317 Stearnlee Ave Long Beach, CA 90815

Pat & Dan Cooper 02/10/2025

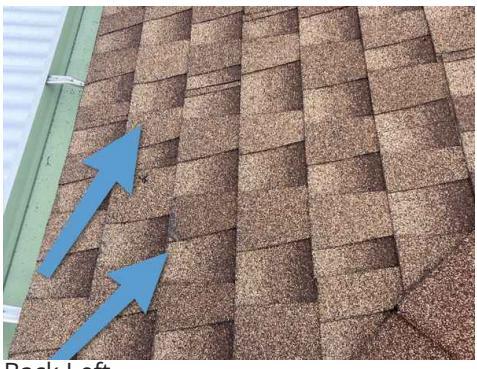
Back Left

During the roof inspection we observed **(minor)** granular material loss in one or more areas of the roof. As the granules are swept away by wind and rain the roof becomes more exposed to UV light and will deteriorate faster. Fiberglass may begin to show on edges of shingles. Recommend further evaluation by a licensed roofer for maintenance check.

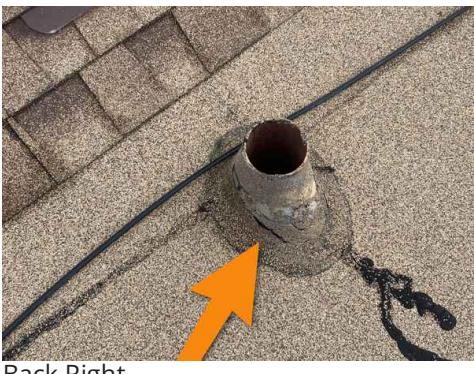
Back Right

ROOF VENT PIPE MASTIC CRACKING/DETERIORATING

Observed one or more roof vent collars/pipes with cracks along mastic line that attaches the pipe to the flashing boot. Recommend to be resealed as maintenance to prevent any water intrusion. Mastic seals should be evaluated and maintained every 5-7 years.

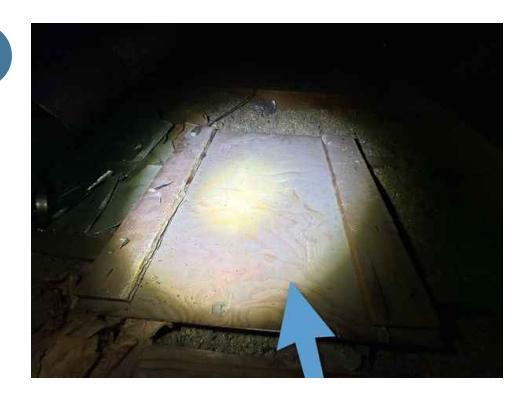
Observed that the attic hatch lid does not have insulation attached. Recommend that Batt or Foam Board Insulation be attached to the Attic Hatch to avoid heat loss.

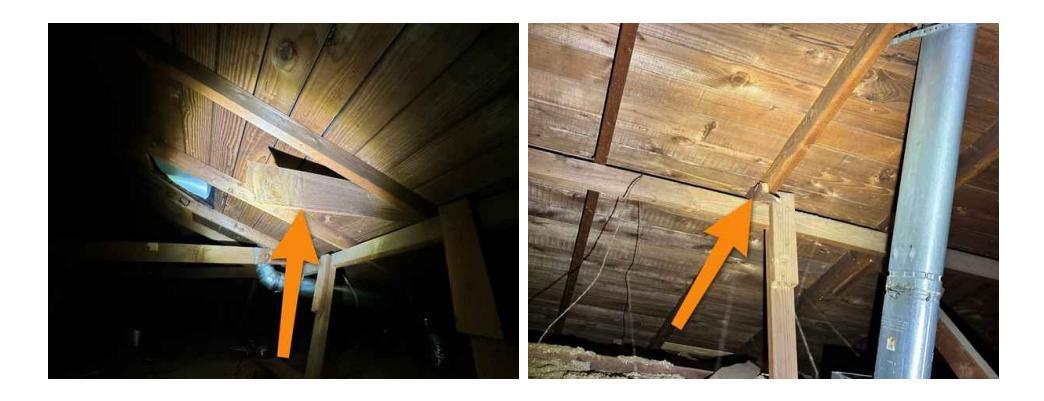
3.2.2 Attic & Insulation DAMAGED AND/OR LOOSE TRUSSES/RAFTERS/BRACING/SHEATHING

Observed loose or damage/holes/notching/splitting of trusses and/or rafters or bracing or roof sheathing/plank components in one or more places. Recommend further evaluation for potential repairing or sistering of noted components to strengthen and/or prevent any future issues or further damage.

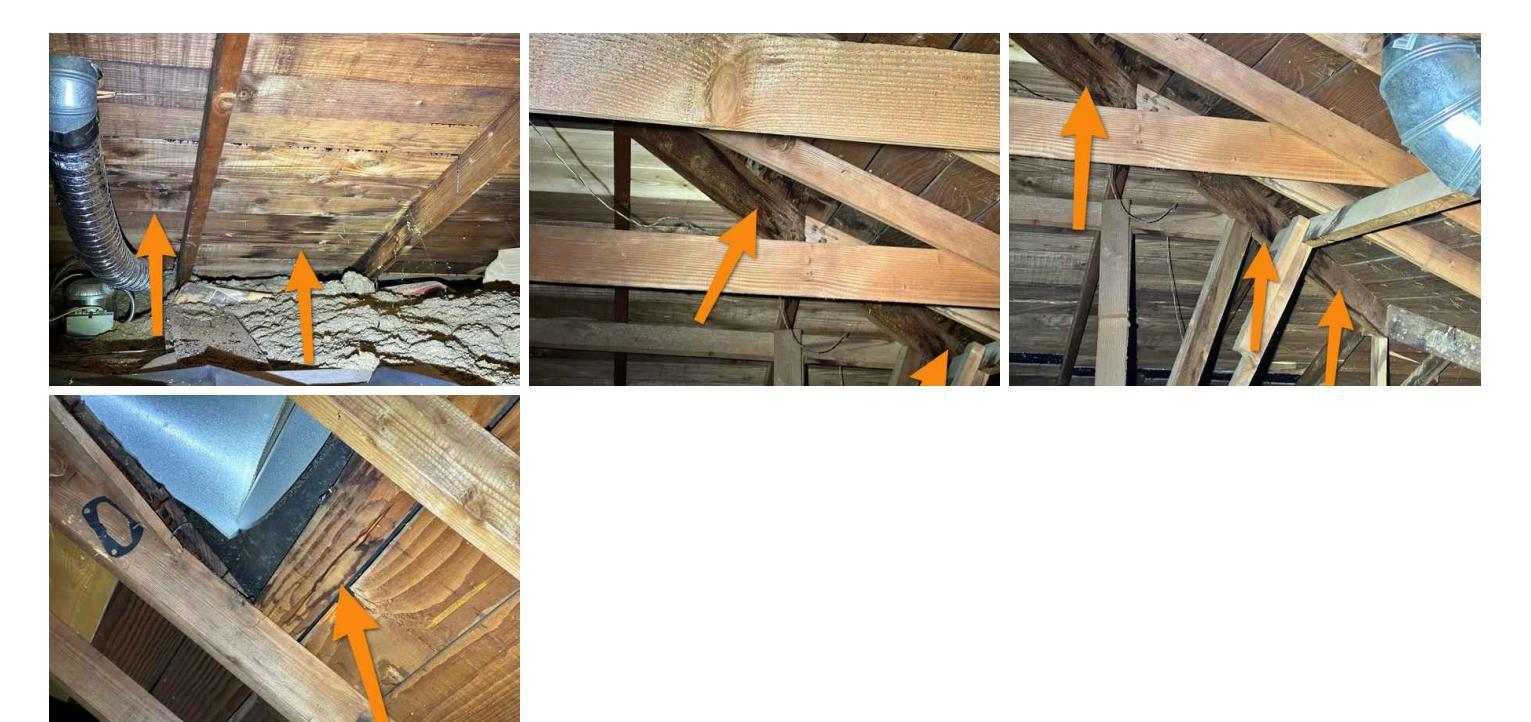
Observed one or more areas in the attic of water stain in the underside of the roof sheathing, decking, planks and/or rafters. Although moisture meter shows dry at time of inspection, this indicates areas of **possible previous roof leak**. Pics are included to assist in locating the areas of the roof tiles that should be checked to assure that there are no current areas that have potential for leaking. Disclosure of this component is recommended.

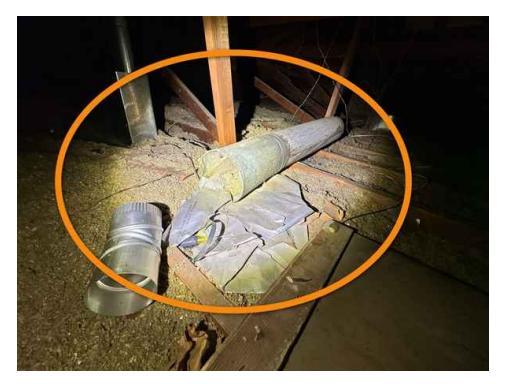
3.2.4 Attic & Insulation

DEBRIS DEFICIENCY

Observed debris or garbage stored in attic space at one or more locations. This can affect the efficiency of installed insulation And promote rodent intrusion. Recommend proper cleaning and removal of these items.

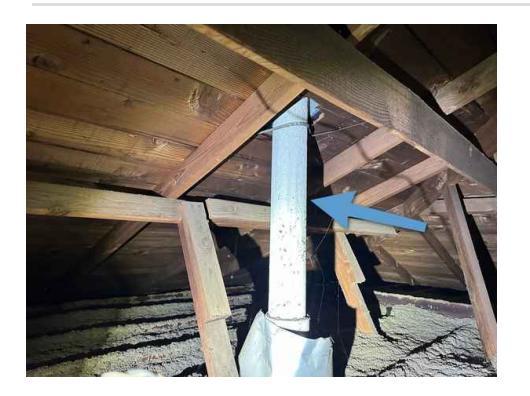
3.4.1 Exhaust Systems TRANSIT TYPE VENT DUCTS NOTED

Transite type vent pipe is not recommended material as it may contain asbestos. Suggest further review by qualified contractor if this component is being replaced. We bring this to your attention for your information. Important Recommendation

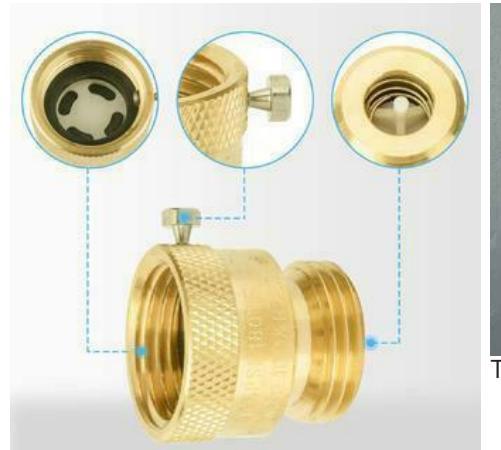
4.3.1 Exterior Water/Gas Plumbing **NO ANTI-SIPHON VALVE**

Observed that there was no Anti-Siphon Valve on one or more exterior hose spigots. An anti-siphon faucet or valve should be installed to prevent the backflow of dirty water into the clean water source. Anti-siphon taps are used for outdoor plumbing, utility sinks, and mainly where a hose is attached to supply water outside of a home. Recommend correction. This is an easy fix. Anti-Siphon Valves can be purchased at your local hardware supply store.

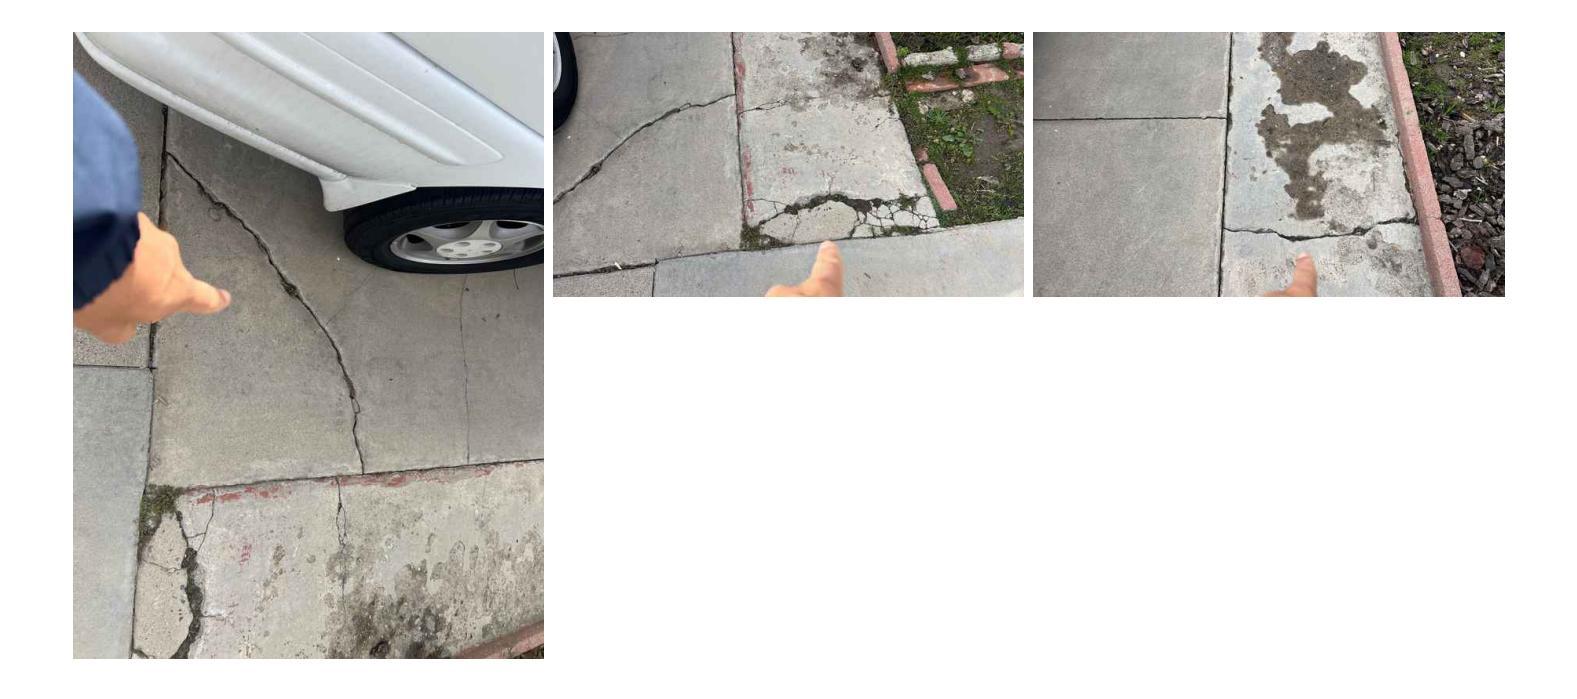
4.7.1 Driveways & Walkways
CONCRETE - MODERATE CRACKING

MODERATE CRACKING - CONCRETE - Moderate settlement cracks were present on the concrete surface at one or more locations noted. Cement cracks are considered normal due to settling over time and age of property. When cracks expand to more than 1/8 to 1/4" in width and/or have displacement, we recommend further evaluation for repair. At a minimum these cracks are recommended to be sealed by a qualified person to prevent further damage in winter months or to avoid becoming a trip hazard with potential vertical lift.

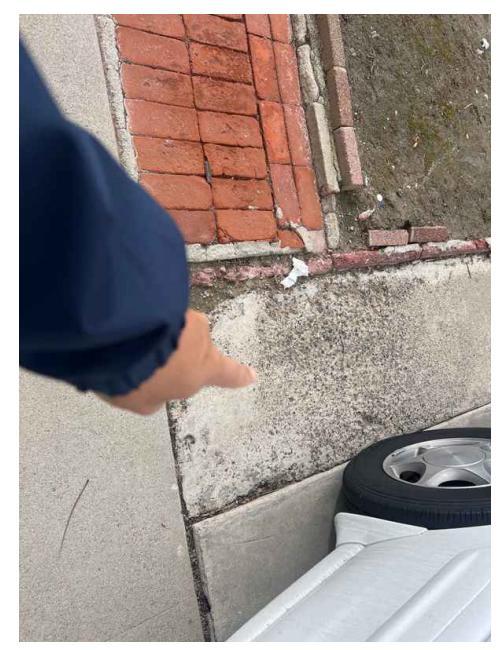
Observed some minor concrete spalling in noted location. This appears mainly to be cosmetic in nature at this time. We recommend monitoring this particular component and repairing as needed.

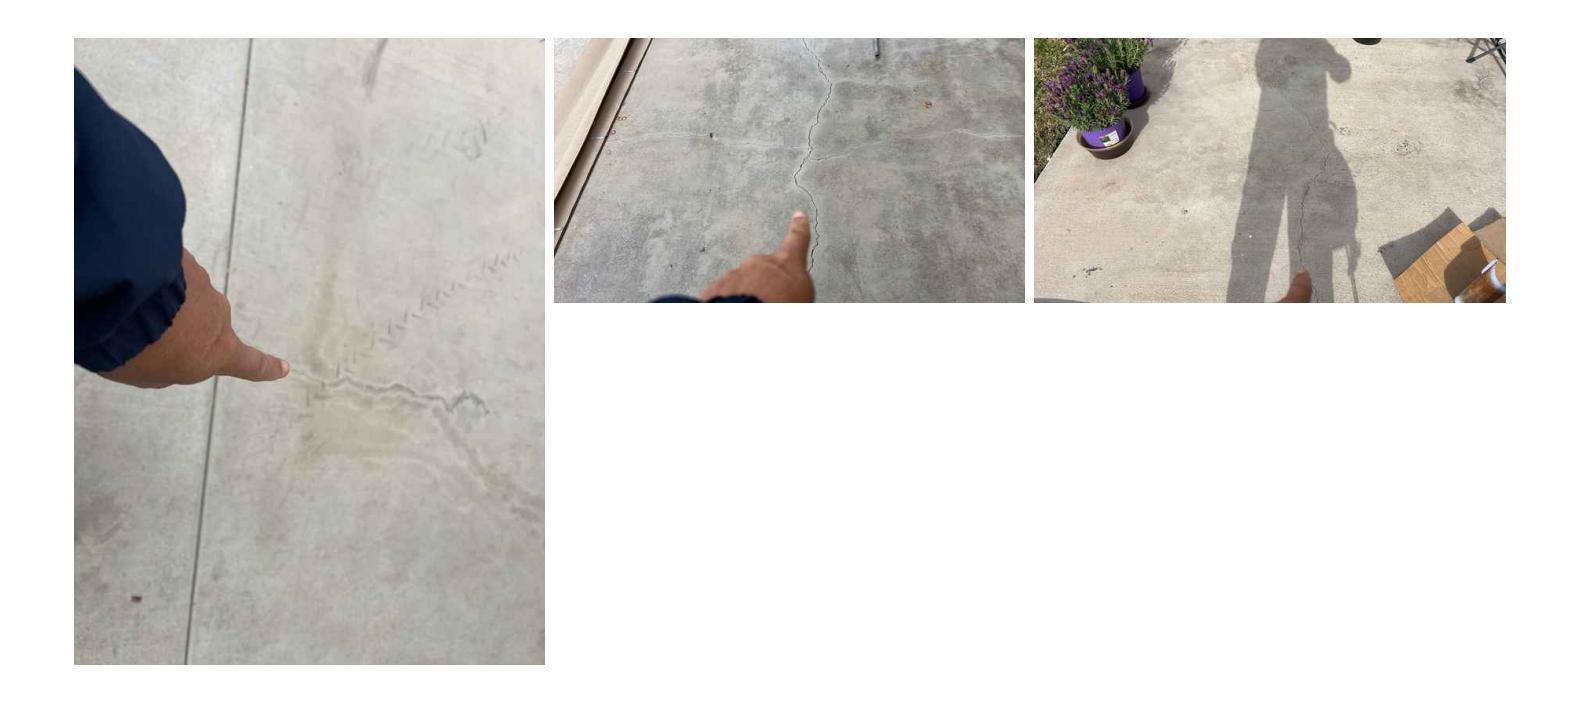
4.7.3 Driveways & Walkways
PATIO TYPICAL SETTLEMENT CRACKS - MINOR

Patio - Typical Settlement Cracks: Typical or Normal settlement / shrinkage cracks were present on the patio concrete slab (under 1/4" wide). These can be caused by the composition of the concrete mix used when the slab was poured, the lack of expansion or relief joints, or standard settlement. At a minimum these cracks should be monitored and/or sealed with a masonry sealant to prevent further damage from freezing rain water in winter months. If a concern, have a concrete contractor to evaluate further.

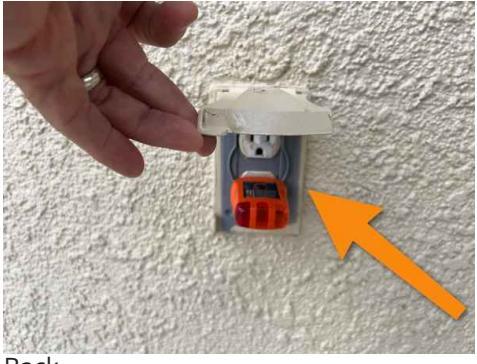
Back

We did not find exterior GFCI electrical outlets in one or more areas. GFCI outlets are required by NEC. Current Code states: Homes are required to have at least one outdoor GFCI PROTECTED receptacle at the front and rear of the house. We recommend this be corrected by a qualified licensed electrical contractor.

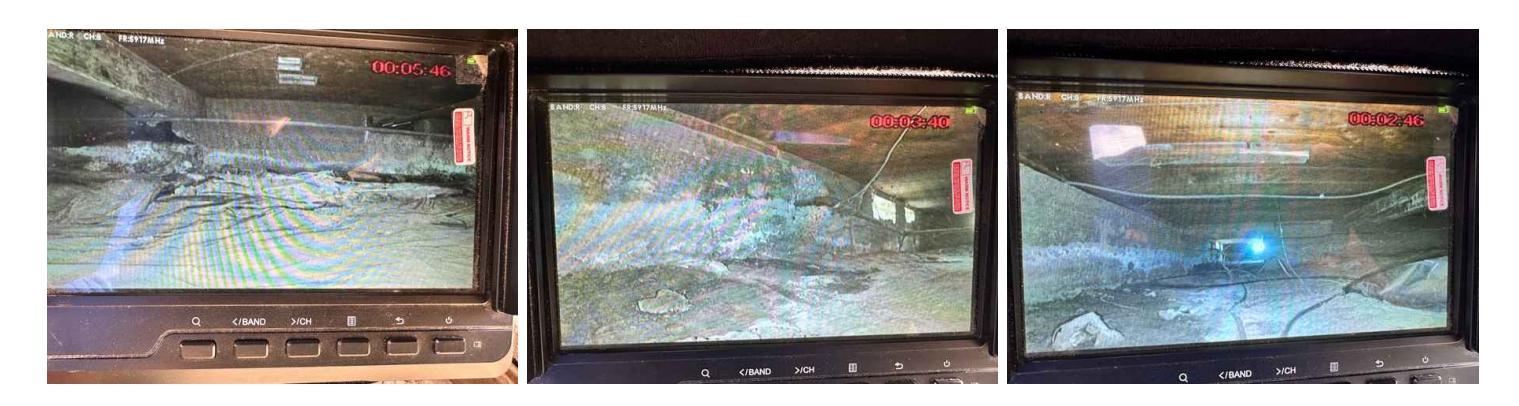
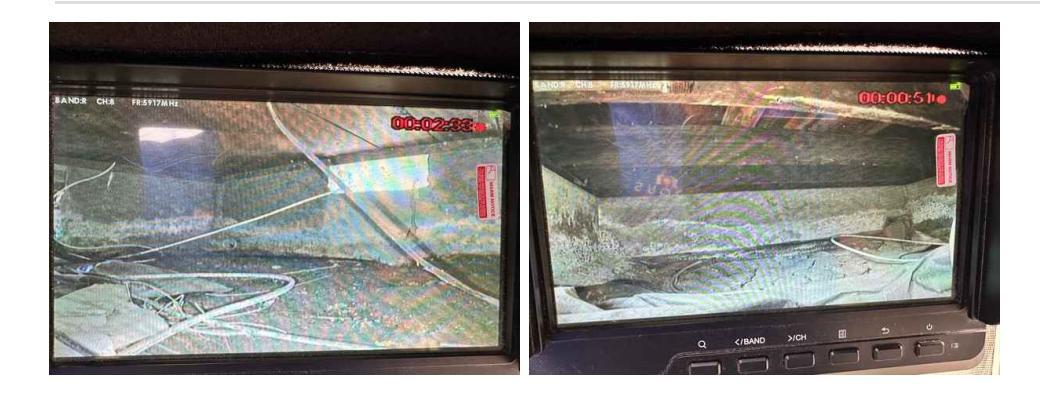
Efflorescence noted on the crawlspace surface and/or stem wall. This a white, powdery deposit is consistent with moisture intrusion. While not an immediate danger, unless other deficiencies are found, over time moisture intrusion may affect the rebar components within the stem wall and can compromise the soil's ability to support the home structure and/or lead to mold growth. Recommend a qualified contractor identify source of moisture and correct and treat if fungus is present.

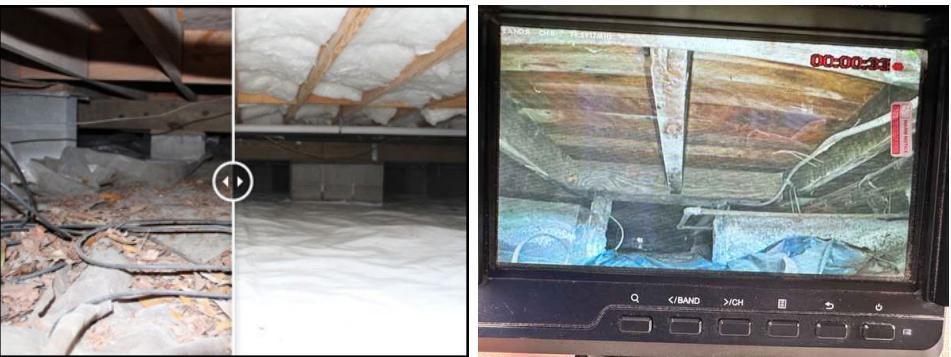
Recommended Upgrade: Minimal or no insulation was present inside crawlspace under wood floor framing system and no vapor barrier was present. While older homes where not required to have under floor insulation according to older building standards, newer construction homes are required to have under floor insulation installed. Recommend considering an upgrade by a qualified licensed insulation contractor to improve heating and cooling costs, control of moisture and pest intrusion and quality of air within the home.

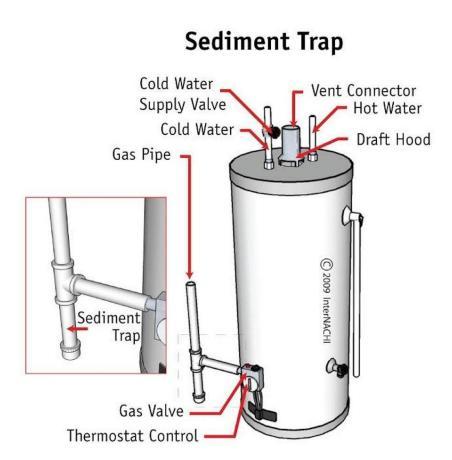
WATER HEATER: Be Advised: No sediment trap is installed on the water heater gas supply line. Sediment Traps are intended to trap oil, scale, sand, water condensation and/or debris from the gas supply lines before they reach and damage the water heater components. However, as per standard building practices, this is commonly not installed by installers however manufacturer may require this in order to honor limited warranty. Check local building codes for specific requirements in your area. We recommend installing a sediment trap by a qualified contractor or upon upgrade.

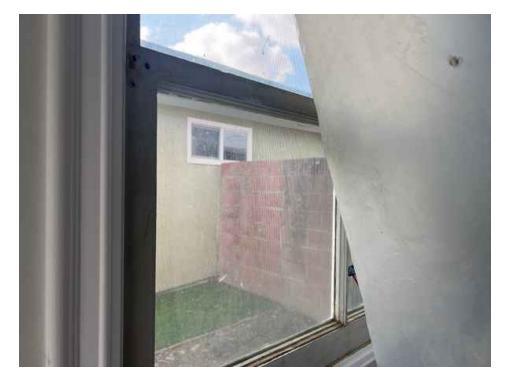
One or more windows appears to have general damage/ware, but are operational. Recommend a window professional clean, lubricate, adjust and/or caulk as necessary.

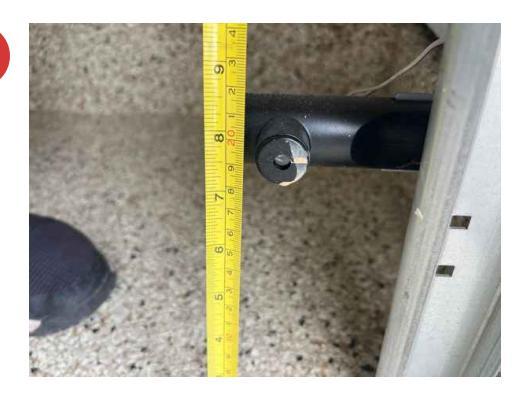
10.9.1 Garage Door Opener

As a general rule, Garage door sensor should be mounted not more than 6 inches above the floor. This is a safety precaution so that people or animals do not get trapped under the door as it closes. Recommend correction in the height of sensor to meet safety standard. Easy fix.

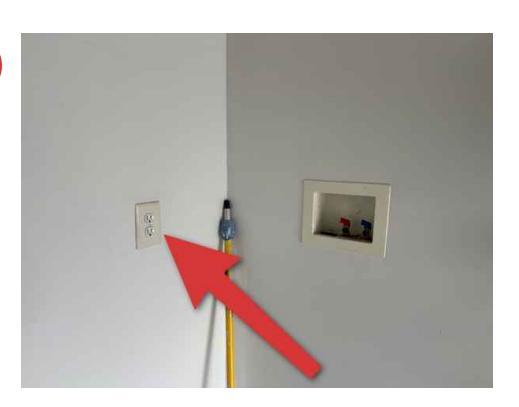
12.11.1 GFCI & AFCI

GFCI protection was not present/found in this location, at the time of inspection. GFCI protection is recommended to be present for the exterior, garage, basement, laundry area, and crawl space receptacles for safety, as well as ALL kitchen and bathroom receptacles. We recommend repairs or upgrades as needed to ensure GFCI protection is present at all recommended locations for safety and recommended work to be performed by a licensed electrician.

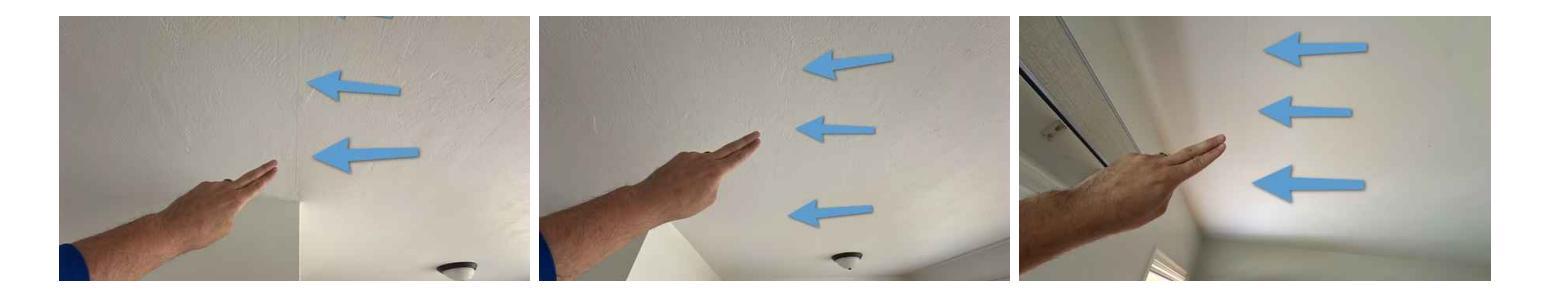
Observed one or more drywall cracks and/or seems separations in the ceilings at 1/16" or less. This may be due to settling, contraction and expansion, and age of the home. They should be considered for maintenance repair.

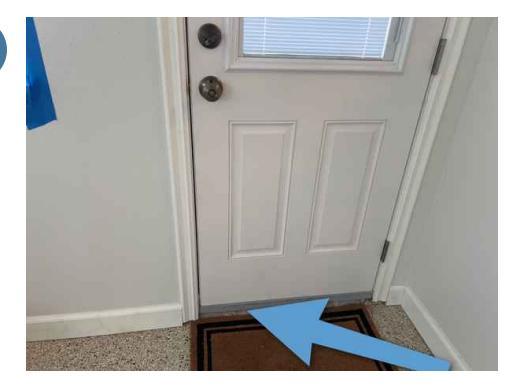
Observe one or more doors without doorstops or with deficient doorstops. Applying doorstops at the baseboard, will keep the door from causing damage to your drywall upon opening.

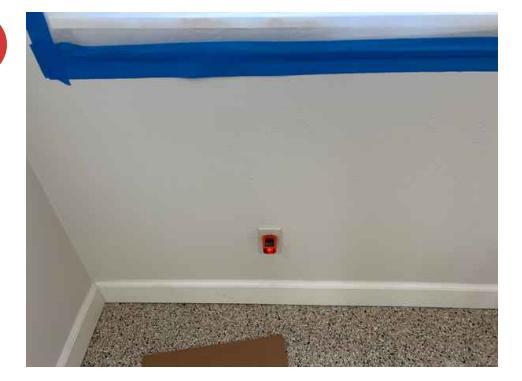
Suspect one or more outlets with open ground indicated. Open ground with three prong receptacle indicates that the receptacle is not connected to an equipment grounding conductor. This is unsafe and increases the chance of arching, sparks and electrical fire. Recommend immediate attention by a licensed electrician.

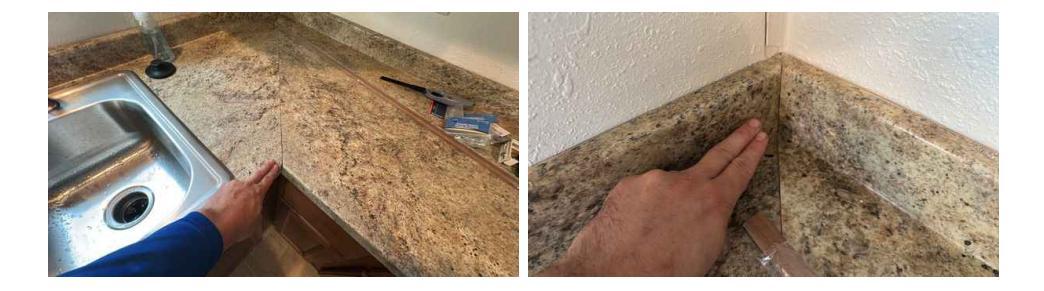
Observed grout or caulking deterioration or deficiency in the noted locations. Recommend repair to prevent any water intrusion and damage.

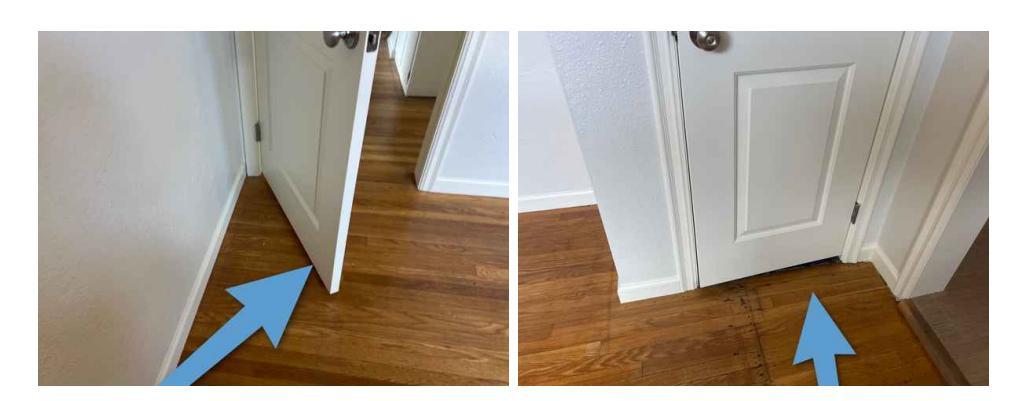
Observe one or more doors without doorstops or with deficient doorstops. Applying doorstops at the baseboard, will keep the door from causing damage to your drywall upon opening.

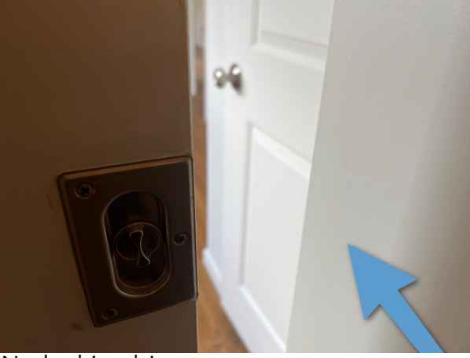
No locking hinges

19.7.1 Doors

Observed door hardware was loose or not functioning properly. Recommend repair or replacement.
