WOOD DESTROYING PESTS AND ORGANISMS INSPECTION REPORT

Building No. 963	Street Balboa Street	City Morro Bay	Zip 93442	Date of Inspection 05/15/2017	Number of Pages 1 of 7
---------------------	-------------------------	-------------------	--------------	----------------------------------	---------------------------

Report #: 84872

Complete Inspection Report

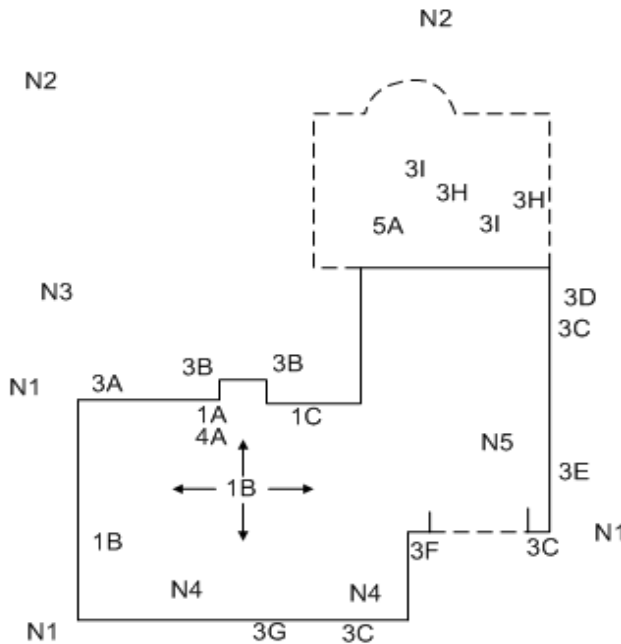
Diagram not to scale-Finding locations approximate

Finding: 1A Evidence of Subterranean Termites infestation was found in the substructure area.
Recommendation: Chemically treat the substructure soil in areas of termite activity using Termidor (fipronil). In addition, an application will be made to the soil adjacent to the exterior wall around the complete perimeter of the structure. Holes may be drilled through concrete, paving or masonry adjacent to the foundation in areas such as, but not limited to; patios, sidewalks, porches and driveways, to allow for chemical treatment of the soil below. We will exercise reasonable caution when drilling but assume no liability for damage to hidden plumbing, electrical, or other utility below these areas. The location of such utilities should be identified prior to our arrival. Regardless of locations of Subterranean Termite infestation found, control of the entire structure is guaranteed. Control is guaranteed by Key Termite and Pest Control for a period of 5 years from the date of treatment.

Finding: 1B Evidence of Subterranean Termites was found in the form boards and/or loose cellulose debris.
Recommendation: Remove and dispose of the loose cellulose debris and form stakes/boards as much as practical. Chemically treat the substructure soil in the areas of infestation with Termidor (fipronil). Remove all the accessible evidence of Subterranean Termite infestation. Chemically treat the embedded portions of the form board(s) that were not practical to remove. In addition, chemically treat the exterior soil around the complete perimeter of the structure for the control of the Subterranean Termite colony. Control is guaranteed for 5 years from the date of application. Chemically treat the soil in areas of Subterranean Termite activity using Termidor (fipronil). In addition, an application will be made to the soil adjacent to the exterior wall around the complete perimeter of the structure. Holes may be drilled through concrete, paving or masonry adjacent to the foundation in areas such as, but not limited to; patios, sidewalks, porches and driveways, to allow for chemical treatment of the soil below. We will exercise reasonable caution when drilling but assume no liability for damage to hidden plumbing, electrical, or other utility below these areas. The location of such utilities should be identified prior to our arrival. Regardless of locations of Subterranean Termite infestation found, control of the entire structure is guaranteed. Control is guaranteed by Key Termite and Pest Control for a period of 5 years from the date of treatment.

Finding: 1C Subterranean Termite damage was noted at the substructure access frame.
Recommendation: Remove and replace the damaged wood members noted.

Finding: 3A Fungus damage was found at the roof sheathing of the eave area.
Recommendation: Replace the fungus damaged portions of roof sheathing as needed.

Finding: 3B Fungus damage was found at the exterior wood trim.
Recommendation: Replace the damaged portions of the trim as necessary.

Finding: 3C Fungus damage was found at the wood siding.

Finding: 3D Fungus damage was found at the wooden window sash.
Recommendation: Remove and replace the damaged window sash. (Wood sash windows are a special order item and may take up to 2 weeks to receive from the date it is ordered.) Exposed wood at the interior and exterior of the installed sash will be painted. Glazing will not be paint as several months exposure will be needed to cure the glazing.

Finding: 3E Fungus damage was found at the siding trim.
Recommendation: Remove and replace the damaged portions of the siding trim as needed to eliminate the fungus infection and damage.

Finding: 3F Fungus damage was found at the fascia of the eave area.
Recommendation: Replace the fungus damaged portions of fascia as needed.

Finding: 3G Fungus damage was found at the exterior door frame.
Recommendation: Replace the damaged portions of the door frame as necessary.

Finding: 3H Fungus infection and damage were found at the wood members of the deck.
Recommendation: Remove and replace the damaged portions of woodmembers of the deck as needed to eliminate the fungus infection. In areas where VERY MINOR fungus growth is present, but no detectable deterioration has occurred, scrape away the surface growth with a wire brush and chemically treat the woodmembers with disodium octaborate tetrahydrate or copper napthenate for elimination of infection. Repair includes replacement of wood members with similar materials (unless improper materials were originally used). Note: Price quoted above does not include complete replacement of the wood deck. Additional damages are often discovered when concealed surfaces of wood members are exposed during the course of repairs. If additional damage is discovered, findings and costs will be submitted on a supplemental report.

Finding: 3I Fungus damage was found at the deck frames.
Recommendation: Remove and replace the damaged portions of the deck frames as needed to eliminate the fungus infection and damage.

Finding: 5A The area beneath the wood deck was inaccessible for inspection due to low clearances. Infestation or infection was found to be extending into this inaccessible area.
Recommendation: Remove two rows of top decking every six feet. Reinspect the area below the deck. Determine the extent of the infestation or infection and issue further recommendation(s) on a supplemental report. Note: Damage may occur to the decking as a result of the decking removal. Additional costs will apply, if necessary, when the decking is reinstalled by this company. Cost for reinspection and the report will be \$50.00 if decking is removed and reinstalled by others.

Finding: 4A Earth to wood contact exists at the base of substructure support post due to lack of a proper concrete footing.
