# WOOD DESTROYING PESTS AND ORGANISMS INSPECTION REPORT

| 810 | Saint Andrews Circle | Paso Robles | 93446 | 02/15/2017 | 1 of 5 |

**Report #: 83837**

## \*\*\*Complete Inspection Report\*\*\*

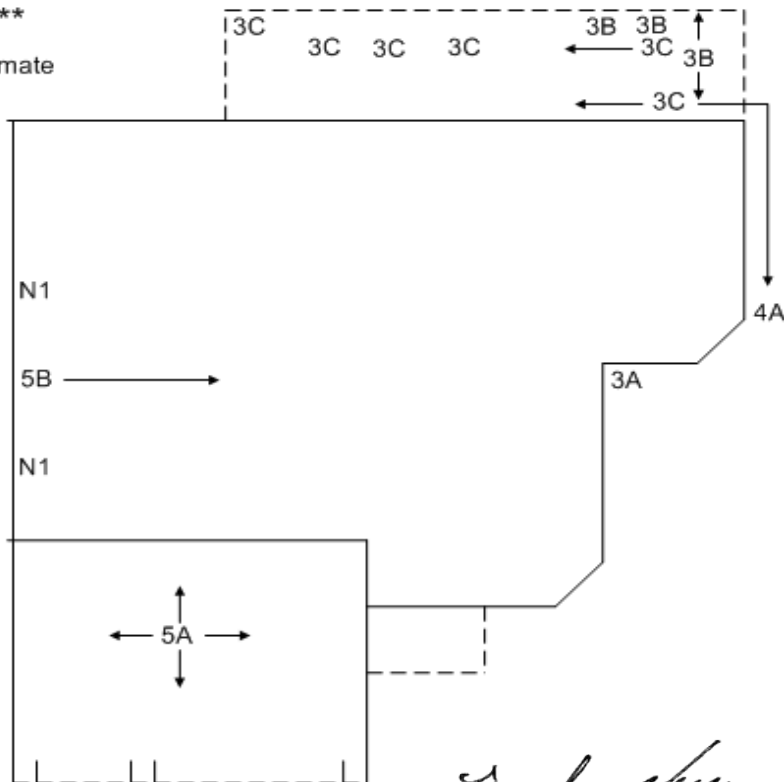
Diagram not to scale-Finding locations approximate

Key: 1 = Subterranean Termites 2 = Drywood Termites 3 = Fungus/Dryrot 4 = Other Findings 5 = Unknown Further Inspection

| Finding: | 3A | Fungus damage was found at the fascia of the eave area. |
| Finding: | 3B | Fungus infection and damage were found at the wood members of the deck. |
| Finding: | 3C | Fungus damage was found at the deck planks . |

| Finding: | 4A | A faulty grade condition exists where the soil grade extends above the weep screed at the base of the stucco. This condition may lead to infestation or infection. |

| Finding: | 5A | Portions of the interior of the garage were inaccessible for inspection due to heavy storage. |
| Finding: | 5B | A room at the interior was inaccessible for inspection due to heavy storage. |

| Recommendation: | | Replace the fungus damaged portions of fascia as needed. |
| Recommendation: | | Remove and replace the damaged portions of woodmembers of the deck as needed to eliminate the fungus infection. In areas where VERY MINOR fungus growth is present, but no detectable deterioration has occurred, scrape away the surface growth with a wire brush and chemically treat the woodmembers with disodium octaborate tetrahydrate or copper naphthenate for elimination of infection. Repair includes replacement of wood members with similar materials (unless improper materials were originally used). Note: Price quoted above does not include complete replacement of the wood deck. Additional damages are often discovered when concealed surfaces of wood members are exposed during the course of repairs. If additional damage is discovered, findings and costs will be submitted on a supplemental report. |
| Recommendation: | | Remove and replace the damaged portions of the deck planks as needed to eliminate the fungus infection and damage. |

| Recommendation: | | Lower the soil grade to allow 4" minimum clearance below the weep screed. |

| Recommendation: | | Reinspect the interior of the garage when the storage has been removed by others. Further findings will be issued on a supplemental report. |
| Recommendation: | | Parties in interest will have to remove the storage as necessary to allow access for inspection of the interior. Further findings will be issued on a supplemental report. |
