# WOOD DESTROYING PESTS AND ORGANISMS INSPECTION REPORT

Building No.	Street	City	Zip	Date of Inspection	Number of Pages
1327	Costa Del Sol	Pismo Beach	93449	08/21/2017	1 of 5

**Report #: 85928**

General Description: Two story; Single family residence; Stucco exterior; Tile roof; Furnished and occupied.	Inspection Tag Posted: GARAGE
Other Tags Posted:

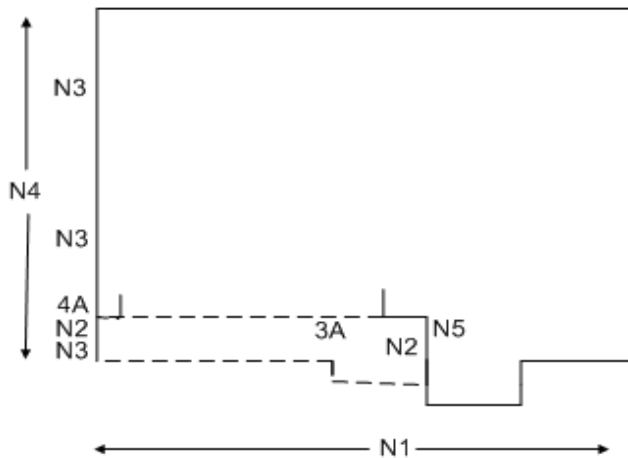
\*\*\*Complete Inspection Report\*\*\*  
 Diagram not to scale-Finding locations approximate

Finding: 3A Fungus damage was found at the second level fascia of the eave area.  
Recommendation: Replace the fungus damaged portions of fascia as needed.  
Price: \$267.00

Finding: 4A A faulty grade condition exists where the soil grade extends above the weep screed at the base of the stucco. This condition may lead to infestation or infection.  
Recommendation: Lower the soil grade to allow 4" minimum clearance below the weep screed.  
Price: \$89.00
