WOOD DESTROYING PESTS AND ORGANISMS INSPECTION REPORT

BUILDING NO. 1805	STREET, CITY, STATE, ZIP Clark Ln #B, Redondo Beach CA 90278	Date of Inspection 1/28/2021	No. of Pages 11
----------------------	---	---------------------------------	--------------------

General Description: Two story wood siding townhouse with slab foundation, attached garage and composition roof.	Inspection Tag Posted: Garage
	Other Tags Posted:

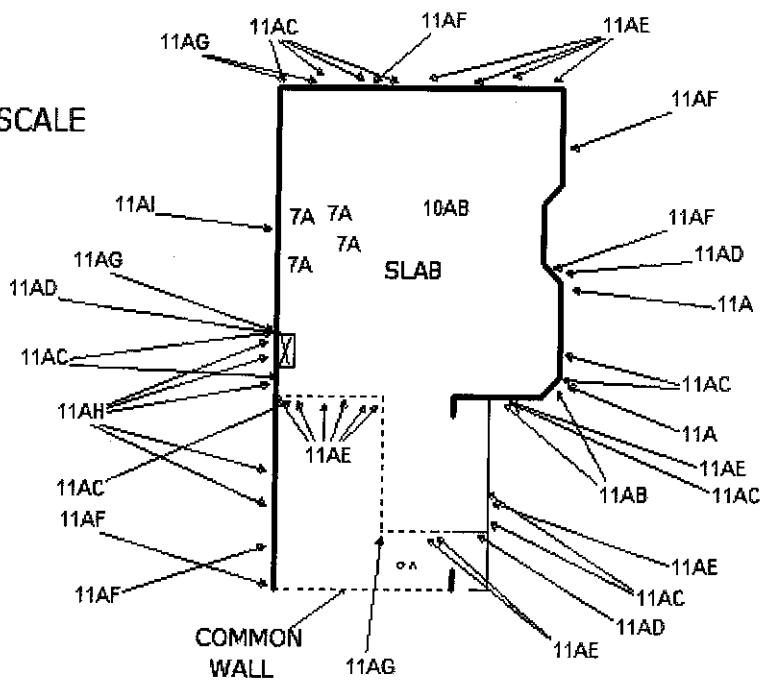
DIAGRAM NOT TO SCALE

ITEM 7A Evidence of drywood termites noted at/in attic as marked 7A on the diagram.

ITEM 8A Evidence of drywood termites noted at/in garage as marked 8A on the diagram.

ITEM 10A Evidence of water stains noted to ridge beam as marked 10A on the diagram.

ITEM 10B Minor surface fungus/dryrot damage noted to interior as marked 10B on the diagram.

ITEM 11A Evidence of drywood termites noted at/in exterior as marked 11A on the diagram.

ITEM 11B Evidence of drywood termite damage noted to fascia as marked 11B on the diagram.

ITEM 11C Evidence of drywood termite damage noted to fascia/trim as marked 11C on the diagram.

ITEM 11D Evidence of minor drywood termite damage noted to fascia as marked 11D on the diagram.

ITEM 11E Evidence of drywood termite damage noted to rafter as marked 11E on the diagram.

ITEM 11F Evidence of minor drywood termite damage noted to trim, jamb as marked 11F on the diagram.

ITEM 11G Evidence of drywood termite damage noted to trim as marked 11G on the diagram.

ITEM 11H Evidence of drywood termite damage noted to bellyboard as marked 11H on the diagram.

ITEM 11I Evidence of drywood termite damage noted to siding as marked 11I on the diagram.

PRIMARY RECOMMENDATION: Fumigation of the entire structure with Vikane* gas fumigant. Entire structure will be guaranteed for three years.

RECOMMENDATION: Owner to contact licensed roofer.

RECOMMENDATION: Chisel out surface fungus/dryrot, treat with a liquid fungicide and wood fill damaged areas. (painting not included)

RECOMMENDATION: Remove and replace damaged wood as needed to correct this item. No painting included. **NOTE:** Upon removal of damaged wood/materials, if infestation is extending into inaccessible areas, a supplemental report will then be issued, outlining findings, recommendations and additional charges (if any).

RECOMMENDATION: Chisel out minor damage and wood fill damaged areas as needed to correct. No painting is included. **NOTE:** Upon removal of damaged wood, if infection is extending into inaccessible areas, a supplemental report will be issued, outlining findings, recommendations and additional charges, (if any.) **NOTE:** If complete replacement is requested, a new estimate will be issued and/or we recommend contacting a licensed contractor for replacement.

RECOMMENDATION: Replace/reinforce and/or wood fill damaged wood as needed to correct this item. While all due care will be exercised, this company cannot warrant/guarantee condition of roofing upon removal/replacement of wood members. (I.e roofing of 2-3 or more layers may not lay flat upon completion.) Repair of this item does not constitute roof repairs and/or certification of condition of roof (refer to roof notation on page 3). Upon removal of damaged wood, if infection is extending into inaccessible areas, a supplemental report will be issued, outlining findings, recommendations and additional charges (if any).(Painting not included)
