# WOOD DESTROYING PESTS AND ORGANISMS INSPECTION REPORT

Building No. 2505	Street Rodman Drive	City Los Osos	Zip 93402	Date of Inspection 04/02/2018	Number of Pages 1 of 6
----------------------	------------------------	------------------	--------------	----------------------------------	---------------------------

**Report #: 87979**

General Description: Single story; Single family residence; Stucco exterior; Tile roof; Furnished and occupied.	Inspection Tag Posted: ATTIC
	Other Tags Posted: KEY 6-5-17 LIMITED

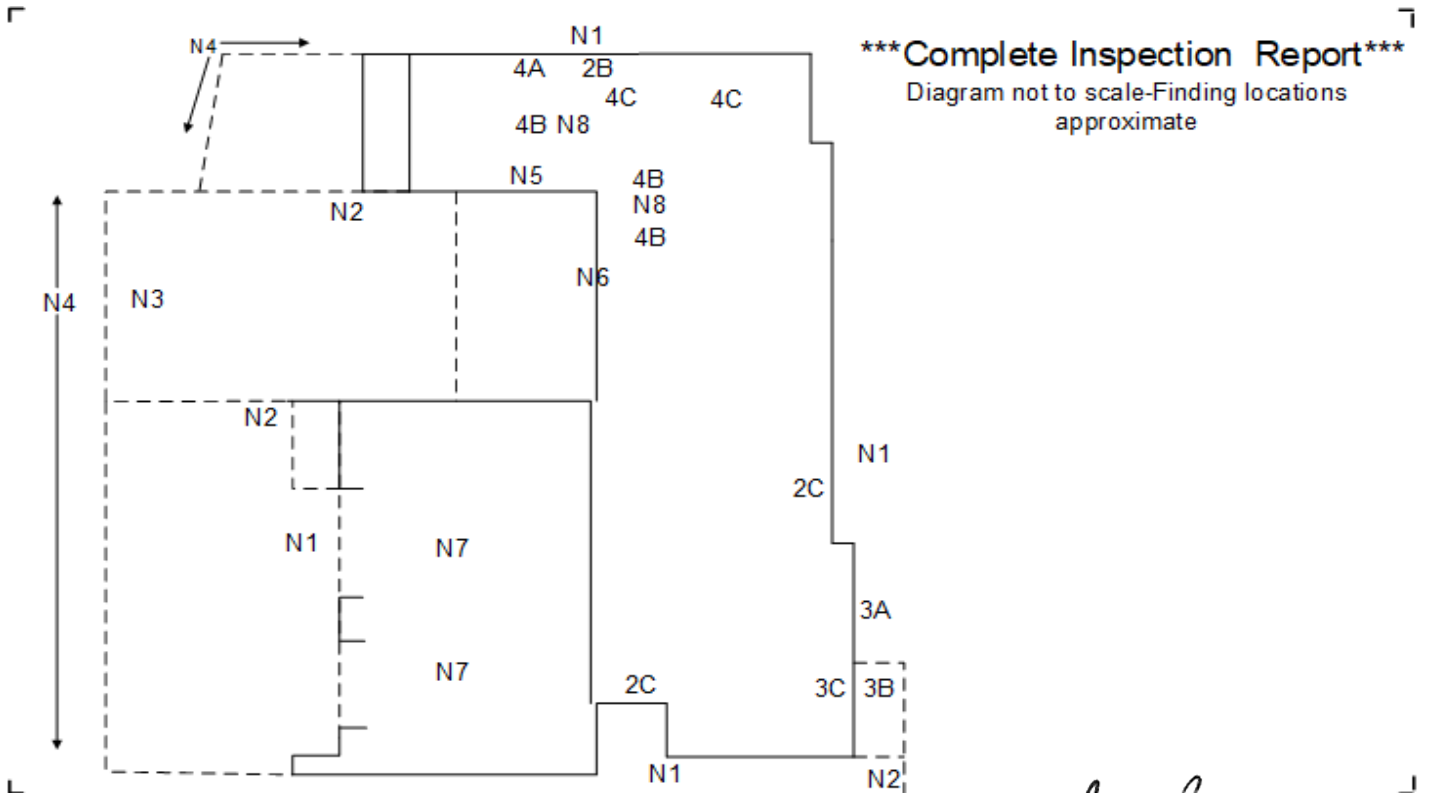
Key: 1 = Subterranean Termites    2 = Drywood Termites    3 = Fungus/Dryrot    4 = Other Findings    5 = Unknown Further Inspection

Evidence of Drywood Termite infestation was found at the exterior, and appears to extend into inaccessible areas of the structure.

Evidence of Drywood Termite infestation was found at the exterior.

Evidence of Drywood Termite infestation was found at the attic.

Fungus damage was found at the substructure door frame.

Fungus damage was found at the side landing joist framing.

Finding: 3C Fungus damage has occurred to the floor adjacent to the door due to leakage at the door frame.

Finding: 4A Moisture damage has occurred to the window sill due to normal condensation.

Finding: 4B Moisture damage has occurred to the wood members of the attic sheathing due to a previous moisture condition.

Finding: 4C Loose cellulose debris (wood scraps,paper,etc..) and form boards were found in the substructure area. This may lead to Subterranean Termite infestation.

Seal the structure and fumigate with a gas lethal to Drywood Termites (Sulfuryl Fluoride). All occupants and pets must vacate the structure until the fumigation is complete. This company will exercise reasonable caution, but cannot be held responsible for damage to plants, TV antennas or roofing due to the fumigation. Further terms and instructions will be supplied upon request or upon scheduling of the fumigation. Information may also be obtained from the fumigation page on our website at [www.keytermite.com](http://www.keytermite.com)

Remove and replace the damaged portions of the substructure door frame as needed to eliminate the fungus infection and damage.

Remove and replace the damaged portions of the side landing joist framing as needed to eliminate the fungus infection and damage.

Recommendation: Remove and replace the damaged portions of the wood floor adjacent to the door. Seal the door frame to control leakage. Additional costs may apply if damage extends into adjacent floor or wall framing. Price does not include replacement of the floor covering. Parties in interest will need to contact a flooring contractor to repair or install new floor covering.

Recommendation: Repair the damaged window sill as needed. Efforts should be made to control the source of the moisture condensation.

Recommendation: Remove and replace or repair the damaged portions of the attic sheathing as needed.

Recommendation: Remove and dispose of all loose cellulose debris from under the dwelling of such size that will not pass through an ordinary garden rake. Remove and dispose of all form boards, as much as is practical, from the substructure area. Chemically treat the embedded portions that could not be removed with an approved termiticide as a control for Subterranean Termites.
