WOOD DESTROYING PESTS AND ORGANISMS INSPECTION REPORT

| Building No. 687 | Street Sequoia Court | City Morro Bay | Zip 93442 | Date of Inspection 04/25/2017 | Number of Pages 1 of 8 |

Report #: 84732

Complete Inspection Report

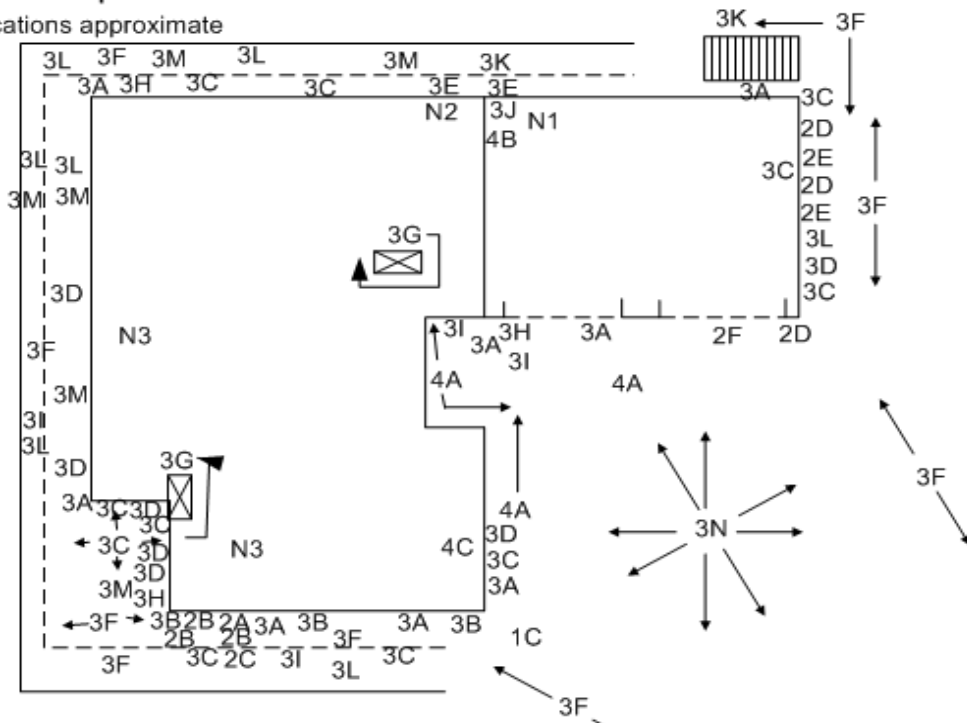
Diagram not to scale-Finding locations approximate

- Finding: 1A Evidence of Subterranean Termite infestation was found at the exterior and indicates an infestation in the soil below the structure.
- Recommendation: Chemically treat the soil in areas of Subterranean Termite activity using Termidor (fipronil). In addition, an application will be made to the soil adjacent to the exterior wall around the complete perimeter of the structure. Holes may be drilled through concrete, paving or masonry adjacent to the foundation in areas such as, but not limited to; patios, sidewalks, porches and driveways, to allow for chemical treatment of the soil below. We will exercise reasonable caution when drilling but assume no liability for damage to hidden plumbing, electrical, or other utility below these areas. The location of such utilities should be identified prior to our arrival. Regardless of locations of Subterranean Termite infestation found, control of the entire structure is guaranteed. Control is guaranteed by Key Termite and Pest Control for a period of 5 years from the date of treatment.

- Price: \$1,375.00
- Finding: 1B Subterranean Termite damage was noted at the trim.
- Recommendation: Remove and replace the damaged wood members noted.

- Price: \$178.00
- Finding: 1C Subterranean Termite damage was noted at the driveway support beam.
- Recommendation: Remove and replace the damaged wood members noted.

- Finding: 2A Evidence of Drywood Termite infestation was found at the exterior and appears to extend into inaccessible areas of the structure.
- Recommendation: Seal the structure and fumigate with a gas lethal to Drywood Termites (Sulfuryl Fluoride) . All occupants and pets must vacate the structure until the fumigation is complete. This company will exercise reasonable caution, but cannot be held responsible for damage to plants, TV antennas or roofing due to the fumigation. Further terms and instructions will be supplied upon request or upon scheduling of the fumigation. Information may also be obtained from the fumigation page on our website at www.keytermite.com

Finding: 2B Drywood termite damage was found at the sheathing.
Recommendation: Replace the Drywood termite damaged wood member.
Price: \$712.00

Finding: 2C Drywood Termite damage was found at the trim.
Recommendation: Remove and replace the damaged portion of the trim as needed.
Price: \$356.00

Finding: 2D Drywood Termite damage was found at the eave.
Recommendation: Remove and replace the damaged portion of the eave as needed.
Price: \$1,068.00

Finding: 2E Drywood Termite damage was found at the 4x12 beam end.
Recommendation: Remove and replace the damaged portion of the 4x12 beam end as needed.
Price: \$445.00

Finding: 2F Minor Drywood Termite damage was found at the garage header.
Recommendation: Repair the minor damage of the wood member with a wood filler.
Price: \$267.00

Finding: 3A Fungus damage was found at the fascia of the eave area.
Recommendation: Replace the fungus damaged portions of fascia as needed.
Price: \$3,560.00

Finding: 3B Fungus damage was found at the 4x12 beam end.
Recommendation: Remove and replace the damaged portions of the 4x12 beam end as needed to eliminate the fungus infection and damage.
Price: \$1,157.00

Finding: 3C Fungus damage was found at the exterior wood trim.
Recommendation: Replace the damaged portions of the trim as necessary.
Price: \$16,020.00

Finding: 3D Fungus damage was found at the wood siding.
Recommendation: Replace the damaged portions of the wood siding. Note: In cases of plywood siding, repair may involve installing wood trim in place of siding removed and/or metal flashing at cut sections of siding replacement. Additional costs will apply if replacement of full sheet(s) of plywood siding is desired by the parties in interest.
Price: \$3,115.00

Finding: 3E Fungus damage was found at the door trim.
Recommendation: Remove and replace the damaged portions of the door trim as needed to eliminate the fungus infection and damage.
Price: \$356.00

Finding: 3F Fungus damage was found in the deck handrail.
Recommendation: Replace the fungus damaged portions of the handrail as needed.
Price: \$20,664.00

Finding: 3G Fungus damage was found at the chimney siding and trim.
Recommendation: Remove and replace the damaged portions of the chimney siding and trim as needed to eliminate the fungus infection and damage.
Price: \$2,670.00

Finding: 3H Fungus damage was found at the roof sheathing of the eave area.
Recommendation: Replace the fungus damaged portions of roof sheathing as needed.
Price: \$801.00

Finding: 3I Fungus damage was found at the rafter end of the eave area.
Recommendation: Replace the fungus damaged portions of the rafter end as needed.
Price: \$356.00

Finding: 3J Fungus damage was found at the exterior door frame.
Recommendation: Replace the damaged portions of the door frame as necessary.
Price: \$178.00

Finding: 3K Fungus damage was found in the wood stairway.
Recommendation: Replace the fungus damaged portions of the wood stairway as needed. This may involve complete replacement.
Price: \$2,136.00

Finding: 3L Fungus infection and damage were found in the wood deck throughout the decking and framing.
Recommendation: Remove and replace the damaged woodmembers of the deck. This will most likely involve complete replacement of the wood deck. In areas where a sound wood member is not replaced and VERY MINOR surface fungus growth is present but no detectable deterioration has occurred, scrape away the surface growth with a wire brush and chemically treat the woodmember with disodium octaborate tetrahydrate or copper naphthenate. Repair includes replacement with nailed con-common redwood decking and doug-fir framing. Additional costs for upgrades to deck screws, con-heart, deck-heart, synthetic decking or pressure treated framing will be quoted upon request.
Note: The upper deck composit decking not included.
Price: \$44,461.00

Finding: 3M Fungus infection and damage were found in the lower deck throughout the decking and framing.
Recommendation: Remove and replace the damaged woodmembers of the deck. This will most likely involve complete replacement of the wood deck. In areas where a sound wood member is not replaced and VERY MINOR surface fungus growth is present but no detectable deterioration has occurred, scrape away the surface growth with a wire brush and chemically treat the woodmember with disodium octaborate tetrahydrate or copper naphthenate. Repair includes replacement with nailed con-common redwood decking and doug-fir framing. Additional costs for upgrades to deck screws, con-heart, deck-heart, synthetic decking or pressure treated framing will be quoted upon request.
Price: \$39,692.00

Finding: 3N Fungus damage was found at the suspended driveway framing.
Recommendation: Remove and replace the damaged portions of the suspended driveway framing fungus infection and damage.
Note: Permits and plans not included in bid. additional cost will occur for plans and permits.
Price: \$52,522.00

Finding: 4A Evidence of excessive moisture was noted at the substructure wood members and indicates that the substructure ventilation is inadequate. Condensation of moisture may lead to infestation, infection and damage.
Recommendation: Seal the base of the wood siding with a durable exterior sealant. This seal must be maintained to remain effective.

Finding: 4B Moisture damage was noted at the exterior door and appears to have been caused by normal exposure to the weather.

Finding: 4C Moisture damage has occurred to the bar sink cabinet floor due to previous plumbing leaks.

Recommendation: Replace the weather damaged door with the same or similar type. Existing door hardware (lock; hinges; sweep, etc) will be reused. Additional costs will apply if the hardware is not functional. Exterior doors are limited to the manufacturers warranty of one year.

Recommendation: Remove and replace the floor of the bar sink cabinet.
