WOOD DESTROYING PESTS AND ORGANISMS INSPECTION REPORT

Building No. 134	Street Avenida De Diamante	City Arroyo Grande	Zip 93420	Date of Inspection 06/12/2017	Number of Pages 1 of 6
---------------------	-------------------------------	-----------------------	--------------	----------------------------------	---------------------------

General Description: Two story; Single family residence; Stucco exterior; Tile roof; Furnished and occupied.	Inspection Tag Posted: ATTIC
	Other Tags Posted: Terminix 2015

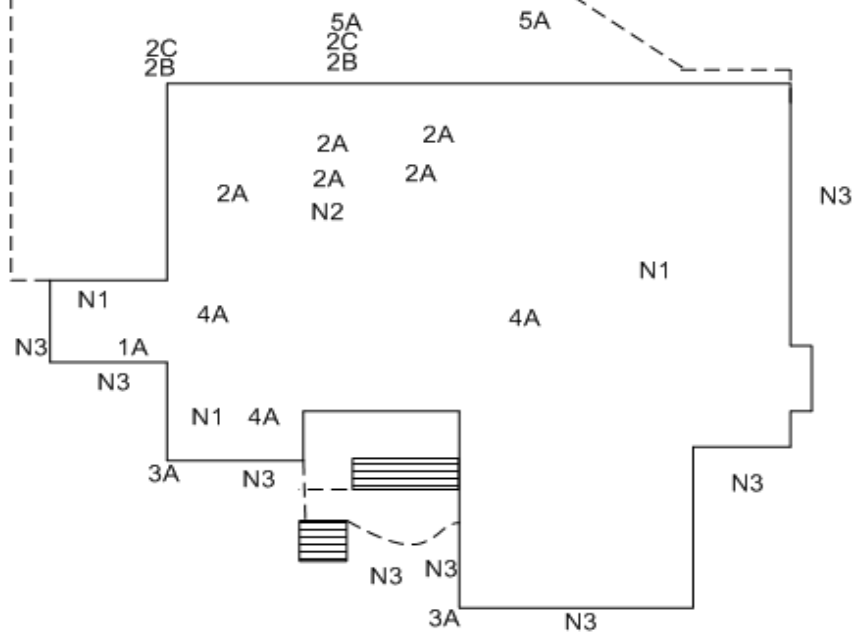
Complete Inspection Report
 Diagram not to scale-Finding locations approximate

Key: 1 = Subterranean Termites 2 = Drywood Termites 3 = Fungus/Dryrot 4 = Other Findings 5 = Unknown Further Inspection

- Finding: 1A Evidence of Subterranean Termites was found in the form boards and/or loose cellulose debris due to the decking area. Decking area will need to be treated from substructure.

- Finding: 2A Evidence of Drywood Termite infestation was found at the attic and appears to extend into inaccessible areas of the structure.
- Recommendation: Seal the structure and fumigate with a gas lethal to Drywood Termites (Sulfuryl Fluoride). All occupants and pets must vacate the structure until the fumigation is complete. This company will exercise reasonable caution, but cannot be held responsible for damage to plants, TV antennas or roofing due to the fumigation. Further terms and instructions will be supplied upon request or upon scheduling of the fumigation. Information may also be obtained from the fumigation page on our website at www.keytermite.com

*****Fumigations are guaranteed for 5 years from the date completed*****
- Price: \$2,964.00
- Finding: 2B Minor Drywood Termite damage was found at the fascia.

- Recommendation: Repair the minor damage of the wood member with a wood filler.
- Price: \$119.00
- Finding: 2C Evidence of Drywood Termite infestation was found at the exterior.

- Finding: 3A Fungus damage was found at the second story fascia of the eave area.
- Recommendation: Replace the fungus damaged portions of fascia as needed.
- Note: If damage is found to be extending into inaccessible areas, a supplemental report may be issued with further findings, recommendations, and costs.
- Price: \$369.00

Finding: 5A The area beneath the wood deck was inaccessible for inspection due to low clearances. Infestation or infection was found to be extending into this inaccessible area.

Finding: 4A Loose cellulose debris (wood scraps/paper) were found in the substructure area. This may lead to Subterranean termite infestation.

- Recommendation: Remove and dispose of the loose cellulose debris and form stakes/boards as much as practical. Chemically treat the substructure soil in the areas of infestation with Termidor (fipronil). Remove all the accessible evidence of Subterranean Termite infestation. Chemically treat the embedded portions of the form board(s) that were not practical to remove. In addition, chemically treat the exterior soil around the complete perimeter of the structure for the control of the Subterranean Termite colony. Control is guaranteed for 5 years from the date of application. Chemically treat the soil in areas of Subterranean Termite activity using Termidor (fipronil). In addition, an application will be made to the soil adjacent to the exterior wall around the complete perimeter of the structure. Holes may be drilled through concrete, paving or masonry adjacent to the foundation in areas such as, but not limited to; patios, sidewalks, porches and driveways, to allow for chemical treatment of the soil below. We will exercise reasonable caution when drilling but assume no liability for damage to hidden plumbing, electrical, or other utility below these areas. The location of such utilities should be identified prior to our arrival. Regardless of locations of Subterranean Termite infestation found, control of the entire structure is guaranteed. Control is guaranteed by Key Termite and Pest Control for a period of 5 years from the date of treatment.

- Recommendation: Refer to item 2A for recommendation. Cost included in item 2A.
- Price: Included as noted in recommendation.

Recommendation: Remove two rows of top decking every six feet. Reinspect the area below the deck. Determine the extent of the infestation or infection and issue further recommendation(s) on a supplemental report. Note: Damage may occur to the decking as a result of the decking removal. Additional costs will apply, if necessary, when the decking is reinstalled by this company. Cost for reinspection and the report will be \$50.00 if decking is removed and reinstalled by others.

Recommendation: Remove and dispose of all loose cellulose debris from under the dwelling of such size that it will not pass through an ordinary garden rake.
