# WOOD DESTROYING PESTS AND ORGANISMS INSPECTION REPORT

BUILDING NO. <b>3844</b>	STREET, CITY, STATE, ZIP <b>E. 15th Street, Long Beach CA 90804</b>	Date of Inspection <b>2/29/2024</b>	No. of Pages <b>16</b>
  <b>Service... We Haven't Forgotten</b> <b>1115 E. Kimberly Avenue</b> <b>Anaheim, CA 92801</b> <b>Ph: (714) 632-3600</b> <b>Fax: (714) 238-0384</b> <b>Toll Free: (800) 585-5424</b>			
Firm Registration No. <b>PR 0474</b>		Report No. <b>2240344</b>	
Ordered By: Pacifica Properties Group 3201 Manhattan Ave. Hermosa Beach, CA 90254 Attn: Jessica Swarbrick 818-826-9440		Property Owner/Party of Interest Pacifica Properties Group 3201 Manhattan Ave. Hermosa Beach, CA 90254 Attn: Jessica Swarbrick 818-826-9440	
COMPLETE REPORT <input checked="" type="checkbox"/>		LIMITED REPORT <input type="checkbox"/>	
General Description: One story single family residence, flat roof, slab foundation, detached garage, vacant		Inspection Tag Posted: Garage	
		Other Tags Posted: None noted

2240344

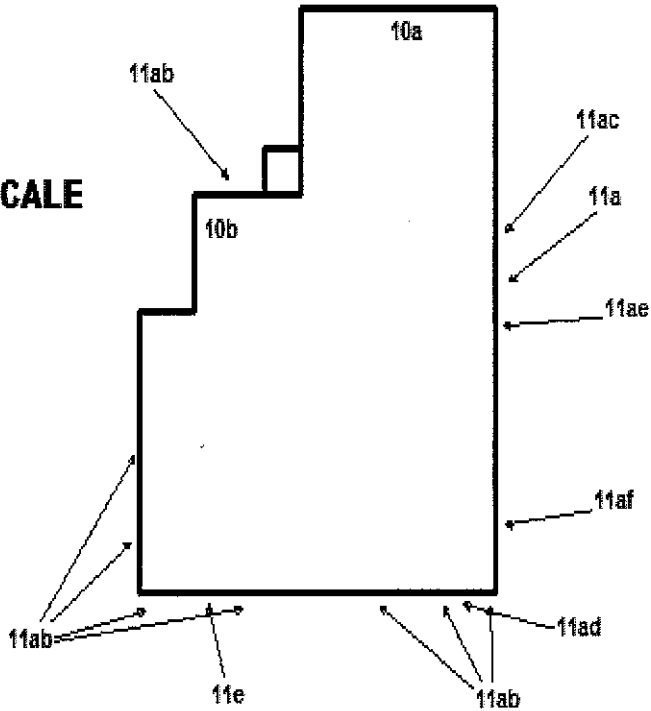
**DIAGRAM NOT TO SCALE**

ITEM 8A Evidence of drywood termites noted in/at interior of garage as marked 8a on the diagram.

ITEM 8B Evidence of drywood termite damage noted to 1x6 bracing as marked 8b on the diagram.

ITEM 8C Evidence of subterranean & drywood termite damage noted to 2x4 framing as marked See 8c on the diagram.

ITEM 8E Evidence of drywood termites noted in/at storage area as marked 8e on the diagram.

ITEM 8F Evidence of drywood termite damage noted to framing as marked 8f on the diagram.

ITEM 8G Evidence of drywood termites noted in/at garage as marked 8g on the diagram.

ITEM 8H Evidence of drywood termite damage noted to fascia as marked 8h on the diagram.

ITEM 8I Evidence of drywood termite damage noted to siding as marked 8i on the diagram.

ITEM 8J Evidence of dryrot & drywood termite damage noted to rafter as marked 8j on the diagram.

ITEM 8K Evidence of drywood termite damage noted to stucco molding as marked 8k on the diagram.

ITEM 8L Evidence of minor drywood termite damage noted to jamb as marked 8l on the diagram.

ITEM 10A Evidence of drywood termites noted in/at interior as marked 10a on the diagram.

ITEM 10B Evidence of subterranean termites noted as marked 10b on the diagram.

ITEM 11A Evidence of drywood termites noted in/at exterior as marked 11a on the diagram.

ITEM 11B Evidence of dryrot & drywood termite damage noted to fascia as marked 11b on the diagram.

ITEM 11C Evidence of minor drywood termite damage noted to fascia as marked 11c on the diagram.

ITEM 11D Evidence of drywood termite damage noted to siding as marked 11d on the diagram.

ITEM 11E Evidence of minor dryrot & drywood termite damage noted to eaves as marked 11e on the diagram.

ITEM 11F Evidence of minor drywood termite damage noted to rafter as marked 11f on the diagram.

**RECOMMENDATION:** Fumigation of structure using Vikane\* (sulfuryl fluoride) gas fumigant (Made in the U.S.A), in conjunction with chloropicrin (warning agent). **While all due care will be taken we cannot be responsible for any roof/plant/antennas/ satellite damage during the course of fumigation.** Please consult with your inspector to see what possible damage may occur. All fumigations are guaranteed for FOUR years from date of completion. (See page 4 for additional details)

**RECOMMENDATION:** Replace/reinforce and/or wood fill damaged wood as needed to correct this item. Painting not included. **NOTE:** While all due care will be exercised, this company cannot warrant/guarantee condition of roofing upon removal/replacement of wood members. (I.e roofing of 2-3 or more layers may not lay flat upon completion.) Repair of this item does not constitute roof repairs and/or certification of condition of roof (refer to roof notation on page 3). **NOTE:** Upon removal of damaged wood, if infection is extending into inaccessible areas, a supplemental report will be issued, outlining findings, recommendations and additional charges (if any).

**RECOMMENDATION:** Fumigation of structure using Vikane\* (sulfuryl flouride) gas fumigant (Made in the U.S.A), in conjunction with chloropicrin (warning agent). **While all due care will be taken we cannot be responsible for any roof/plant/antennas/ satellite damage during the course of fumigation.** Please consult with your inspector to see what possible damage may occur. All fumigations are guaranteed for FOUR years from date of completion. (See page 4 for additional details)

**RECOMMENDATION:** Remove and replace (7) rows of 1x8 & (18) rows of 4x6 as needed to correct this item. No painting included. **NOTE:** Upon removal of damaged wood/materials, if infestation is extending into inaccessible areas, a supplemental report will then be issued, outlining findings, recommendations and additional charges (if any). **NOTE:** IF RAIN GUTTERS ARE REMOVED IN ORDER TO PERFORM REPAIRS, NO GUARANTEE IS GIVEN TO CONDITION OF RAIN GUTTERS UPON RE-INSTALLATION BY SUNCREST EXTERMINATING.

**RECOMMENDATION:** Remove and replace 3 sides as needed to correct this item. No painting included. **NOTE:** Upon removal of damaged wood/materials, if infestation is extending into inaccessible areas, a supplemental report will then be issued, outlining findings, recommendations and additional charges (if any). **NOTE:** IF RAIN GUTTERS ARE REMOVED IN ORDER TO PERFORM REPAIRS, NO GUARANTEE IS GIVEN TO CONDITION OF RAIN GUTTERS UPON RE-INSTALLATION BY SUNCREST EXTERMINATING.

**RECOMMENDATION:** Chisel out minor damage and wood fill damaged areas as needed to correct. No painting is included. **NOTE:** Upon removal of damaged wood, if infection is extending into inaccessible areas, a supplemental report will be issued, outlining findings, recommendations and additional charges, (if any.) **NOTE:** If complete replacement is requested, a new estimate will be issued and/or we recommend contacting a licensed contractor for replacement.

**RECOMMENDATION:** Treat wall voids with termidor foam approximately 05'-10' of wall. **NOTE:** IN ORDER FOR THIS COMPANY TO PERFORM FOAM TREATMENT TO WALL VOIDS, 1/8 INCH HOLES MUST BE OPENED 6 INCHES FROM FLOORING EVERY 18 INCHES. THIS COMPANY WILL FILL ALL HOLES WITH DRYWALL PATCH. THIS COMPANY WILL TEXTURE AREAS OF PATCHING. PAINT MUST BE PROVIDED BY OWNERS. **NOTE: LOCAL TREATMENT IS NOT INTENDED TO BE AN ENTIRE STRUCTURE TREATMENT METHOD. IF INFESTATIONS OF WOOD-DESTROYING PESTS EXTEND OR EXIST BEYOND THE AREA(S) OF LOCAL TREATMENT, THEY MAY NOT BE EXTERMINATED.**

**RECOMMENDATION:** Fumigation of structure using Vikane\* (sulfuryl flouride) gas fumigant (Made in the U.S.A), in conjunction with chloropicrin (warning agent). **While all due care will be taken we cannot be responsible for any roof/plant/antennas/ satellite damage during the course of fumigation.** Please consult with your inspector to see what possible damage may occur. All fumigations are guaranteed for FOUR years from date of completion. (**See page 4 for additional details**)

**RECOMMENDATION:** Remove and replace 56' of fascia as needed to correct this item. No painting included. **NOTE:** Upon removal of damaged wood/materials, if infestation is extending into inaccessible areas, a supplemental report will then be issued, outlining findings, recommendations and additional charges (if any). **NOTE:** IF RAIN GUTTERS ARE REMOVED IN ORDER TO PERFORM REPAIRS, NO GUARANTEE IS GIVEN TO CONDITION OF RAIN GUTTERS UPON RE-INSTALLATION BY SUNCREST EXTERMINATING.

**RECOMMENDATION:** Remove and replace (2) 1x8x10 s/l as needed to correct this item. No painting included. **NOTE:** Upon removal of damaged wood/materials, if infestation is extending into inaccessible areas, a supplemental report will then be issued, outlining findings, recommendations and additional charges (if any). **NOTE:** IF RAIN GUTTERS ARE REMOVED IN ORDER TO PERFORM REPAIRS, NO GUARANTEE IS GIVEN TO CONDITION OF RAIN GUTTERS UPON RE-INSTALLATION BY SUNCREST EXTERMINATING.
