WOOD DESTROYING PESTS AND ORGANISMS INSPECTION REPORT

BUILDING NO. 3850 &	STREET, CITY, STATE, ZIP 3852 E. 15th Street, Long Beach CA 90804	Date of Inspection 2/29/2024	No. of Pages 18

2240347

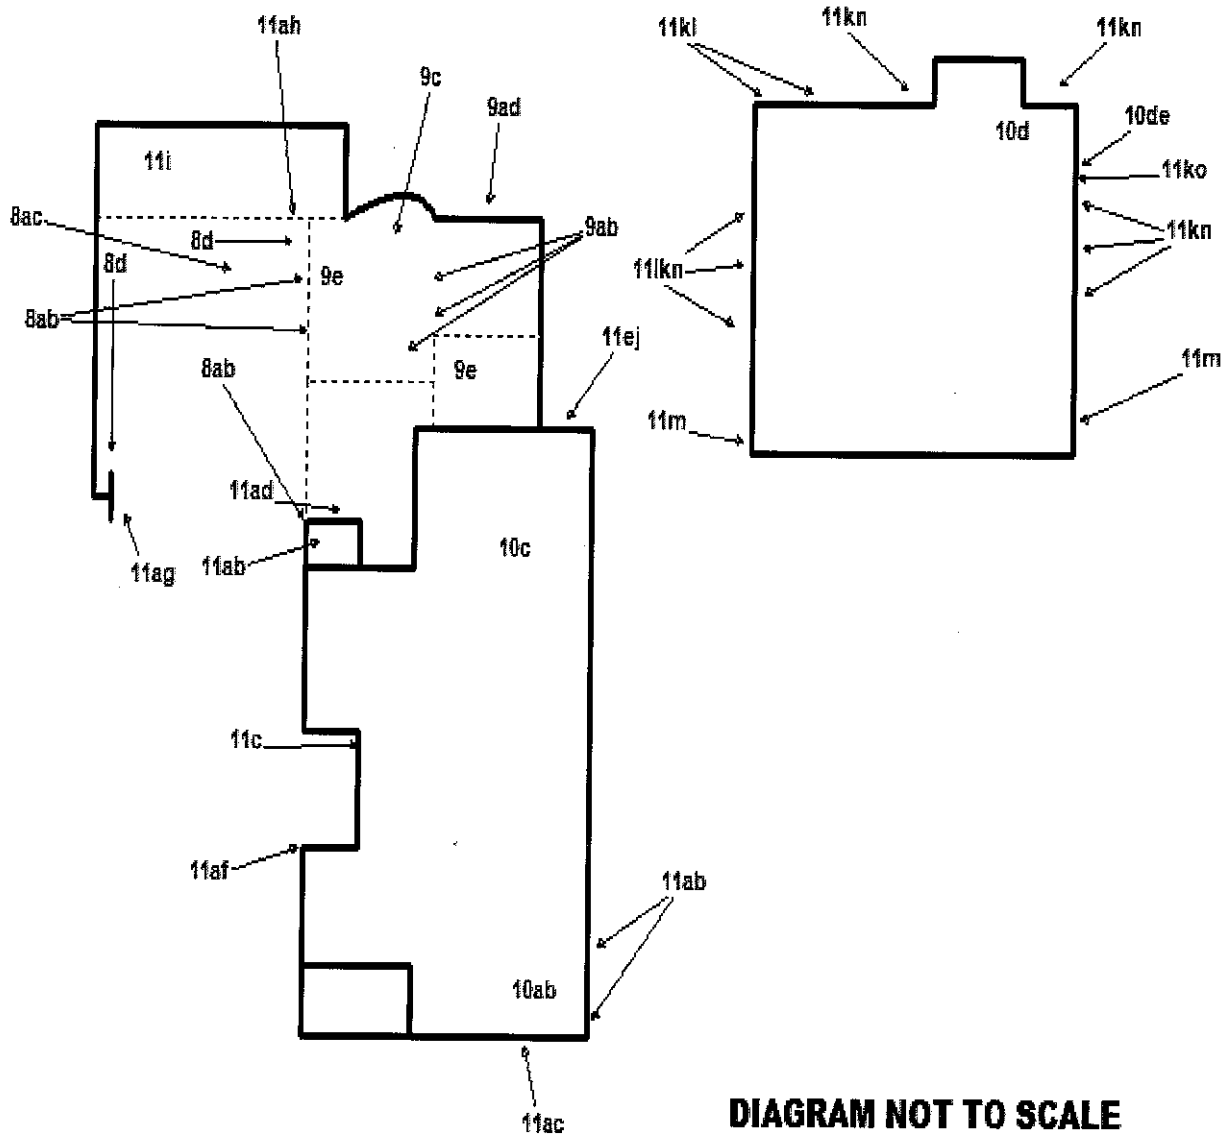
DIAGRAM NOT TO SCALE

ITEM 8A Evidence of drywood termites noted in/at garage as marked 8a on the diagram.

ITEM 8B Evidence of drywood termite damage noted to top plate as marked 8b on the diagram.

ITEM 8C Evidence of drywood termite damage noted to rafter as marked 8c on the diagram.

ITEM 8D Evidence of heavy storage noted in garage as marked 8d on the diagram.

ITEM 9A Evidence of drywood termites noted in/at enclosed patio as marked 9a on the diagram.

ITEM 9B Evidence of drywood termite damage noted to rafter as marked 9b on the diagram.

ITEM 9D Evidence of drywood termite damage noted to jamb as marked 9d on the diagram.

ITEM 10A Evidence of drywood termites noted in/at interior as marked 10a on the diagram.

ITEM 10B Evidence of drywood termite damage noted to window/window sill as marked 10b on the diagram.

ITEM 10C Evidence of subterranean termites noted as marked 10c on the diagram.

ITEM 10D Evidence of drywood termites noted in/at interior of rear unit as marked 10d on the diagram.

ITEM 10E Evidence of minor drywood termite damage noted to beam as marked 10e on the diagram.

ITEM 11A Evidence of drywood termites noted in/at exterior as marked 11a on the diagram.

ITEM 11B Evidence of drywood termite damage noted to rafter as marked 11b on the diagram.

ITEM 11C Evidence of minor dryrot & drywood termite damage noted to siding as marked 11c on the diagram.

ITEM 11D Evidence of drywood termite damage noted to siding as marked 11d on the diagram.

ITEM 11E Subterranean termites were noted at/in exterior as marked 11e on the diagram.

ITEM 11F Evidence of drywood termite damage noted to fascia as marked 11f on the diagram.

ITEM 11G Evidence of drywood termite damage noted to jamb as marked 11g on the diagram.

ITEM 11H Evidence of drywood termite damage noted to jamb as marked 11h on the diagram.

ITEM 11I Evidence of excessive moisture noted at bomb shelter under back storage room as marked 11i on the diagram.

ITEM 11J Evidence of subterranean termite damage noted to window framing as marked 11j on the diagram.

ITEM 11K Evidence of drywood termites noted in/at rear of home as marked 11k on the diagram.

ITEM 11L Evidence of drywood termite damage noted to fascia as marked 11l on the diagram.

ITEM 11M Evidence of minor dryrot damage noted to fascia as marked 11mon the diagram.

ITEM 11N Evidence of minor drywood termite damage noted to T & G as marked 11n on the diagram.

ITEM 11O Evidence of minor drywood termite damage noted to beam as marked 11o on the diagram.

RECOMMENDATION: Fumigation of structure using Vikane* (sulfuryl flouride) gas fumigant (Made in the U.S.A), in conjunction with chloropicrin (warning agent). **While all due care will be taken we cannot be responsible for any roof/plant/antennas/ satellite damage during the course of fumigation.** Please consult with your inspector to see what possible damage may occur. All fumigations are guaranteed for FOUR years from date of completion. (See page 4 for additional details)

RECOMMENDATION: Replace/reinforce and/or wood fill damaged wood as needed to correct this item. Painting not included. **NOTE:** While all due care will be exercised, this company cannot warrant/guarantee condition of roofing upon removal/replacement of wood members. (I.e roofing of 2-3 or more layers may not lay flat upon completion.) Repair of this item does not constitute roof repairs and/or certification of condition of roof (refer to roof notation on page 3). **NOTE:** Upon removal of damaged wood, if infection is extending into inaccessible areas, a supplemental report will be issued, outlining findings, recommendations and additional charges (if any).

RECOMMENDATION: Upon removal of storage, Suncrest will inspect garage. Upon further inspection a supplemental report will be issued outlining findings, recommendation and additional charges, if any.

RECOMMENDATION: Fumigation of structure using Vikane* (sulfuryl fluoride) gas fumigant (Made in the U.S.A), in conjunction with chloropicrin (warning agent). **While all due care will be taken we cannot be responsible for any roof/plant/antennas/ satellite damage during the course of fumigation.** Please consult with your inspector to see what possible damage may occur. All fumigations are guaranteed for FOUR years from date of completion. (**See page 4 for additional details**)

RECOMMENDATION: Owner to contact a licensed contractor.

RECOMMENDATION: Fumigation of structure using Vikane* (sulfuryl flouride) gas fumigant (Made in the U.S.A), in conjunction with chloropicrin (warning agent). **While all due care will be taken we cannot be responsible for any roof/plant/antennas/ satellite damage during the course of fumigation.** Please consult with your inspector to see what possible damage may occur. All fumigations are guaranteed for FOUR years from date of completion. (**See page 4 for additional details**)

RECOMMENDATION: Treat wall voids with termidor foam. **NOTE:** IN ORDER FOR THIS COMPANY TO PEFORM FOAM TREATMENT TO WALL VOIDS, 1/8 INCH HOLES MUST BE OPENED 6 INCHES FROM FLOORING EVERY 18 INCHES. THIS COMPANY WILL FILL ALL HOLES WITH DRYWALL PATCH. THIS COMPANY WILL TEXTURE AREAS OF PATCHING. PAINT MUST BE PROVIDED BY OWNERS. **NOTE: LOCAL TREATMENT IS NOT INTENDED TO BE AN ENTIRE STRUCTURE TREATMENT METHOD. IF INFESTATIONS OF WOOD-DESTROYING PESTS EXTEND OR EXIST BEYOND THE AREA(S) OF LOCAL TREATMENT, THEY MAY NOT BE EXTERMINATED.**

RECOMMENDATION: Chisel out minor damage and wood fill damaged areas as needed to correct. No painting is included. **NOTE:** Upon removal of damaged wood, if infection is extending into inaccessible areas, a supplemental report will be issued, outlining findings, recommendations and additional charges, (if any.) **NOTE:** If complete replacement is requested, a new estimate will be issued and/or we recommend contacting a licensed contractor for replacement.

RECOMMENDATION: Remove and replace (2) 1x8x2 s/l as needed to correct this item. No painting included. **NOTE:** Upon removal of damaged wood/materials, if infestation is extending into inaccessible areas, a supplemental report will then be issued, outlining findings, recommendations and additional charges (if any). **NOTE:** IF RAIN GUTTERS ARE REMOVED IN ORDER TO PERFORM REPAIRS, NO GUARANTEE IS GIVEN TO CONDITION OF RAIN GUTTERS UPON RE-INSTALLATION BY SUNCREST EXTERMINATING.

RECOMMENDATION: Rod and trench the soil (6" deep) at infested areas with TERMIDOR*. Remove/mask/cover all accessible subterranean termite evidence. **WE ARE NOT RESPONSIBLE FOR DAMAGE TO VEGETATION WITHIN 12- 18" OF AREAS TO BE TREATED.** **NOTE:** This is a local treatment method and local treatments are not intended to be an entire structure treatment method. If infestations of subterranean termites extend or exist beyond the area of local treatment, they may not be exterminated. **LOCALIZED TREATMENTS ARE GUARANTEED FOR A PERIOD OF ONE YEAR FROM THE DATE OF COMPLETION. GUARANTEED APPLIES TO AREAS OF TREATMENT ONLY, AND DOES NOT ENCOMPASS THE ENTIRE STRUCTURE.**

RECOMMENDATION: Remove and replace 1x6x10 & 2x6x8 as needed to correct this item. No painting included. **NOTE:** Upon removal of damaged wood/materials, if infestation is extending into inaccessible areas, a supplemental report will then be issued, outlining findings, recommendations and additional charges (if any). **NOTE:** IF RAIN GUTTERS ARE REMOVED IN ORDER TO PERFORM REPAIRS, NO GUARANTEE IS GIVEN TO CONDITION OF RAIN GUTTERS UPON RE-INSTALLATION BY SUNCREST EXTERMINATING.

RECOMMENDATION: Remove and replace 2x6x8 & 1x4x8 as needed to correct this item. No painting included. **NOTE:** Upon removal of damaged wood/materials, if infestation is extending into inaccessible areas, a supplemental report will then be issued, outlining findings, recommendations and additional charges (if any). **NOTE:** IF RAIN GUTTERS ARE REMOVED IN ORDER TO PERFORM REPAIRS, NO GUARANTEE IS GIVEN TO CONDITION OF RAIN GUTTERS UPON RE-INSTALLATION BY SUNCREST EXTERMINATING.

RECOMMENDATION: Remove and replace damaged wood as needed to correct this item. No painting included. **NOTE:** Upon removal of damaged wood/materials, if infestation is extending into inaccessible areas, a supplemental report will then be issued, outlining findings, recommendations and additional charges (if any). **NOTE:** IF RAIN GUTTERS ARE REMOVED IN ORDER TO PERFORM REPAIRS, NO GUARANTEE IS GIVEN TO CONDITION OF RAIN GUTTERS UPON RE-INSTALLATION BY SUNCREST EXTERMINATING.

RECOMMENDATION: Owner to contact an appropriate trades person.

RECOMMENDATION: Fumigation of structure using Vikane* (sulfuryl fluoride) gas fumigant (Made in the U.S.A), in conjunction with chloropicrin (warning agent). **While all due care will be taken we cannot be responsible for any roof/plant/antennas/ satellite damage during the course of fumigation.** Please consult with your inspector to see what possible damage may occur. All fumigations are guaranteed for FOUR years from date of completion. (See page 4 for additional details)

RECOMMENDATION: Remove and replace 2x8x16 DF as needed to correct this item. No painting included. **NOTE:** Upon removal of damaged wood/materials, if infestation is extending into inaccessible areas, a supplemental report will then be issued, outlining findings, recommendations and additional charges (if any). **NOTE:** IF RAIN GUTTERS ARE REMOVED IN ORDER TO PERFORM REPAIRS, NO GUARANTEE IS GIVEN TO CONDITION OF RAIN GUTTERS UPON RE-INSTALLATION BY SUNCREST EXTERMINATING.
