# WOOD DESTROYING PESTS AND ORGANISMS INSPECTION REPORT

| 2550 | Emerson Rd | Cambria | 93428-4819 | 11/06/2025 | 1 of 6 |

**Report #: 112079**

| General Description:<br>Two story; Single family residence; Composition shingle roof; Wood siding; Vacant. | Inspection Tag Posted:<br>WATER HEATER CLOSET |

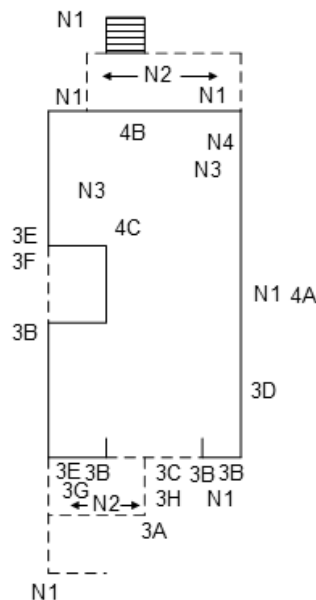
Diagram not to scale  
Finding locations approximate

| Finding: | 3A | Minor fungus damage was found at the deck fascia. Replacement of the wood member appears to be impractical. |
| Finding: | 3B | Fungus damage was found at the siding. |
| Finding: | 3C | Fungus damage was found at the upper garage trim. |
| Finding: | 3D | Fungus damage was found at the trim. |
| Finding: | 3E | Fungus damage was found at the window trim. |
| Finding: | 3F | Fungus damage was found at the fascia of the eave area. |
| Finding: | 3G | Fungus damage was found at the second level siding. |

Finding: 3H Fungus damage was found at the second level window trim.  
Recommendation: Remove and replace the damaged portions of the second level window trim as needed to eliminate the fungus infection and damage.

Finding: 4A Moisture damage was noted at the exterior door and appears to have been caused by normal exposure to the weather.  
Recommendation: Replace the weather damaged door with the same or similar type. Existing door hardware (lock; hinges; sweep, etc) will be reused. Additional costs will apply if the hardware is not functional. Exterior doors are limited to the manufacturers warranty of one year.

Finding: 4B The toilet was found to be loosely bolted to the floor. This creates a potential source of leakage.  
Recommendation: Reset the toilet using a new wax seal and bolts. Additional costs may apply if the toilet flange is found to be damaged or if existing supply line/valve cannot be reused.

Finding: 4C An excessive moisture condition exists due to plumbing leakage at the substructure.  
Recommendation: Contact a licensed plumber to correct the excessive moisture condition.

| Recommendation: | | Remove the minor damage with a wood chisel. Fill the void with an exterior wood filler. |
| Recommendation: | | Remove and replace the damaged portions of the siding as needed to eliminate the fungus infection and damage. |
| Recommendation: | | Remove and replace the damaged portions of the upper garage trim as needed to eliminate the fungus infection and damage. |
| Recommendation: | | Remove and replace the damaged portions of the trim as needed to eliminate the fungus infection and damage. |
| Recommendation: | | Remove and replace the damaged portions of the window trim as needed to eliminate the fungus infection and damage. |
| Recommendation: | | Replace the fungus damaged portions of fascia as needed. |
| Recommendation: | | Remove and replace the damaged portions of the second level siding as needed to eliminate the fungus infection and damage. |
