WOOD DESTROYING PESTS AND ORGANISMS INSPECTION REPORT

Building No.	Street	City	ZIP	Date	of Inspection	Number of Pages
12513	Maidstone Ave	Norwalk	90650	04	/10/2023	4
Downey Exterminators Inc 9730 Washburn RD Report #: 13636						
DOWN	VEY		DOWNEY CA 90241		Regist	tration # : PR4485
EXTERMIN	ATORS		(562) 401-5000		Escro	w # :
		downe	yexterminators@gmai Fax (562) 401-5001	l.com	□со	RRECTED REPORT
Ordered by: Jose Rafael Realty One Group		Property Owne	r and/or Party of Interest:		Report sent to: Jose Rafael Realty One Group	
COMPLETE REPORT	「 ⊠ LIMITED F	REPORT	SUPPLEMENT	AL REPOR	T REINSF	PECTION REPORT
GENERAL DESCRIPTION: One story single Family residence , composition roof, attached garage. Inspection Tag Posted: Attic Other Tags Posted:						
An inspection has been made of the structure(s) shown on the diagram in accordance with the Structural Pest Control Act. Detached porches, detached steps, detached decks and any other structures not on the diagram were not inspected.

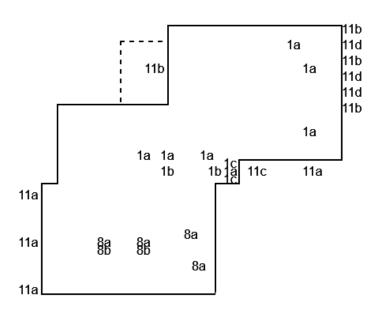
Diagram Not To Scale

FINDING - Evidence of cellulose debris noted in the subarea.

FINDING- Drywood termites noted at SUBFLOOR.

FINDING- Dry Rot damage was noted at SUBFLOOR.

FINDING- Drywood termite damage was noted at PLYWOOD.

FINDING- Drywood termites noted at GARAGE.

FINDING- Drywood termite damage was noted at FASCIA.

FINDING- Drywood termite damage was noted at EAVES.

FINDING- Drywood termites noted at RAFTERS.

RECOMMENDATION - Remove all cellulose debris of a size that can be raked (or larger).

RECOMMENDATION - Locally treat for the control of drywood termites. Remove or cover the drywood termite fecal pellets in accessible areas.

RECOMMENDATION - Contact other trades to correct.

RECOMMENDATION - Repair or Replace the drywood termite damaged wood member(s) noted in the above.
