WOOD DESTROYING PESTS AND ORGANISMS INSPECTION REPORT

Building No. 700	Street E. 50th	City Los Angeles	ZIP 90011	Date of Inspection 06/30/2024	Number of Pages 5
---------------------	-------------------	---------------------	--------------	----------------------------------	----------------------

Foothill Termite Control

Report # : 10087

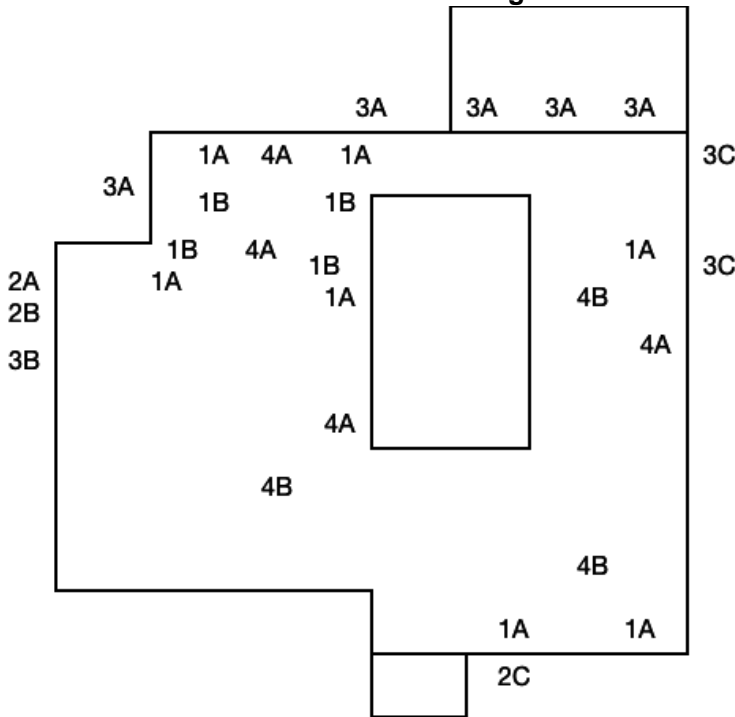
Diagram Not To Scale

GENERAL DESCRIPTION: One story, single family, wood siding, comp roof, detached garage (not inspected) attached patio, furnished and occupied at the time of the inspection.	Inspection Tag Posted: Subarea Other Tags Posted:
--	---

An inspection has been made of the structure(s) shown on the diagram in accordance with the Structural Pest Control Act. Detached porches, detached steps, detached decks and any other structures not on the diagram were not inspected.
