# WOOD DESTROYING PESTS AND ORGANISMS INSPECTION REPORT

BUILDING NO. 427	STREET, CITY, STATE, ZIP Avenue F, Redondo Beach CA 90277	Date of Inspection 4/11/2022	No. of Pages 12
---------------------	--	---------------------------------	--------------------

COMPLETE REPORT <input checked="" type="checkbox"/>	LIMITED REPORT <input type="checkbox"/>	SUPPLEMENTAL REPORT <input type="checkbox"/>	REINSPECTION REPORT <input type="checkbox"/>
General Description: 2-story stucco house, att garage, tile roof, vacant.		Inspection Tag Posted: Attic	
		Other Tags Posted:	
An inspection has been made to the structure(s) shown on the diagram in accordance with the Structural Pest Control Act. Detached porches, detached steps, detached decks and any other structures not on the diagram were not inspected.			
Subterranean Termites <input checked="" type="checkbox"/> Drywood Termites <input checked="" type="checkbox"/> Fungus/Dryrot <input checked="" type="checkbox"/> Other Findings <input type="checkbox"/> Further Inspection <input type="checkbox"/>			
If any of above boxes are checked, it indicates that there were visible problems in accessible areas. Read the report for details on checked items.

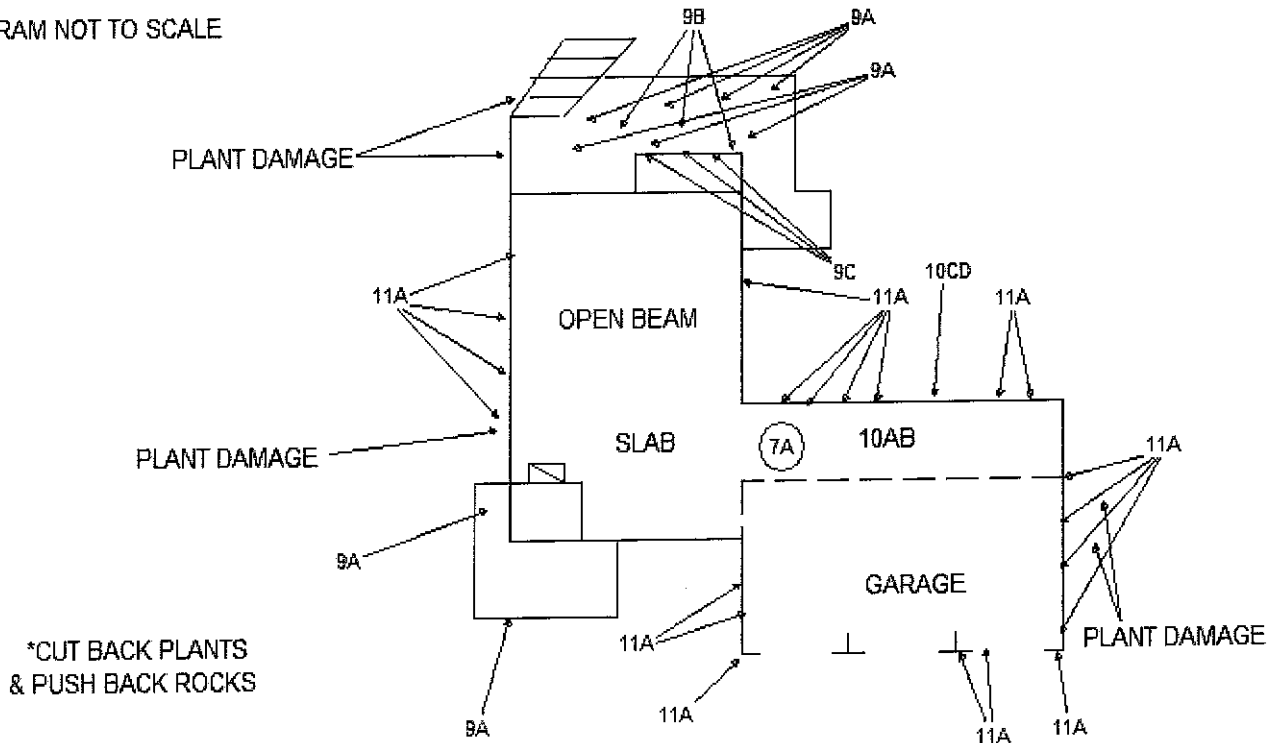
DIAGRAM NOT TO SCALE

ITEM 7A Evidence of drywood termites noted in/at attic as marked 7A on the diagram.

ITEM 9A Evidence of drywood termite damage and dryrot noted to front and back decks as marked 9A on the diagram.

ITEM 9B Surface fungus was noted on the wood members under back deck as marked 9B on the diagram.

ITEM 9C Evidence of dryrot damage noted to post, bottom rails and landing board at balcony as marked 9C on the diagram.

ITEM 10A Subterranean termites were noted at/in baseboard at laundry room as marked 10A on the diagram.

ITEM 10B Evidence of subterranean termite damage noted to baseboard at laundry room as marked 10B on the diagram.

ITEM 10C Subterranean termites were noted at/in jamb as marked 10C on the diagram.

ITEM 10D Evidence of subterranean termite damage noted to jamb as marked 10D on the diagram.

ITEM 11A Evidence of drywood termite damage noted to eaves, rafters and fascia as marked 11A on the diagram.

**RECOMMENDATION:** Fumigation of structure using Vikane\* (sulfuryl fluoride) gas fumigant (Made in the U.S.A), in conjunction with chloropicrin (warning agent). **While all due care will be taken we cannot be responsible for any roof/plant/antennas/ satellite damage during the course of fumigation.** Please consult with your inspector to see what possible damage may occur. All fumigations are guaranteed for FOUR years from date of completion. (See page 4 for additional details)

**RECOMMENDATION:** Replace/reinforce and/or wood fill damaged wood as needed to correct this item. Painting not included. **NOTE:** While all due care will be exercised, this company cannot warrant/guarantee condition of roofing upon removal/replacement of wood members. (I.e roofing of 2-3 or more layers may not lay flat upon completion.) Repair of this item does not constitute roof repairs and/or certification of condition of roof (refer to roof notation on page 3). **NOTE:** Upon removal of damaged wood, if infection is extending into inaccessible areas, a supplemental report will be issued, outlining findings, recommendations and additional charges (if any).

**RECOMMENDATION:** Scrape and treat the infected wood members with a registered fungicide in accordance with the manufacturers label.

**RECOMMENDATION:** Drill a series of holes through the concrete slab and pressure inject TERMIDOR\* into the soil below. Remove/mask/cover all accessible subterranean termite evidence. **WE ARE NOT RESPONSIBLE FOR DAMAGE THAT WILL OCCUR TO FLOOR COVERINGS, PLASTIC/PVC PIPES BELOW SLAB, AND RE-STRETCHING OF CARPET.** Note: This is a local treatment method and local treatments are not intended to be an entire structure treatment method. If infestations of subterranean termites extend or exist beyond the area of local treatment, they may not be exterminated. **LOCALIZED TREATMENTS ARE GUARANTEED FOR A PERIOD OF ONE YEAR FROM THE DATE OF COMPLETION. GUARANTEED APPLIES TO AREAS OF TREATMENT ONLY, AND DOES NOT ENCOMPASS THE ENTIRE STRUCTURE.**

**RECOMMENDATION:** Replace/reinforce and/or wood fill damaged wood as needed to correct this item. Painting not included. **NOTE:** Upon removal of damaged wood, if infection is extending into inaccessible areas, a supplemental report will be issued, outlining findings, recommendations and additional charges (if any).
