# WOOD DESTROYING PESTS AND ORGANISMS INSPECTION REPORT

| Building No.<br><b>2556</b> | Street<br><b>Nutmeg Ave</b> | City<br><b>Morro Bay</b> | Zip<br><b>93442-1736</b> | Date of Inspection<br><b>08/19/2025</b> | Number of Pages<br><b>1 of 6</b> |

**Report #: 111443**

## \*\*\*Complete Inspection Report\*\*\*

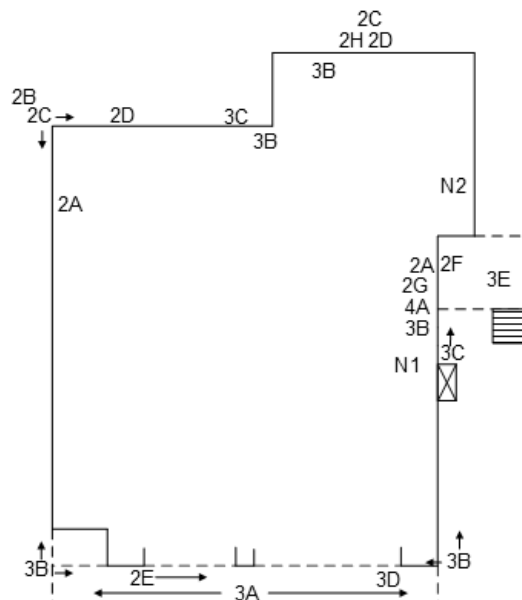
Diagram not to scale  
Finding locations approximate

Key: 1 = Subterranean Termites    2 = Drywood Termites    3 = Fungus/Dryrot    4 = Other Findings    5 = Unknown Further Inspection

| Finding: | 2A | Evidence of Drywood Termite infestation was found at the interior and appears to extend into inaccessible areas of the structure. |
| Finding: | 2B | Evidence of Drywood Termite infestation was found at the exterior. |
| Finding: | 2C | Drywood Termite damage was found at the fascia. |
| Finding: | 2D | Evidence of Drywood Termite infestation was found at the exterior weep screed. |
| Finding: | 2E | Drywood termite damage was found at the garage trim. |
| Finding: | 2F | Drywood Termite damage was found at the jamb. |
| Finding: | 2G | Minor Drywood Termite damage was found at the interior door jamb. |
| Finding: | 2H | Drywood Termite damage was found at the sheathing. |

| Finding: | 3A | Fungus damage was found at the second level cantilever balcony framing and handrail. |

Finding: 3B Fungus damage was found at the second level fascia of the eave area.  
Recommendation: Replace the fungus damaged portions of fascia as needed.  
Price: \$1,428.00

Finding: 3C Fungus damage was found at the fascia of the eave area.  
Recommendation: Replace the fungus damaged portions of fascia as needed.  
Price: \$612.00

Finding: 3D Fungus damage was found at the exterior door frame and trim.  
Recommendation: Replace the damaged portions of the door frame and trim as necessary.  
Price: \$306.00

Finding: 3E Fungus infection and damage were found in the wood deck and steps throughout the decking and framing.  
Recommendation: Remove and replace the damaged wood members of the deck. This will most likely involve complete replacement of the wood deck. In areas where a sound wood member is not replaced and VERY MINOR surface fungus growth is present but no detectable deterioration has occurred, scrape away the surface growth with a wire brush and chemically treat the wood member with disodium octaborate tetrahydrate or copper naphthenate. Repair includes replacement with nailed con-common redwood decking and doug-fir framing. Additional costs for upgrades to deck screws, con-heart, deck-heart, synthetic decking or pressure treated framing will be quoted upon request.  
Price: \$7,600.00

| Recommendation: | | Seal the structure and fumigate with a gas lethal to Drywood Termites (Sulfuryl Fluoride). All occupants and pets must vacate the structure until the fumigation is complete. This company will exercise reasonable caution, but cannot be held responsible for damage to plants, TV antennas or roofing due to the fumigation. Further terms and instructions will be supplied upon request or upon scheduling of the fumigation. Information may also be obtained from the fumigation page on our website at <a href="http://www.keytermite.com">www.keytermite.com</a><br><b>***Fumigations are guaranteed for 5 years from the date completed***</b> |
| Recommendation: | | Refer to item 2A for recommendation. Cost included in item 2A. |
| Recommendation: | | Remove and replace the damaged portion of the fascia as needed. |
| Recommendation: | | Replace the Drywood termite damaged wood member. |
| Recommendation: | | Remove and replace the damaged portion of the jamb as needed. |
| Recommendation: | | Repair the minor damage of the wood member with a wood filler. |
| Recommendation: | | Remove and replace the damaged portion of the sheathing as needed. |

Recommendation: Remove and replace the damaged portions of the second level cantilever balcony framing and handrail as needed to eliminate the fungus infection and damage.
