# WOOD DESTROYING PESTS AND ORGANISMS INSPECTION REPORT

| Building No.<br>558 | Street<br>Rose Lane | City<br>Twin Peaks | ZIP<br>92391 | Date of Inspection<br>02/11/2026 | Number of Pages<br>6 |
| GENERAL DESCRIPTION:<br>Two story, single family dwelling, wood frame, wood/concrete floor | | | | Inspection Tag Posted:<br>Closet<br>Other Tags Posted:<br>old tag noted | |

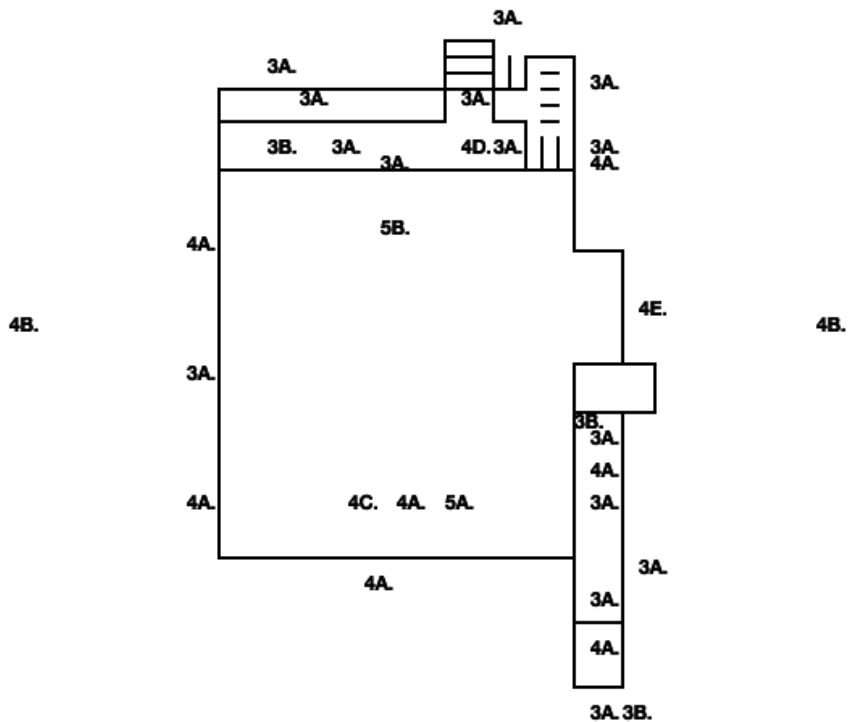
**Diagram Not To Scale**

| An inspection has been made of the structure(s) shown on the diagram in accordance with the Structural Pest Control Act. Detached porches, detached steps, detached decks and any other structures not on the diagram were not inspected. | | | | | |
