WOOD DESTROYING PESTS AND ORGANISMS INSPECTION REPORT

BUILDING NO. 217	STREET, CITY, STATE, ZIP Avenue F, Redondo Beach CA 90277	Date of Inspection 6/29/2022	No. of Pages 13
---------------------	--	---------------------------------	--------------------

General Description: 2-story stucco house, pan tile roof, furn & occupied. Detached guest house, att garage, furn & occupied.	Inspection Tag Posted: Attic Other Tags Posted:
---	---

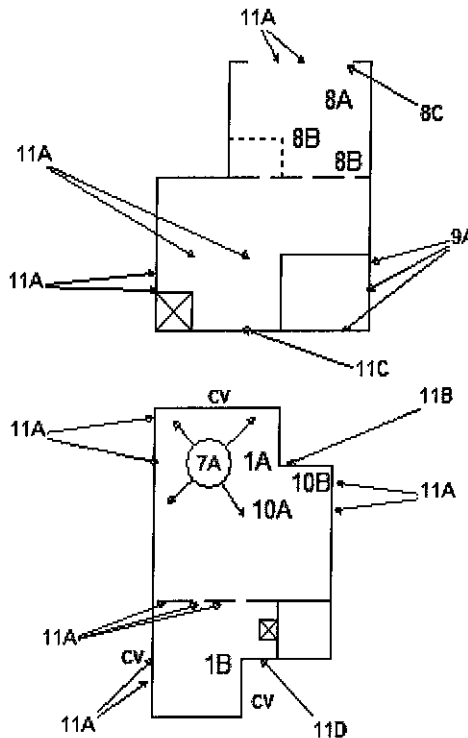
DIAGRAM NOT TO SCALE

ITEM 1A Cellulose debris (wood, paper products) was noted in the subarea as marked 1A on the diagram.

ITEM 1B Evidence of dryrot damage noted to sill as marked 1B on the diagram.

ITEM 7A Evidence of drywood termites noted in/at attic as marked 7A on the diagram.

ITEM 8A Evidence of drywood termites noted in/at garage as marked 8A on the diagram.

ITEM 8B Subterranean termites were noted at/in garage as marked 8B on the diagram.

ITEM 8C Evidence of drywood termite damage noted to stud as marked 8C on the diagram.

ITEM 9A Evidence of dryrot noted to joist and lattice as marked 9A on the diagram.

ITEM 10A Evidence of drywood termite damage noted to hardwood floor as marked 10A on the diagram.

ITEM 10B Evidence of drywood termites noted in/at window as marked 10B on the diagram.

ITEM 11A Evidence of drywood termite damage and dryrot noted to eaves, rafters and fascia as marked 11A on the diagram.

ITEM 11B Evidence of dryrot damage noted to meter box as marked 11B on the diagram.

ITEM 11C Evidence of dryrot damage noted to sidelight, sill and stucco moulding as marked 11C on the diagram.

ITEM 11D Evidence of dryrot damage noted to window frame as marked 11D on the diagram.

RECOMMENDATION: Remove the cellulose debris from the subarea and dispose of.

RECOMMENDATION: Remove and replace damaged wood as needed to correct this item. No painting included. **NOTE:** Upon removal of damaged wood/materials, if infestation is extending into inaccessible areas, a supplemental report will then be issued, outlining findings, recommendations and additional charges (if any). **NOTE:** IF RAIN GUTTERS ARE REMOVED IN ORDER TO PERFORM REPAIRS, NO GUARANTEE IS GIVEN TO CONDITION OF RAIN GUTTERS UPON RE-INSTALLATION BY SUNCREST EXTERMINATING.

RECOMMENDATION: Fumigation of structure using Vikane* (sulfuryl flouride) gas fumigant (Made in the U.S.A), in conjunction with chloropicrin (warning agent). **While all due care will be taken we cannot be responsible for any roof/plant/antennas/ satellite damage during the course of fumigation.** Please consult with your inspector to see what possible damage may occur. All fumigations are guaranteed for FOUR years from date of completion. (See page 4 for additional details)

RECOMMENDATION: Drill a series of holes through the concrete slab and pressure inject TERMIDOR* into the soil below. Remove/mask/cover all accessible subterranean termite evidence. **WE ARE NOT RESPONSIBLE FOR DAMAGE THAT WILL OCCUR TO FLOOR COVERINGS, PLASTIC/PVC PIPES BELOW SLAB, AND RE-STRETCHING OF CARPET.** Note: This is a local treatment method and local treatments are not intended to be an entire structure treatment method. If infestations of subterranean termites extend or exist beyond the area of local treatment, they may not be exterminated. **LOCALIZED TREATMENTS ARE GUARANTEED FOR A PERIOD OF ONE YEAR FROM THE DATE OF COMPLETION. GUARANTEED APPLIES TO AREAS OF TREATMENT ONLY, AND DOES NOT ENCOMPASS THE ENTIRE STRUCTURE.**

RECOMMENDATION: Replace/reinforce and/or wood fill damaged wood as needed to correct this item. Painting not included. **NOTE:** While all due care will be exercised, this company cannot warrant/guarantee condition of roofing upon removal/replacement of wood members. (I.e roofing of 2-3 or more layers may not lay flat upon completion.) Repair of this item does not constitute roof repairs and/or certification of condition of roof (refer to roof notation on page 3). **NOTE:** Upon removal of damaged wood, if infection is extending into inaccessible areas, a supplemental report will be issued, outlining findings, recommendations and additional charges (if any).

RECOMMENDATION: Owner to correct.

RECOMMENDATION: Fumigation of structure using Vikane* (sulfuryl flouride) gas fumigant (Made in the U.S.A), in conjunction with chloropicrin (warning agent). **While all due care will be taken we cannot be responsible for any roof/plant/antennas/ satellite damage during the course of fumigation.** Please consult with your inspector to see what possible damage may occur. All fumigations are guaranteed for FOUR years from date of completion. (**See page 4 for additional details**)
