# WOOD DESTROYING PESTS AND ORGANISMS INSPECTION REPORT

Building No. 147	Street Cypress Avenue	City Cayucos	Zip 93430	Date of Inspection 10/08/2018	Number of Pages 1 of 6
---------------------	--------------------------	-----------------	--------------	----------------------------------	---------------------------

**Report #: 90072**

### \*\*\*Complete Inspection Report\*\*\*

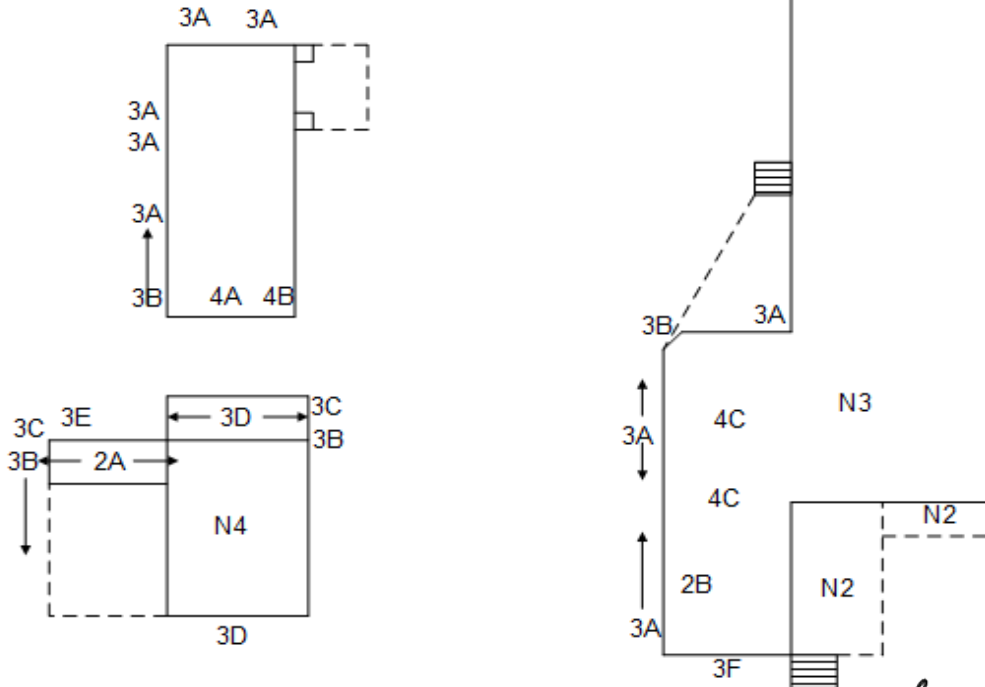
Diagram not to scale-Finding locations approximate

Finding: 2A Evidence of Drywood Termite infestation was found at the exterior and appears to extend into inaccessible areas of the structure.

Finding: 2B Evidence of Drywood Termite infestation was found at the substructure framing.

Finding: 3A Fungus damage was found at the wooden window sash.

Finding: 3B Fungus damage was found at the roof sheathing of the eave area.

Finding: 3C Fungus damage was found at the fascia of the eave area.

Finding: 3D Fungus damage was found at the exterior wood trim.

Finding: 3E Fungus damage was found at the beam end.

Finding: 3F Fungus damage was found at the screen frame.  
Recommendation: Remove and replace the damaged portions of the screen frame as needed to eliminate the fungus infection and damage.  
Price: \$267.00

Finding: 4A The toilet was found to be loosely bolted to the floor. This creates a potential source of leakage.  
Recommendation: Reset the toilet using a new wax seal and bolts. Additional costs may apply if the toilet flange is found to be damaged or if existing supply line/valve cannot be reused.  
Price: No Bid offered at this time. Owner should contact appropriate tradesman to complete recommended corrections.

Finding: 4B Moisture damage has occurred to the wood members of the baseboard of the studio due to a previous moisture condition.  
Recommendation: Remove and replace or repair the damaged portions of the baseboard as needed.  
Price: \$222.00

Finding: 4C Loose cellulose debris (wood scraps/paper) were found in the substructure area. This may lead to Subterranean termite infestation.  
Recommendation: Remove and dispose of all loose cellulose debris from under the dwelling of such size that it will not pass through an ordinary garden rake.  
Price: Price on request

Recommendation: Seal the structure and fumigate with a gas lethal to Drywood Termites (Sulfuryl Fluoride). All occupants and pets must vacate the structure until the fumigation is complete. This company will exercise reasonable caution, but cannot be held responsible for damage to plants, TV antennas or roofing due to the fumigation. Further terms and instructions will be supplied upon request or upon scheduling of the fumigation. Information may also be obtained from the fumigation page on our website at [www.keytermite.com](http://www.keytermite.com)

Recommendation: Remove and replace the damaged window sash. (Wood sash windows are a special order item and may take up to 2 weeks to receive from the date it is ordered.) Exposed wood at the interior and exterior of the installed sash will be painted. Glazing will not be paint as several months exposure will be needed to cure the glazing.

Recommendation: Replace the fungus damaged portions of roof sheathing as needed.

Recommendation: Replace the fungus damaged portions of fascia as needed.

Recommendation: Replace the damaged portions of the trim as necessary.

Recommendation: Remove and replace the damaged portions of the beam end as needed to eliminate the fungus infection and damage.
