# WOOD DESTROYING PESTS AND ORGANISMS INSPECTION REPORT

Building No. 527	Street Valley Dr	City Crestline	ZIP 92325	Date of Inspection 01/03/2022	Number of Pages 5
<b>Aubrey's Termite &amp; Pest Control</b> P.O. Box 6404 Crestline CA 92325 (909) 338-3127 (909) 633-4869 aubreysstermite@yahoo.com				Report # 1843 Registration #: PR5688 Escrow #: <input type="checkbox"/> CORRECTED REPORT	
Ordered by: Gregg Grant San Moritz Realty Crestline CA 92325 WORK: (909) 338-1861 gragggrant@aol.com		Property Owner and/or Party of Interest:		Report sent to: Gregg Grant San Moritz Realty Crestline CA 92325 WORK: (909) 338-1861 gragggrant@aol.com	
COMPLETE REPORT <input checked="" type="checkbox"/> LIMITED REPORT <input type="checkbox"/> SUPPLEMENTAL REPORT <input type="checkbox"/> REINSPECTION REPORT <input type="checkbox"/>					
GENERAL DESCRIPTION: SINGLE STORY, LOFT, RAISED FOUNDATION, FURNISHED, VACANT, COMPOSITION ROOF, WOOD DECK(S), SINGLE FAMILY RESIDENCE

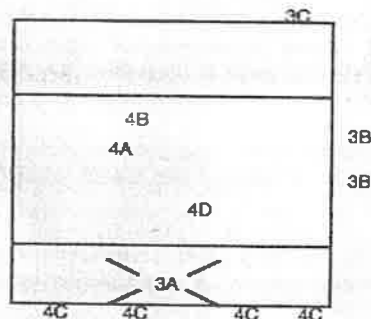
Diagram Not To Scale

**FINDING: EVIDENCE OF FUNGUS AND/OR DRY ROT DAMAGE WAS NOTED AT DECKING & JOIST AS MARKED ON DIAGRAM.**

**FINDING: EVIDENCE OF FUNGUS AND/OR DRY ROT DAMAGE WAS NOTED AT SIDING AS MARKED ON DIAGRAM.**

**FINDING: EVIDENCE OF FUNGUS AND/OR DRY ROT DAMAGE WAS NOTED AT POST AS MARKED ON DIAGRAM.**

**FINDING:** EVIDENCE OF EARTH TO WOOD CONTACT WAS NOTED AT LOAD POST AS MARKED ON DIAGRAM.

**FINDING:** EVIDENCE OF EXCESSIVE MOISTURE CONDITION WAS NOTED AT SUBAREA DUE TO WATER LEACHING IN AS MARKED ON DIAGRAM.

**FINDING:** EVIDENCE OF EARTH TO WOOD CONTACT WAS NOTED AT FRONT DECK BEAMAS MARKED ON DIAGRAM.

**FINDING:** EVIDENCE OF CARPENTER ANTS WAS NOTED AT SUBFLOOR IN SUBAREA AS MARKED ON DIAGRAM.

**RECOMMENDATION: OPEN DECK TO FURTHER PRICE REPAIR, REMOVAL OR REPLACEMENT OF DAMAGED OR INFECTED WOOD MEMBERS. UPON OPENING, IF DAMAGE EXTENDS BEYOND OR INTO AREAS NOT ACCESSIBLE AT THE TIME OF OUR ORIGINAL INSPECTION, THEN WE WILL ISSUE A SUPPLEMENTAL REPORT WITH FURTHER FINDINGS AND RECOMMENDATIONS AND ADDITIONAL BID, IF ANY. THIS BID DOES NOT INCLUDE PAINT UNLESS OTHERWISE SPECIFIED.**

**RECOMMENDATION: DAMAGED OR INFECTED WOOD MEMBERS BE REPAIRED, REMOVED OR REPLACED. UPON REMOVAL, IF DAMAGE EXTENDS BEYOND OR INTO AREAS NOT ACCESSIBLE AT THE TIME OF OUR ORIGINAL INSPECTION, THEN WE WILL ISSUE A SUPPLEMENTAL REPORT WITH FURTHER FINDINGS AND RECOMMENDATIONS AND ADDITIONAL BID, IF ANY. THIS BID DOES NOT INCLUDE PAINT UNLESS OTHERWISE SPECIFIED.**

**RECOMMENDATION: DAMAGED OR INFECTED WOOD MEMBERS BE REPAIRED, REMOVED OR REPLACED. UPON REMOVAL, IF DAMAGE EXTENDS BEYOND OR INTO AREAS NOT ACCESSIBLE AT THE TIME OF OUR ORIGINAL**

**RECOMMENDATION:** IT IS RECOMMENDED THAT THE EARTH IN CONTACT WITH WOOD BE LOWER TO BREAK THE EARTH TO WOOD CONTACT. UPON REMOVAL, IF DAMAGE EXTENDS BEYOND OR INTO AREAS NOT ACCESSIBLE AT THE TIME OF OUR ORIGINAL INSPECTION, THEN WE WILL ISSUE A SUPPLEMENTAL REPORT WITH FURTHER FINDINGS AND RECOMMENDATIONS AND ADDITIONAL BID, IF ANY.

**RECOMMENDATION:** IT IS RECOMMENDED THAT THE EARTH IN CONTACT WITH WOOD BE LOWERED TO BREAK THE EARTH TO WOOD CONTACT. UPON REMOVAL, IF DAMAGE EXTENDS BEYOND OR INTO AREAS NOT ACCESSIBLE AT THE TIME OF OUR ORIGINAL INSPECTION, THEN WE WILL ISSUE A SUPPLEMENTAL REPORT WITH FURTHER FINDINGS AND RECOMMENDATIONS AND ADDITIONAL BID, IF ANY.

**RECOMMENDATION:** SINCE INFESTATION DOES NOT APPEAR TO EXTEND INTO INACCESSIBLE AREAS, IT IS RECOMMENDED THAT THE INFESTED AREA (S) BE LOCALLY TREATED WITH A STATE REGISTERED CHEMICAL SUCH AS, TIMBOR (ACTIVE INGREDIENT, DISODIUM OCTABORATE TETRAHYDRATE), PREMISE 2 (ACTIVE INGREDIENT, IMADACLOPRID), PREMISE FOAM (ACTIVE INGREDIENT, IMADACLOPRID), DRAGNET SFR (ACTIVE INGREDIENT, PERMETHRIN), AND OR TERMIDOR SC, (ACTIVE INGREDIENT, FIPRONIL FOR THE CONTROL OF CARPENTER ANTS OWNER/AGENT UNDERSTANDS THAT THIS IS A SPOT TREATMENT AND ONLY AND THE AREAS OF ACTUAL TREATMENT CAN BE WARRANTED.
