Professional Foundation Repair

Foundation Observation Report	1.0	\$0.00	\$0.00
-------------------------------	-----	--------	--------

I Joe Medina did a Foundation Inspection at
28619 Lomo Drive,
Rancho Palos Verdes, CA 90275

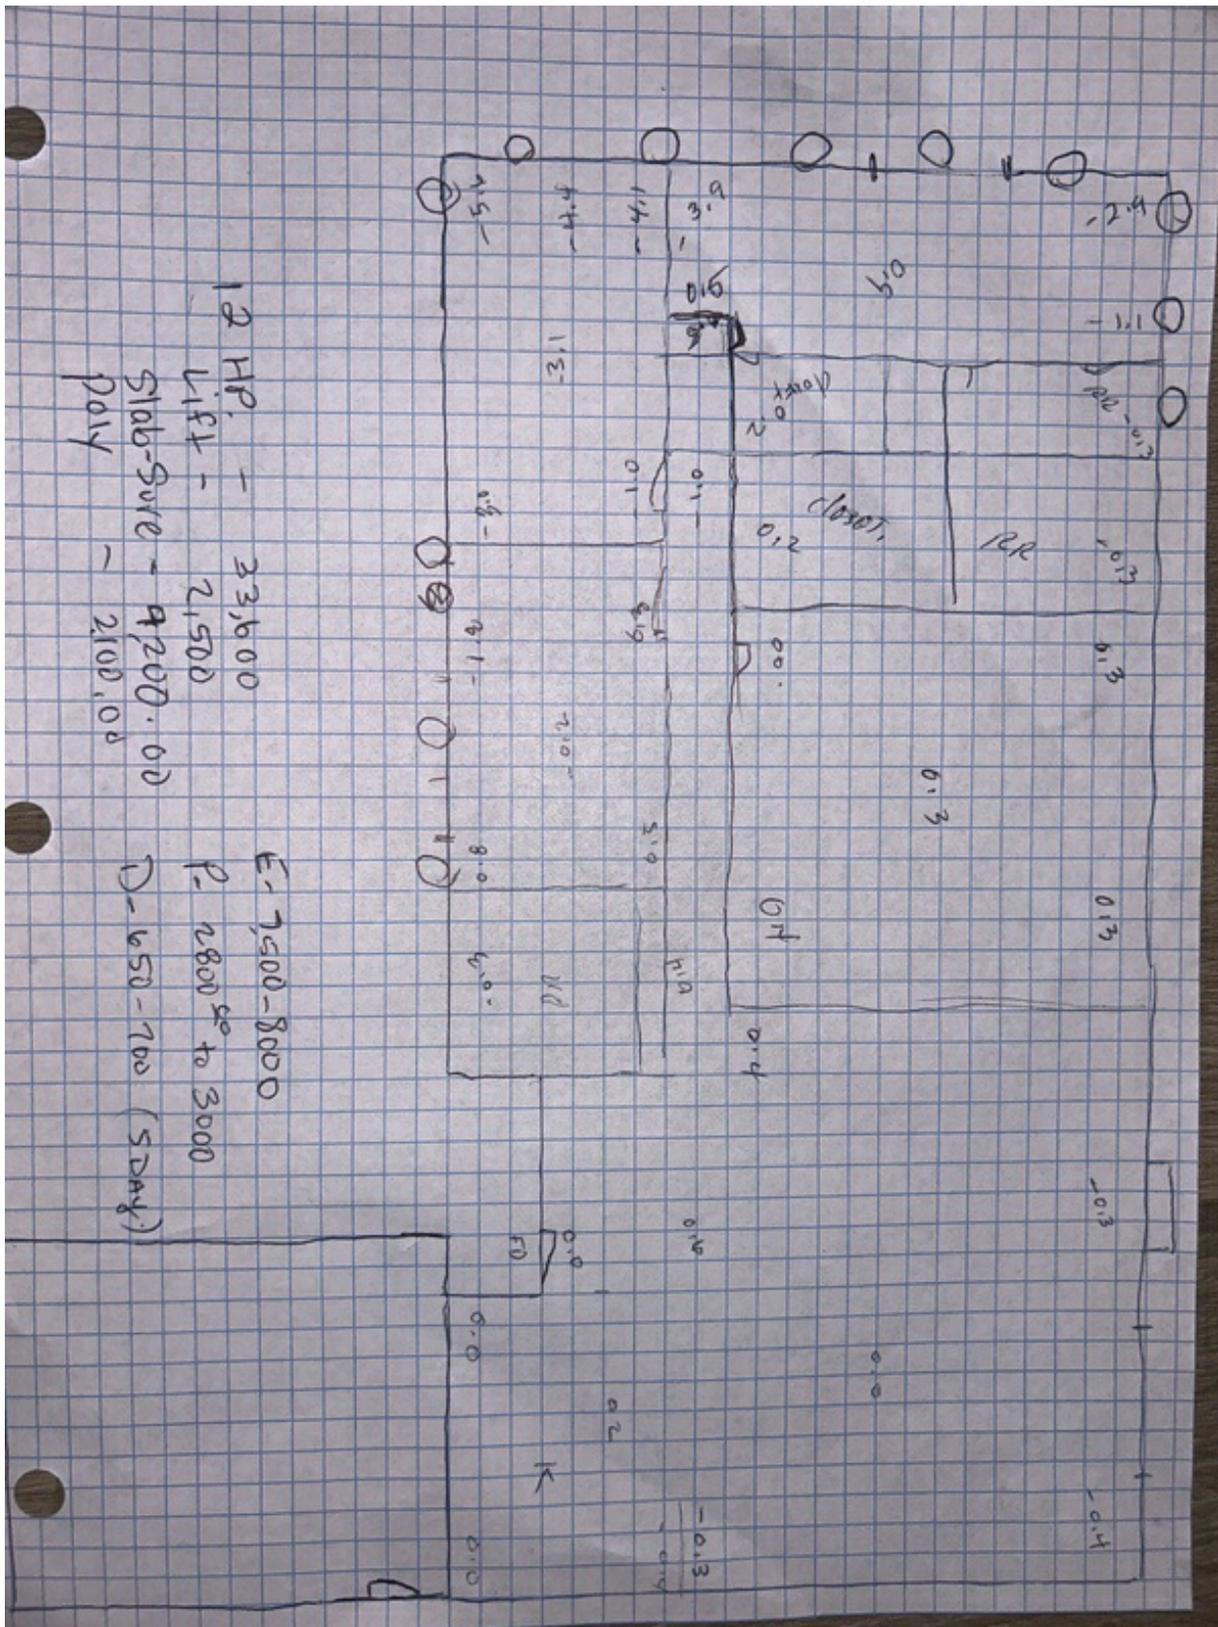
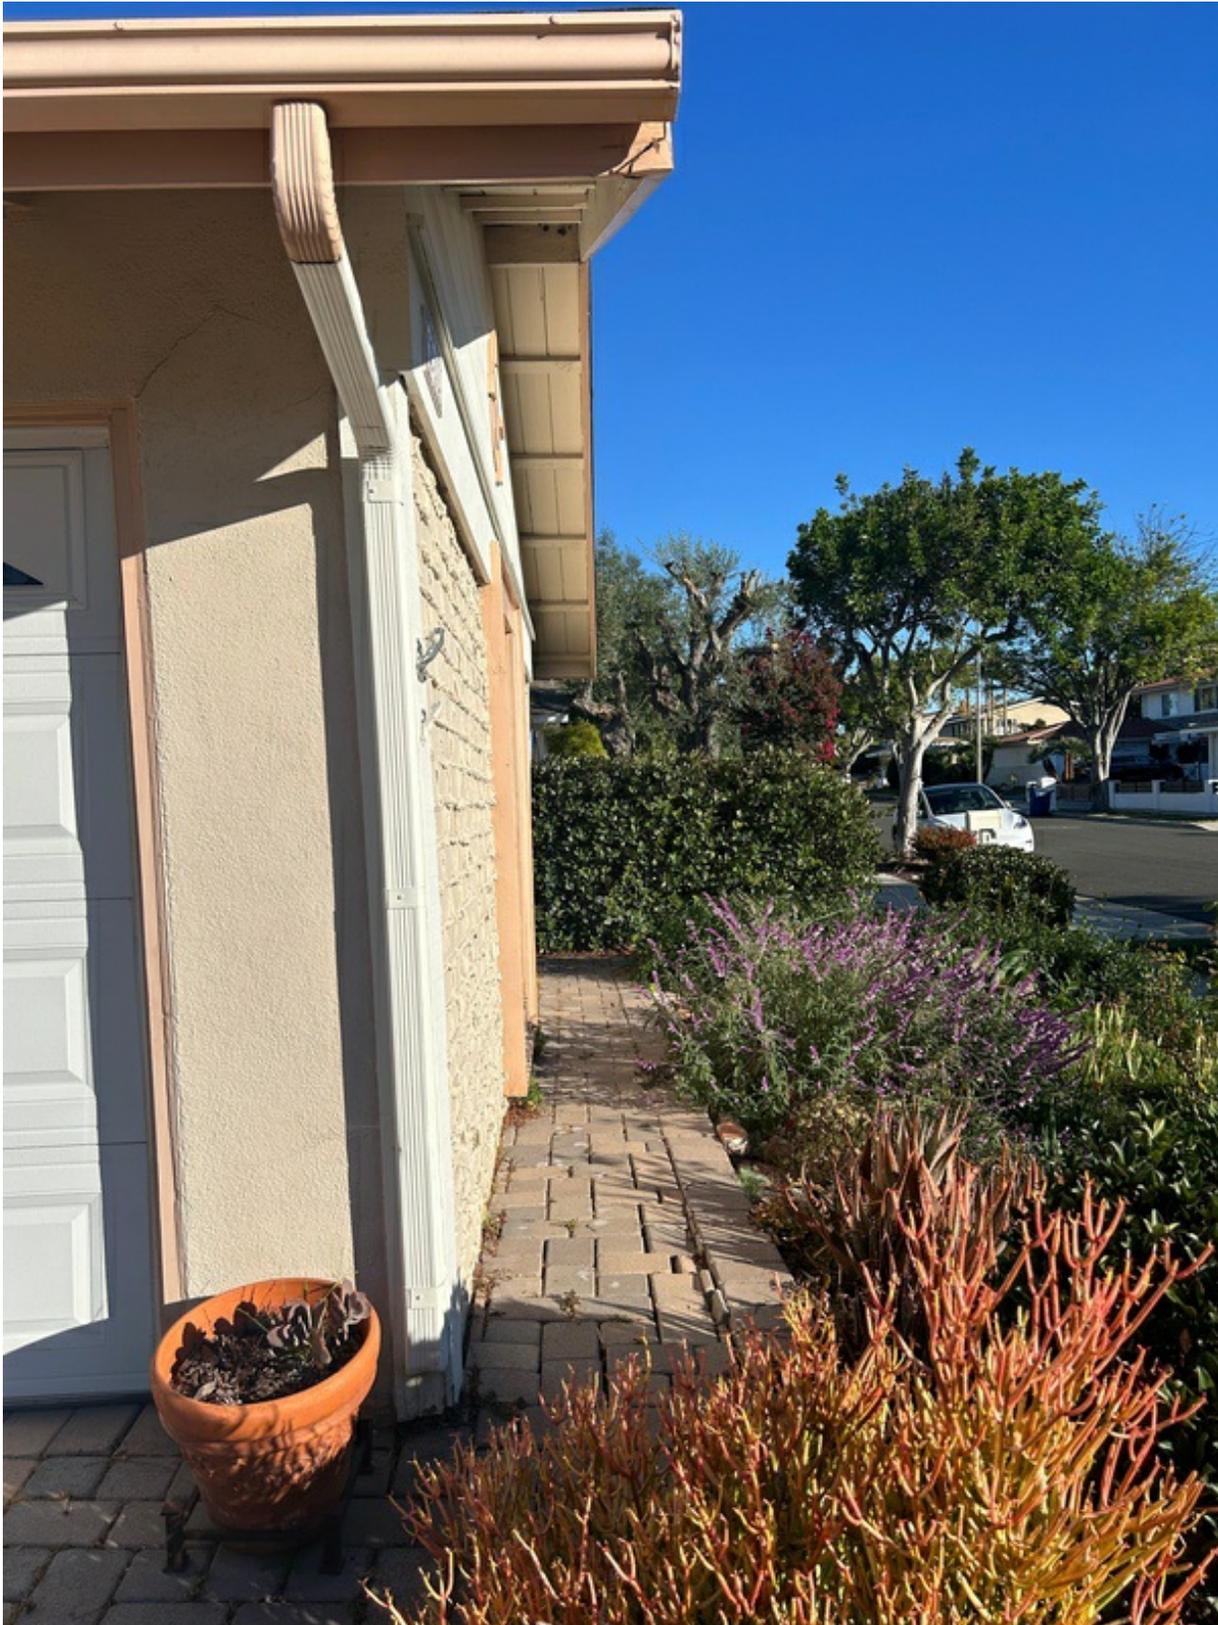
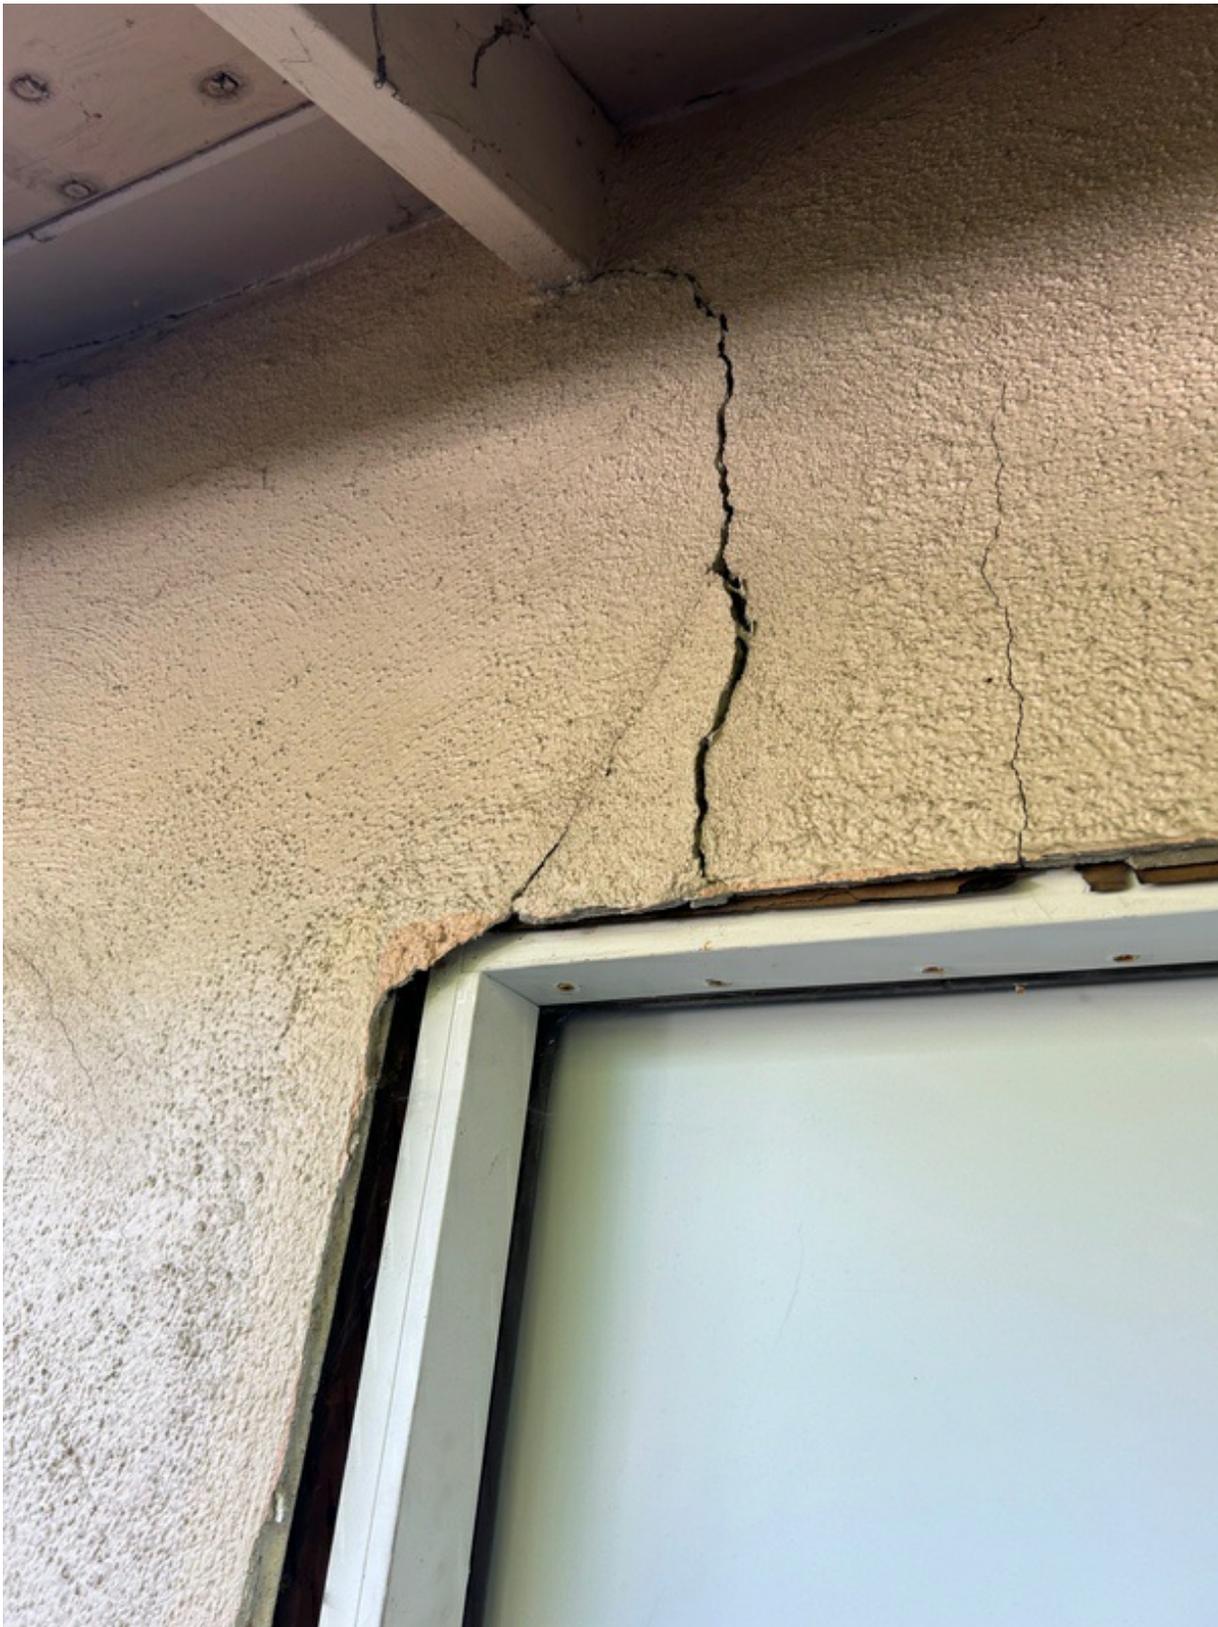
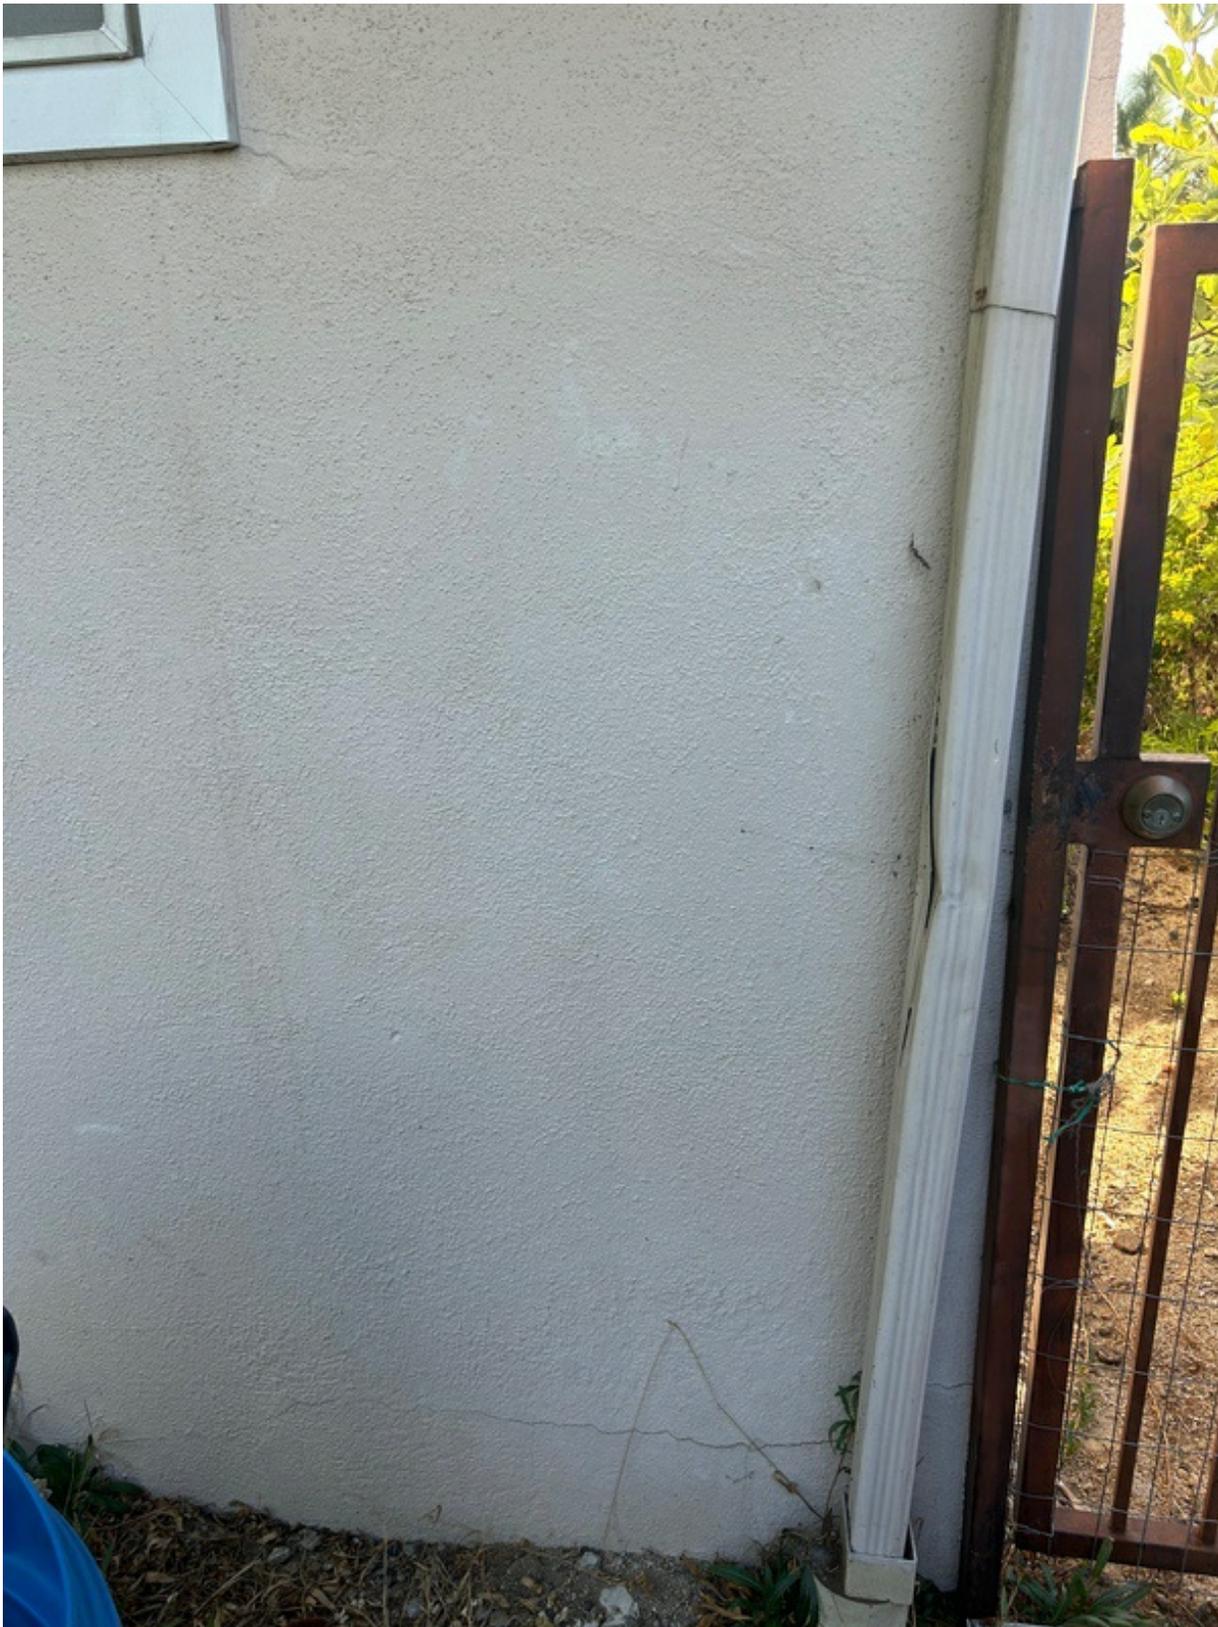
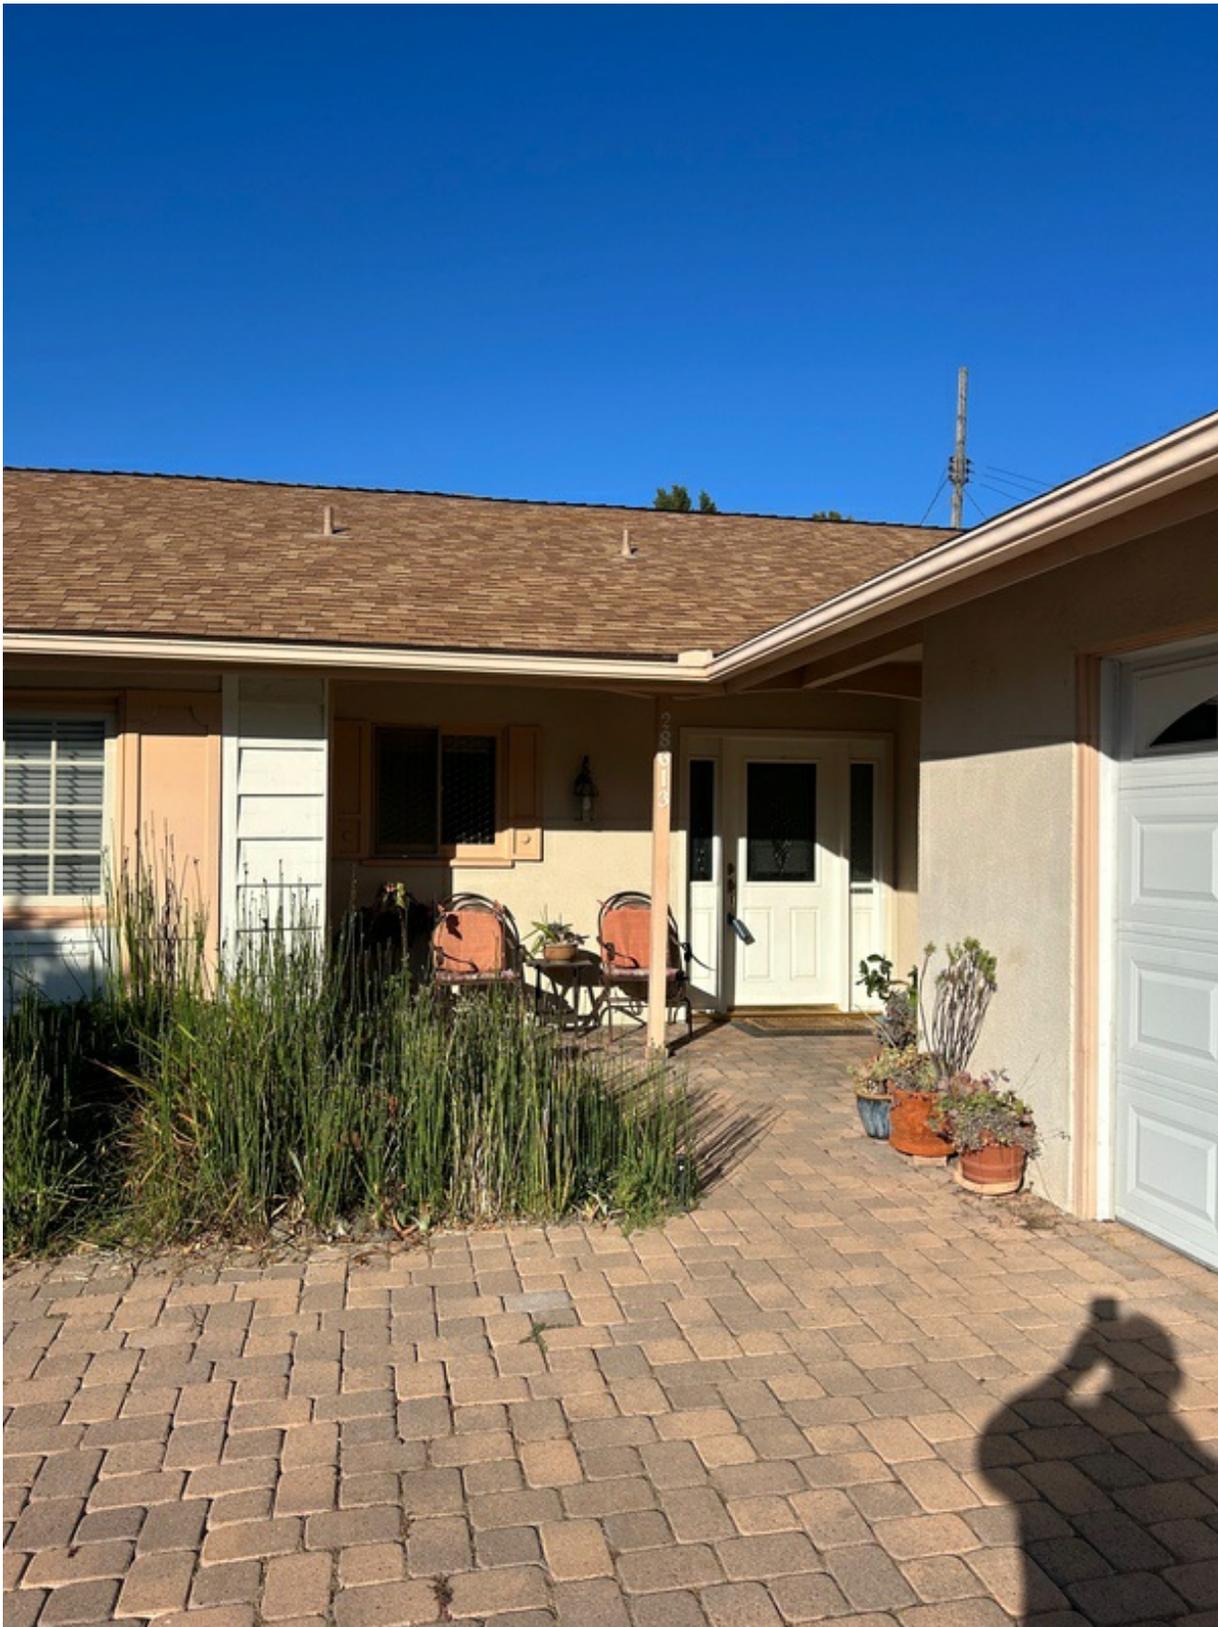
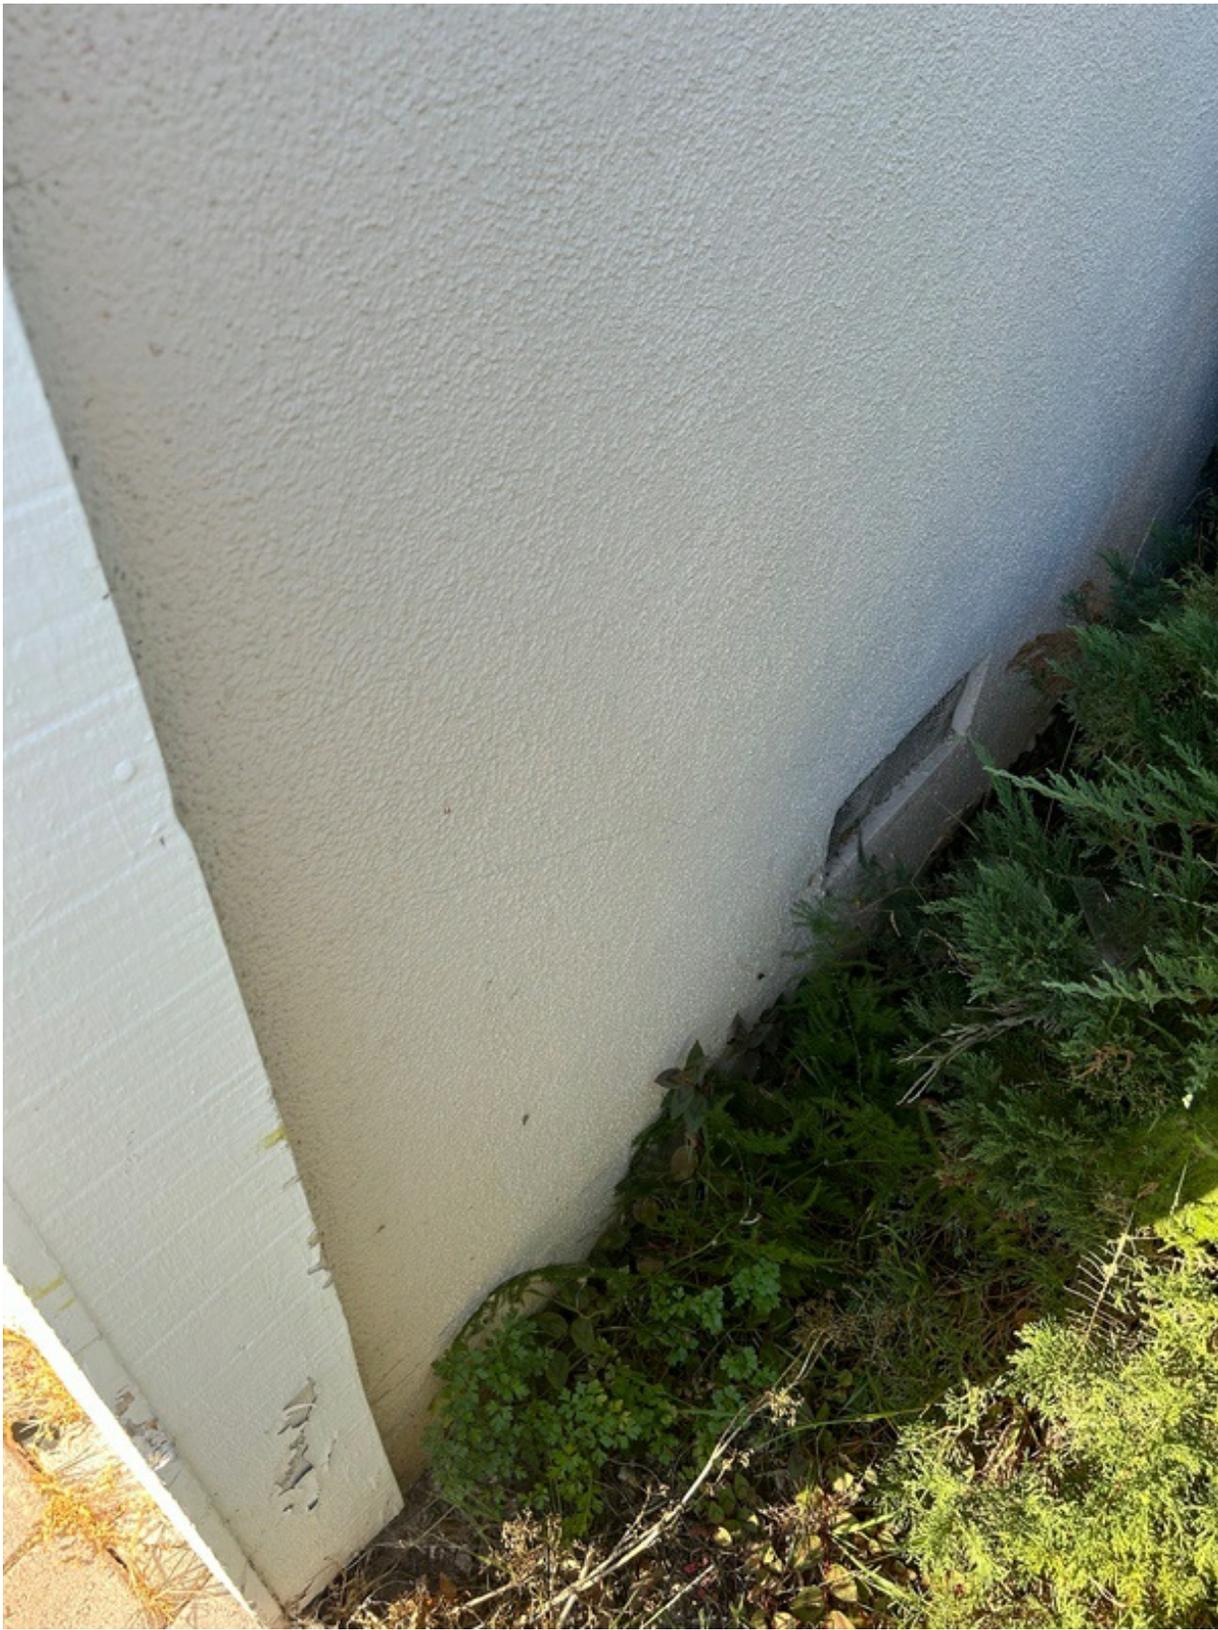
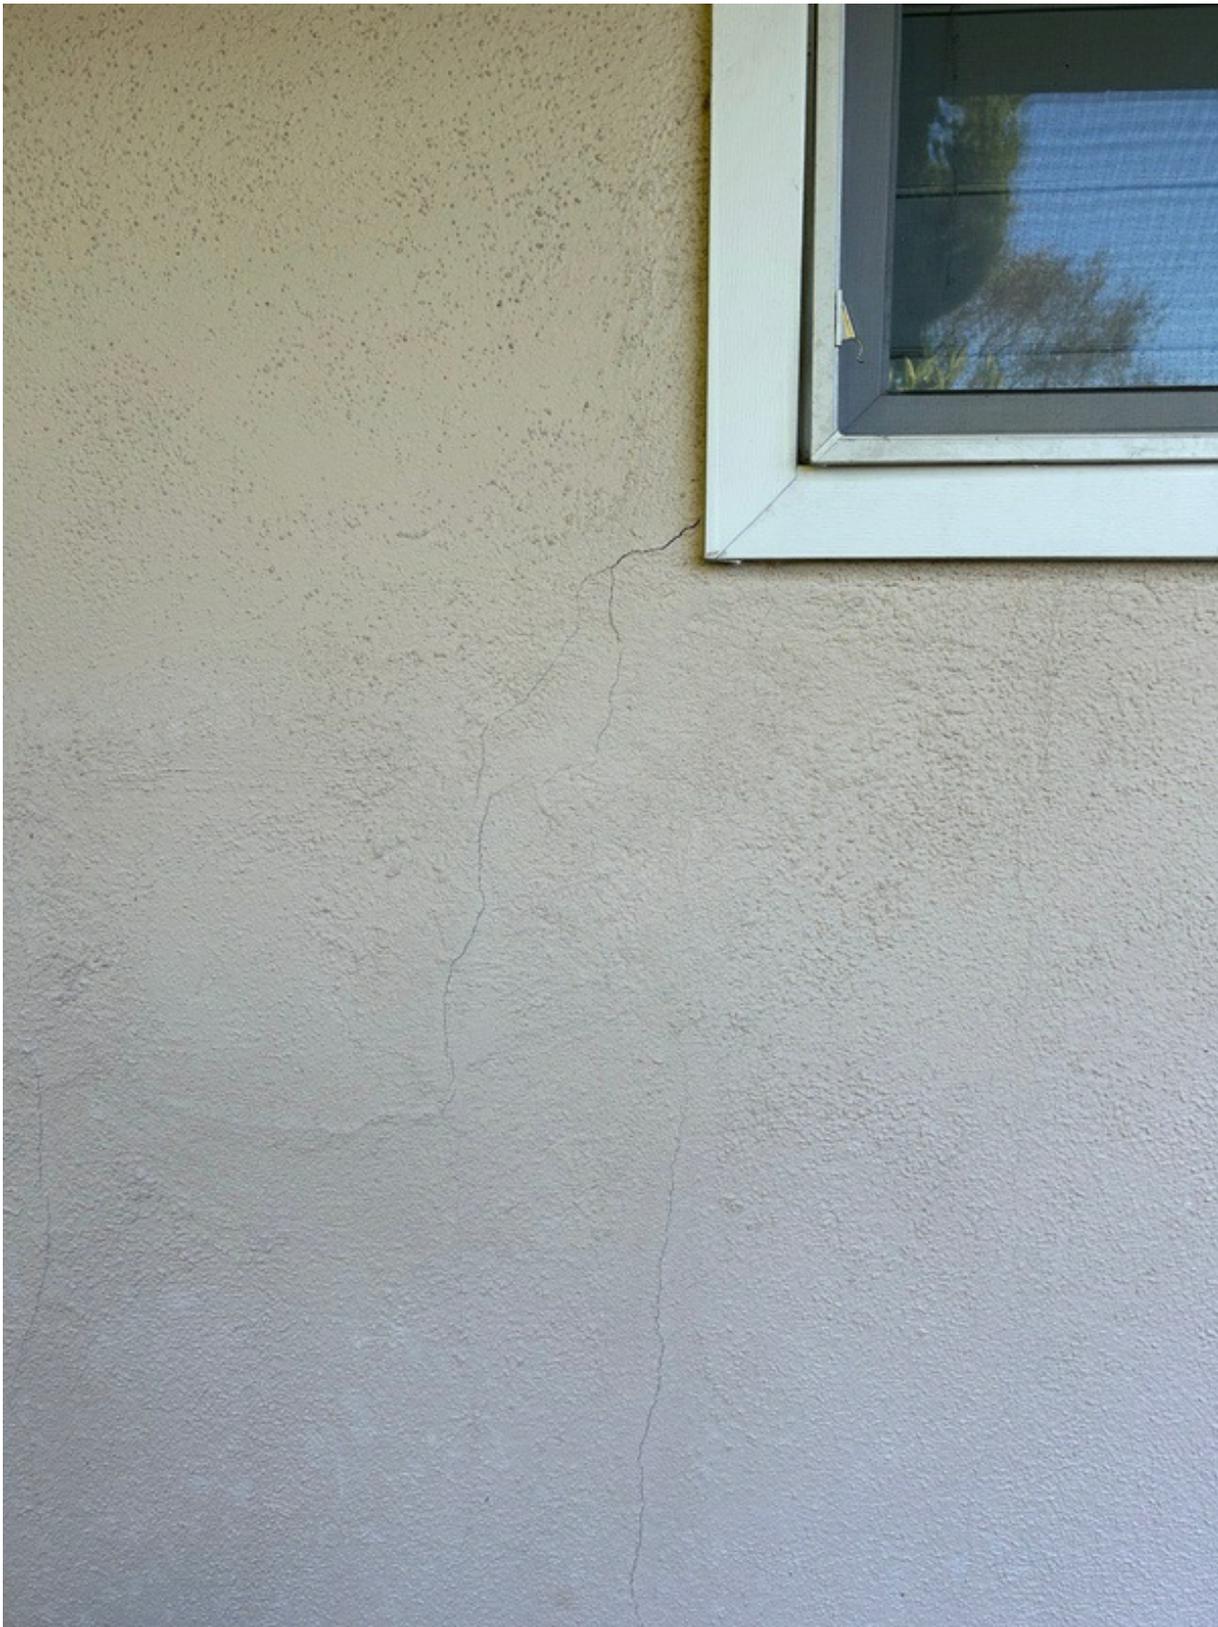
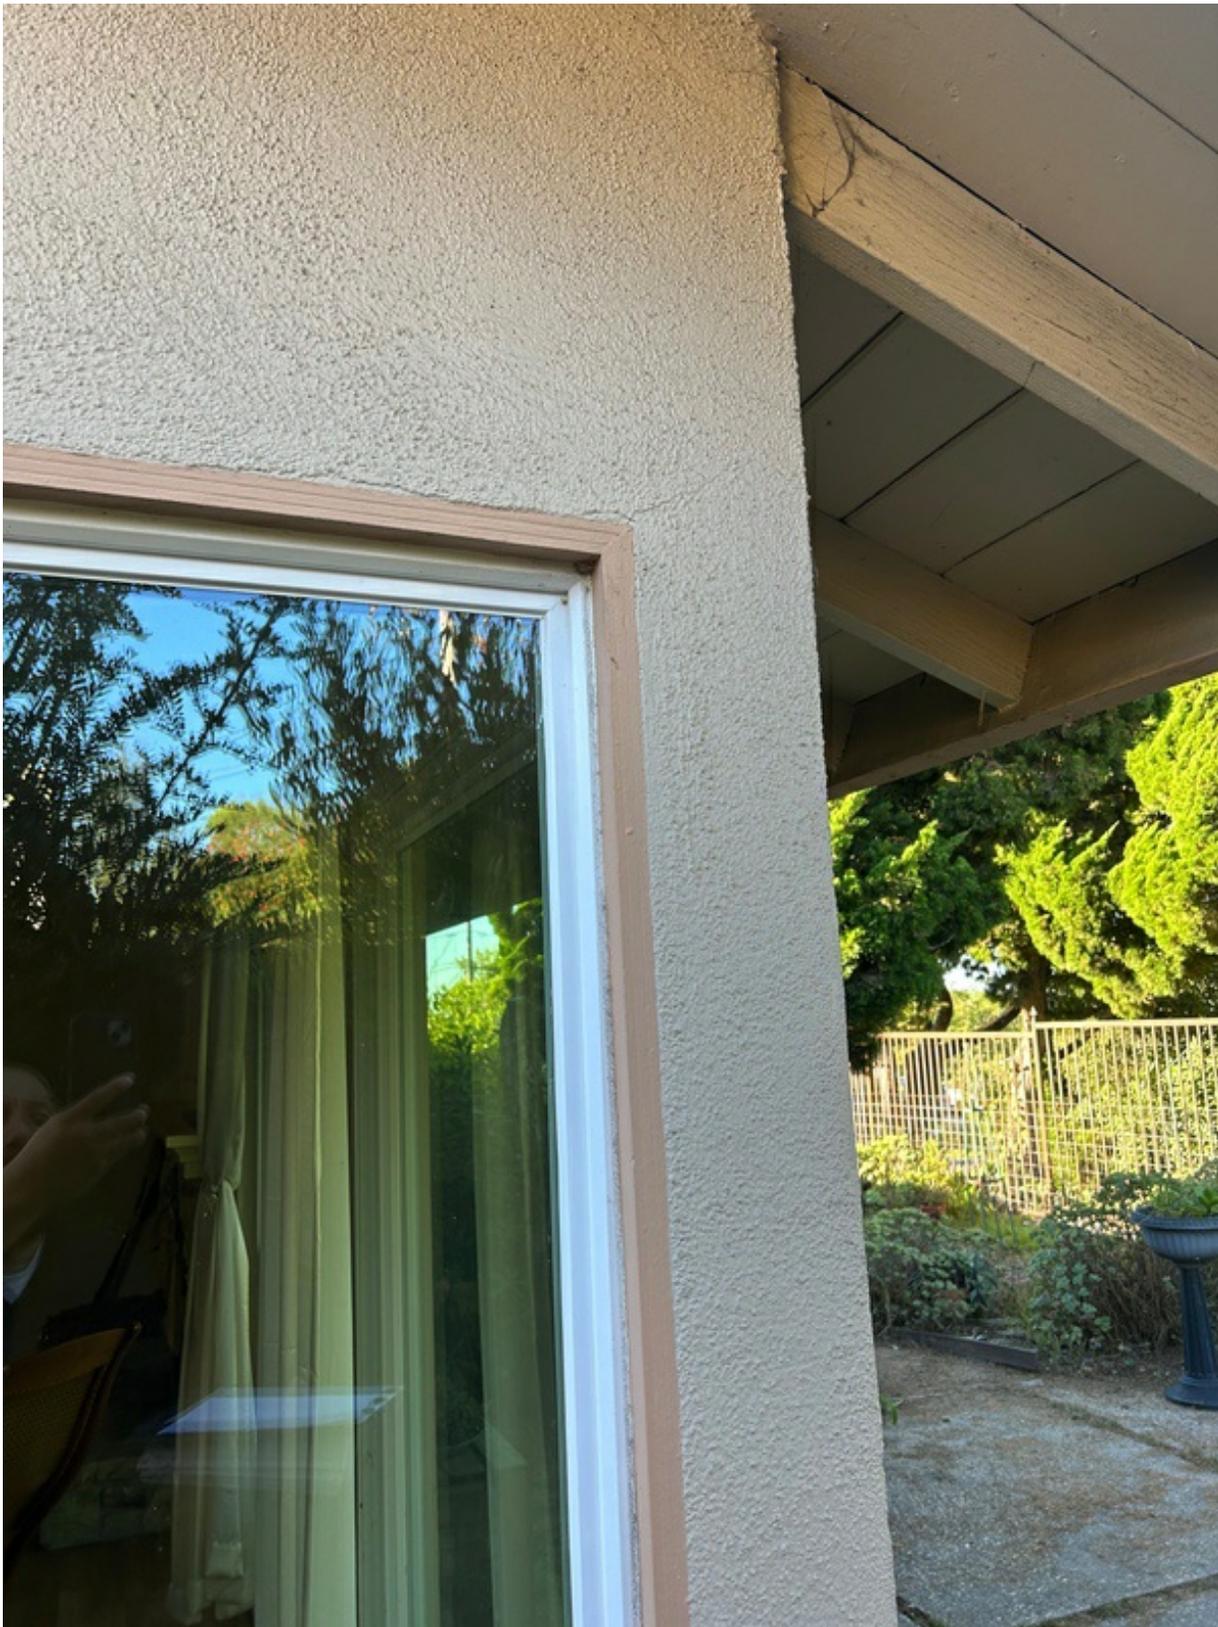
Upon arrival, I was met by the listing agent, the inspection began with the exterior walk-through, on the exterior walk-through I discovered the front face of the home. There was a noticeable slant toward the hillside. As I made my way around the garage, I noticed the footing of the garage had indications of lateral movement. This was later on confirmed.

On the right side of the home, there is a door that leads into the garage. The frame appeared to be pulling away from the home. I proceeded to walk around the house. There was not too many visible cracks that raise concerns.(pictures attached)

I am recommending the installation of a helical pile system, (picture attached) which will give the ability to lift the foundation. (all lifts are different. We will try to lift as much as the structure allows us.)

The garage foundation may need tiebacks that go underneath the foundation and hold the Stemwall in place. This will be. Call out by a structural engineer.
