# WOOD DESTROYING PESTS AND ORGANISMS INSPECTION REPORT

| Building No. / Street<br>2891 Galloping Hills Road | City<br>Chino Hills | Zip<br>91709 | Date of Inspection<br>10/03/2025 | Number of Pages<br>1 of 8 |
| General Description:<br>Vacant Single Family Two Story<br>Attached Garage<br>Slab Foundation with Clay Roof | | Inspection Tag Posted:<br>Garage<br><br>Other Tags Posted:<br>none | | |

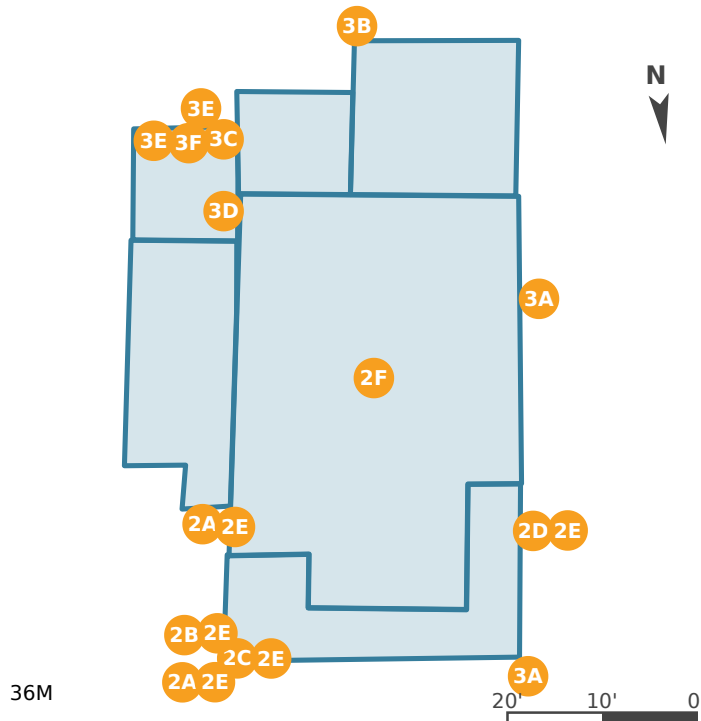
- 2) Drywood Termites  
3) Fungus/Dryrot

Evidence of drywood termites found in fascia marked on Diagram.

Evidence of drywood termites found in raftertail marked on Diagram.

Evidence of drywood termites found in shiplap marked on Diagram.

Evidence of drywood termites found in areas marked on Diagram.

Termite damaged wood found at areas marked on diagram.

Fungus damaged wood found in fascia board(s) as marked on diagram.

Fungus damaged wood at post trim marked on diagram

| <b>3C</b> | <b>Finding</b><br>Fungus damaged wood at girder marked on diagram | <b>Recommendation</b><br>Remove and replace fungus damaged wood as needed. Painting is included in this estimate. If damaged wood extends into concealed or inaccessible areas, cost of repair will be in addition to estimate given.<br><div>Price: <i>Inc in 3A</i></div> |
| <b>3D</b> | <b>Finding</b><br>Fungus damaged wood at blocking marked on diagram | <b>Recommendation</b><br>Remove and replace fungus damaged wood as needed. Painting is included in this estimate. If damaged wood extends into concealed or inaccessible areas, cost of repair will be in addition to estimate given.<br><div>Price: <i>Inc in 3A</i></div> |
| <b>3E</b> | <b>Finding</b><br>Fungus damaged wood at sun slats marked on diagram | <b>Recommendation</b><br>Remove and replace fungus damaged wood as needed. Painting is included in this estimate. If damaged wood extends into concealed or inaccessible areas, cost of repair will be in addition to estimate given.<br><div>Price: <i>Inc in 3A</i></div> |
| <b>3F</b> | <b>Finding</b><br>Fungus damaged wood at joist marked on diagram | <b>Recommendation</b><br>Remove and replace fungus damaged wood as needed. Painting is included in this estimate. If damaged wood extends into concealed or inaccessible areas, cost of repair will be in addition to estimate given.<br><div>Price: <i>Inc in 3A</i></div> |

Cover entire structure(s) and fumigate with Sulfuryl Fluoride for the elimination of drywood termites. Chloropicrin will be used as a warning agent. Cover or remove accessible termite pellets. Lloyd Termite Control Company assumes no responsibility for damage to any plant life or roofing caused by fumigation operation.

Repair termite damaged wood as needed. Painting is included in this estimate. If damaged wood extends into concealed or inaccessible areas, cost of repair will be in addition to estimate given.

Remove and replace fungus damaged wood as needed. Painting is included in this estimate. If damaged wood extends into concealed or inaccessible areas, cost of repair will be in addition to estimate given.
