WOOD DESTROYING PESTS AND ORGANISMS INSPECTION REPORT

Building No. 47	Street Northampton Ct	City Newport Beach	Zip 92660-4206	Date of Inspection 01/17/2022	Number of Pages 1 of 7
---------------------------	---------------------------------	------------------------------	--------------------------	---	----------------------------------

General Description: 1+2 Story Condo, Tile Roof	Inspection Tag Posted: Others
Other Tags Posted:

This a limited inspection to 47 Northampton Ct only. Property is an attached unit and represents only a limited portion of a larger structure. Recommend further inspection of entire structure. Inspection of additional units or additional portions of a structure may be performed, if requested, at an additional cost.

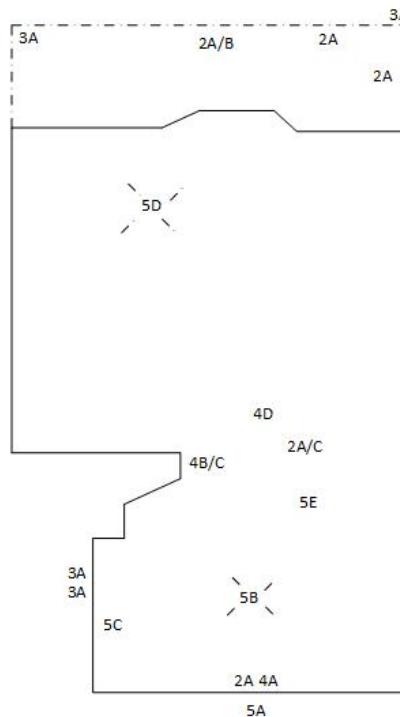
An inspection has been made of the structure(s) shown on the diagram in accordance with the Structural Pest Control Act. Detached porches, detached steps, detached decks and any other structures not on the diagram were not inspected.

Key: 1 = Subterranean Termites
 2 = Drywood Termites
 3 = Fungus/Dryrot
 4 = Other Findings
 5 = Unknown Further Inspection

- Finding: 2A Evidence of drywood termites noted at railing, soffit, attic and garage framing extending into inaccessible areas as marked on diagram.
Recommendation: Primary recommendation fumigation (whole house treatment). Due to condo-apt type situation, if requested as a secondary substandard recommendation in lieu of fumigation, we will locally treat infested areas for the control of drywood termites - no guarantee. Pellets to be covered or cleaned up where practical. Local treatment is not intended to be an entire structure treatment method. If infestations of wood destroying pests extend or exist beyond the areas(s) of local treatment, they may not be exterminated.

- Finding: 2B Drywood termite damage noted at railing as marked on diagram.
Recommendation: Remove damaged wood members and replace with new material and/or fill minor damage (primer/paint bid available upon request).

- Finding: 2C Adult drywood termite reproductive swarmers are appearing in the interior areas, which indicates the presence of mature established colonies. Due to the nature of this type of evidence, the source of the swarmers appears to be hidden in the concealed areas of the inner framing of the structure.
Recommendation: Primary recommendation fumigation (whole house treatment). Due to condo-apt type situation, if requested as a secondary substandard recommendation in lieu of fumigation, we will locally treat infested areas for the control of drywood termites - no guarantee. Pellets to be covered or cleaned up where practical. Local treatment is not intended to be an entire structure treatment method. If infestations of wood destroying pests extend or exist beyond the areas(s) of local treatment, they may not be exterminated.

- Finding: 3A Fungus damage noted at railing, fascia, header and jambs as marked on diagram.
Recommendation: Remove fungus infected and/or damaged wood members and replace with new material (primer/paint bid available upon request). Upon removal of wood, if further fungus infection and/or damage is noted, a supplemental report will be issued with findings, recommendations and costs of repairs, if any.

- Finding: 4A Water stain(s) noted at garage framing as marked on diagram.
Recommendation: Appropriate tradesman inspect and make necessary repairs.
- Finding: 4D Water stain(s) noted at upstairs hall bathroom sink cabinet as marked on diagram.
Recommendation: Appropriate tradesman inspect and make necessary repairs.

- Finding: 5C Excessive moisture noted at utility closet as marked on diagram.
Recommendation: Others make accessible for further inspection. Upon further inspection, a supplemental report will be issued with findings, recommendations and costs, if any.

- Finding: 4B Moisture damage noted at sill as marked on diagram.
Recommendation: Others make accessible for further inspection. Upon further inspection, a supplemental report will be issued with findings, recommendations and costs, if any.
- Finding: 4C Water stain(s) noted at baseboard as marked on diagram.
Recommendation: Others make accessible for further inspection. Upon further inspection, a supplemental report will be issued with findings, recommendations and costs, if any.

- Finding: 5A Trim was noted to have been previously patched by others as marked on diagram. NOTE: Newport Exterminating does not guarantee work completed by others nor were we present at time of repairs.
Recommendation: Future inspections to be made. Newport Exterminating does not guarantee work completed by others.

- Finding: 5B Portions of garage were inaccessible for inspection due to storage and/or construction style as marked on diagram.
Recommendation: Others to remove storage for further inspection. Upon further inspection, a supplemental report will then be issued with findings, recommendations and costs, if any.

- Finding: 5D Sub-area was inaccessible for inspection due to hanging insulation as marked on diagram.
Recommendation: Others make accessible for further inspection. Upon further inspection, a supplemental report will be issued with findings, recommendations and costs, if any.

- Finding: 5E Sub-area was inaccessible for inspection due to access blocked as marked on diagram.
Recommendation: Others make accessible for further inspection. Upon further inspection, a supplemental report will be issued with findings, recommendations and costs, if any.

2A/2C Primary Fumigation - Bid Upon Request **-OR-**
2A/2C Secondary Local Termite Treatment - \$550.00
2B/3A Repairs - \$3,994.00

4A/4B/4C/4D/5B/5C/5D/5E - Others
5A - Future Inspections
