WOOD DESTROYING PESTS AND ORGANISMS INSPECTION REPORT

| BUILDING NO. 1931 | STREET, CITY, STATE, ZIP Ruhland Ave., Redondo Beach CA 90278 | Date of Inspection 2/1/2023 | No. of Pages 15 |

| General Description: 3-story duplex, att garage, comp roof, raised foundation, furn/occ & vac. | Inspection Tag Posted: Garage |

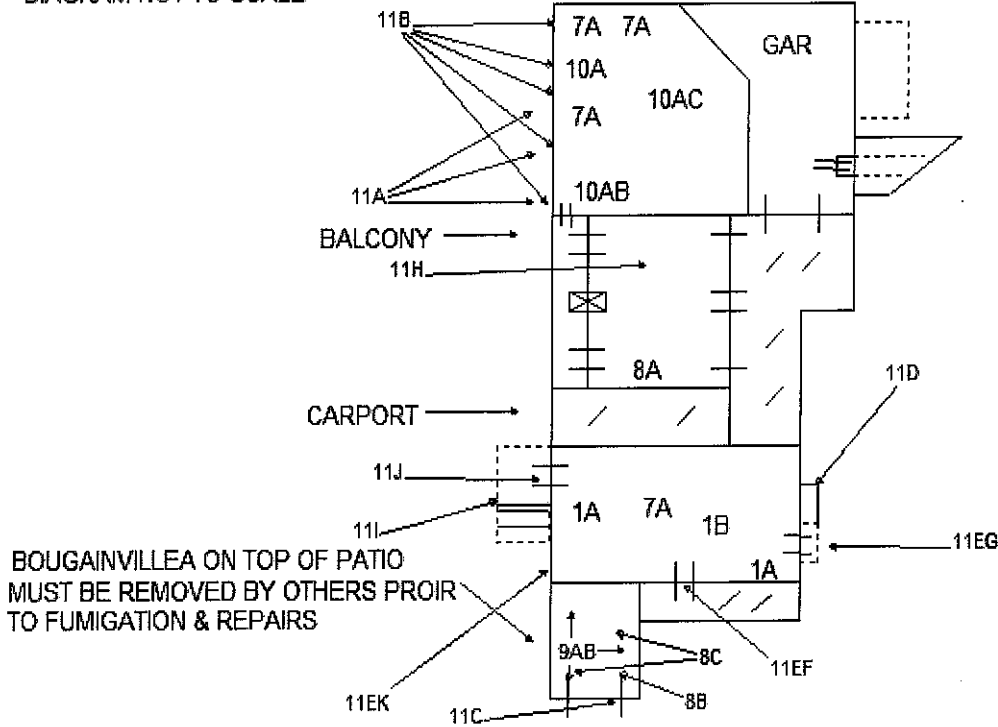
DIAGRAM NOT TO SCALE

ITEM 1A Evidence of drywood termites noted in/at subarea as marked 1A on the diagram.

ITEM 1B Cellulose debris (wood, paper products) was noted in the subarea as marked 1B on the diagram.

ITEM 7A Evidence of drywood termites noted in/at attic as marked 7A on the diagram.

ITEM 8A Subterranean termites were noted at/in interior of garage as marked 8A on the diagram.

ITEM 8B Evidence of drywood termites noted in/at garage as marked 8B on the diagram.

ITEM 8C Evidence of dryrot damage noted to garage sheathing as marked 8C on the diagram.

ITEM 9A Evidence of drywood termites noted in/at patio as marked 9A on the diagram.

ITEM 9B Evidence of drywood termite damage and dryrot noted to joists, header and post trims and as marked 9B on the diagram.

ITEM 10A Evidence of drywood termites noted in/at interior as marked 10A on the diagram.

ITEM 10B Evidence of drywood termite damage noted to interior jamb as marked 10B on the diagram.

- ITEM 10C Evidence of drywood termite damage noted to flooring at interior of 3rd story balcony door as marked 10C on the diagram.

- ITEM 11A Subterranean termites were noted at/in exterior as marked 11A on the diagram.

- ITEM 11B A faulty grade condition was noted on the left side at rear of house as marked 11B on the diagram.

- ITEM 11C Evidence of minor dryrot damage noted to jamb as marked 11C on the diagram.

ITEM 11D Evidence of dryrot damage noted to siding as marked 11D on the diagram.

ITEM 11E Evidence of drywood termites noted in/at exterior as marked 11E on the diagram.

ITEM 11F Dryrot damage noted to front door(s) as indicated as marked 11F on the diagram.

ITEM 11G Evidence of drywood termite damage noted to over hang at side door as marked 11G on the diagram.

ITEM 11H Dryrot damage noted to door(s) at 3rd story balcony as indicated as marked 11H on the diagram.

ITEM 11I Evidence of dryrot damage noted to landing, stairs and framing as marked 11I on the diagram.

ITEM 11J Dryrot damage noted to 10-lite door(s) as indicated as marked 11J on the diagram.

RECOMMENDATION: Fumigation of structure using Vikane* (sulfuryl flouride) gas fumigant (Made in the U.S.A), in conjunction with chloropicrin (warning agent). **While all due care will be taken we cannot be responsible for any roof/plant/antennas/ satellite damage during the course of fumigation.** Please consult with your inspector to see what possible damage may occur. All fumigations are guaranteed for FOUR years from date of completion. (See page 4 for additional details)

RECOMMENDATION: Remove the cellulose debris from the subarea and dispose of.

RECOMMENDATION: Fumigation of structure using Vikane* (sulfuryl fluoride) gas fumigant (Made in the U.S.A), in conjunction with chloropicrin (warning agent). **While all due care will be taken we cannot be responsible for any roof/plant/antennas/ satellite damage during the course of fumigation.** Please consult with your inspector to see what possible damage may occur. All fumigations are guaranteed for FOUR years from date of completion. (See page 4 for additional details)

RECOMMENDATION: Drill a series of holes through the concrete slab and pressure inject TERMIDOR* into the soil below. Remove/mask/cover all accessible subterranean termite evidence. **WE ARE NOT RESPONSIBLE FOR DAMAGE THAT WILL OCCUR TO FLOOR COVERINGS, PLASTIC/PVC PIPES BELOW SLAB, AND RE-STRETCHING OF CARPET.** Note: This is a local treatment method and local treatments are not intended to be an entire structure treatment method. If infestations of subterranean termites extend or exist beyond the area of local treatment, they may not be exterminated. **LOCALIZED TREATMENTS ARE GUARANTEED FOR A PERIOD OF ONE YEAR FROM THE DATE OF COMPLETION. GUARANTEED APPLIES TO AREAS OF TREATMENT ONLY, AND DOES NOT ENCOMPASS THE ENTIRE STRUCTURE.**
***** This is a Section 1 Item *****

RECOMMENDATION: Open area to allow for further inspection from top of garage. If no further damage leading into inaccessible areas, remove and replace damaged wood as needed to correct this item. Suncrest to apply one coat of resealant to entire area over garage. **NOTE:** Seam may be apparent upon completion. Texture/color may not match existing. No painting included.

RECOMMENDATION: Fumigation of structure using Vikane* (sulfuryl fluoride) gas fumigant (Made in the U.S.A), in conjunction with chloropicrin (warning agent). **While all due care will be taken we cannot be responsible for any roof/plant/antennas/ satellite damage during the course of fumigation.** Please consult with your inspector to see what possible damage may occur. All fumigations are guaranteed for FOUR years from date of completion. (**See page 4 for additional details**)

RECOMMENDATION: Remove and replace damaged wood as needed to correct this item. No painting included. **NOTE: Upon removal of post trims, a further inspection of posts may be required.** **NOTE:** Upon removal of damaged wood/materials, if infestation is extending into inaccessible areas, a supplemental report will then be issued, outlining findings, recommendations and additional charges (if any). **NOTE: IF RAIN GUTTERS ARE REMOVED IN ORDER TO PERFORM REPAIRS, NO GUARANTEE IS GIVEN TO CONDITION OF RAIN GUTTERS UPON RE-INSTALLATION BY SUNCREST EXTERMINATING.**

RECOMMENDATION: Replace and/or repair (wood fill) as needed to correct damages. **NOTE:** Upon removal of damaged wood, if infection is extending into inaccessible areas, a supplemental report will be issued, outlining findings, recommendations and additional charges,(if any.) Painting is not included.

RECOMMENDATION: Open for further inspection. If infestation is extending into inaccessible areas, a supplemental report will then be issued, outlining findings, recommendations and additional charges. Remove and replace damaged wood as needed to correct this item. No painting included. **NOTE: Upon removal of damaged wood/materials, if infestation is extending into inaccessible areas, a supplemental report will then be issued, outlining findings, recommendations and additional charges.** **NOTE:** IF RAIN GUTTERS ARE REMOVED IN ORDER TO PERFORM REPAIRS, NO GUARANTEE IS GIVEN TO CONDITION OF RAIN GUTTERS UPON RE-INSTALLATION BY SUNCREST EXTERMINATING.

RECOMMENDATION: Rod and trench the soil (6" deep) at infested areas with TERMIDOR*. Remove/mask/cover all accessible subterranean termite evidence. **WE ARE NOT RESPONSIBLE FOR DAMAGE TO VEGETATION WITHIN 12- 18" OF AREAS TO BE TREATED.** NOTE: This is a local treatment method and local treatments are not intended to be an entire structure treatment method. If infestations of subterranean termites extend or exist beyond the area of local treatment, they may not be exterminated. **LOCALIZED TREATMENTS ARE GUARANTEED FOR A PERIOD OF ONE YEAR FROM THE DATE OF COMPLETION. GUARANTEED APPLIES TO AREAS OF TREATMENT ONLY, AND DOES NOT ENCOMPASS THE ENTIRE STRUCTURE.**

RECOMMENDATION: Owner to correct.

RECOMMENDATION: Chisel out minor damage and wood fill damaged areas as needed to correct. No painting is included. **NOTE:** Upon removal of damaged wood, if infection is extending into inaccessible areas, a supplemental report will be issued, outlining findings, recommendations and additional charges, (if any.) **NOTE:** If complete replacement is requested, a new estimate will be issued and/or we recommend contacting a licensed contractor for replacement.

RECOMMENDATION: Remove and replace damaged wood as needed to correct this item. No painting included. **NOTE:** Upon removal of damaged wood/materials, if infestation is extending into inaccessible areas, a supplemental report will then be issued, outlining findings, recommendations and additional charges (if any). **NOTE:** IF RAIN GUTTERS ARE REMOVED IN ORDER TO PERFORM REPAIRS, NO GUARANTEE IS GIVEN TO CONDITION OF RAIN GUTTERS UPON RE-INSTALLATION BY SUNCREST EXTERMINATING.

RECOMMENDATION: Replace door which has damage. NOTE: Original hardware will be used at no extra charge. However, if door hardware, such as hinges, doorknob or lock, are old and or painted over, breaks, or needs to be replaced, an additional charge for standard materials or parts is \$ 50.00 and will be added to the invoice and completion papers. (painting not included). **NOTE: NEW DOOR WILL NOT MATCH EXISTING. THIS IS A SPECIAL ORDER ITEM.**

RECOMMENDATION: Remove and replace damaged wood as needed to correct this item. No painting included. **NOTE:** Upon removal of damaged wood/materials, if infestation is extending into inaccessible areas, a supplemental report will then be issued, outlining findings, recommendations and additional charges (if any). **NOTE: IF RAIN GUTTERS ARE REMOVED IN ORDER TO PERFORM REPAIRS, NO GUARANTEE IS GIVEN TO CONDITION OF RAIN GUTTERS UPON RE-INSTALLATION BY SUNCREST EXTERMINATING.**

RECOMMENDATION: Replace door which has damage. **NOTE:** Original hardware will be used at no extra charge. However, if door hardware, such as hinges, doorknob or lock, are old and or painted over, breaks, or needs to be replaced, an additional charge for standard materials or parts is \$ 50.00 and will be added to the invoice and completion papers. (painting not included)

RECOMMENDATION: Replace door which has damage. **NOTE:** Original hardware will be used at no extra charge. However, if door hardware, such as hinges, doorknob or lock, are old and or painted over, breaks, or needs to be replaced, an additional charge for standard materials or parts is \$ 50.00 and will be added to the invoice and completion papers. (painting not included) **NOTE: NEW DOOR WILL NOT MATCH EXISTING. THIS IS A SPECIAL ORDER ITEM.**
