# WOOD DESTROYING PESTS AND ORGANISMS INSPECTION REPORT

| 3662 | Rock Garden Ln | San Luis Obispo | 93401-6217 | 08/07/2025 | 1 of 5 |

**Report #: 111333**

## \*\*\*Complete Inspection Report\*\*\*

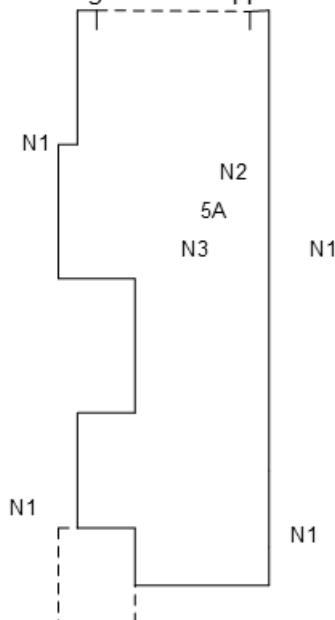
Diagram not to scale  
Finding locations approximate

Finding: 5A      The attic space was inaccessible for inspection due to lack of an adequate access opening.

Recommendation:      Install an adequate access opening, reinspect and submit further findings and on a supplemental report. Cost for reinspection and report will be \$50.00 if access is installed by others.
