# WOOD DESTROYING PESTS AND ORGANISMS INSPECTION REPORT

| 1299 | Bay Oaks Drive | Los Osos | 93402 | 09/29/2025 | 1 of 6 |

**Report #: 111770**

### \*\*\*Complete Inspection Report\*\*\*

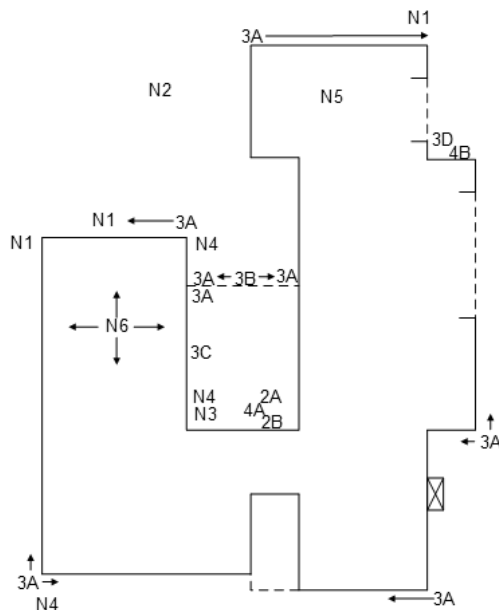
Diagram not to scale  
Finding locations approximate

| Finding: | 2A | Evidence of Drywood Termite infestation was found at the exterior and appears to extend into inaccessible areas of the structure. |
| Finding: | 2B | Minor Drywood Termite damage was found at the siding. |

| Finding: | 3A | Fungus damage was found at the fascia of the eave area. |
| Finding: | 3B | Fungus damage was found at the pergola support beam. |

Finding: 3C Fungus damage was found at the wood siding and base trim.  
Recommendation: Replace the damaged portions of the wood siding. Note: In cases of plywood siding, repair may involve installing wood trim in place of siding removed and/or metal flashing at cut sections of siding replacement. Additional costs will apply if replacement of full sheet(s) of plywood siding is desired by the parties in interest.

Finding: 3D Fungus damage was found at the wood siding.  
Recommendation: Replace the damaged portions of the wood siding. Note: In cases of plywood siding, repair may involve installing wood trim in place of siding removed and/or metal flashing at cut sections of siding replacement. Additional costs will apply if replacement of full sheet(s) of plywood siding is desired by the parties in interest.

Finding: 4A An excessive moisture condition exists due to the base of the wood siding which is embedded in concrete. Moisture may be trapped at the base of the wood siding and may lead to infestation, infection and damage.  
Recommendation: Seal the base of the wood siding with a durable exterior sealant. This seal must be maintained to remain effective.

Finding: 4B An excessive moisture condition exists due to the base of the wood trim which is embedded in concrete. Moisture may be trapped at the base of the wood trim and may lead to infestation, infection and damage.  
Recommendation: Seal the base of the wood trim with a durable exterior sealant. This seal must be maintained to remain effective.

| Recommendation: | | Seal the structure and fumigate with a gas lethal to Drywood Termites (Sulfuryl Fluoride). All occupants and pets must vacate the structure until the fumigation is complete. This company will exercise reasonable caution, but cannot be held responsible for damage to plants, TV antennas or roofing due to the fumigation. Further terms and instructions will be supplied upon request or upon scheduling of the fumigation. Information may also be obtained from the fumigation page on our website at <a href="http://www.keytermite.com">www.keytermite.com</a><br><b>***Fumigations are guaranteed for 5 years from the date completed***</b> |
| Recommendation: | | Repair the minor damage of the wood member with a wood filler. |

| Recommendation: | | Replace the fungus damaged portions of fascia as needed. |
| Recommendation: | | Remove and replace the damaged portions of the pergola support beam as needed to eliminate the fungus infection and damage. |
