# WOOD DESTROYING PESTS AND ORGANISMS INSPECTION REPORT

| 3960 | Higuera St Spc 176, S. | San Luis Obispo | 93401-1533 | 10/06/2025 | 1 of 6 |

**Report #: 111820**

| General Description:<br>Single story; Mobile home; Metal exterior; Flat roof; Furnished and occupied. | Inspection Tag Posted:<br>WATER HEATER CLOSET |

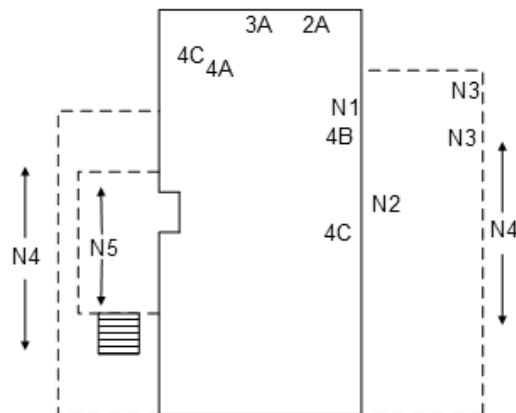
Diagram not to scale-Finding locations approximate

Finding: 2A Evidence of Drywood Termite infestation was found at the substructure and appears to extend into inaccessible areas of the structure.

Finding: 3A Fungus damage was found at the heater closet floor.

Finding: 4A Moisture damage was noted at the interior bedroom ceiling and appears to have been caused by a previous moisture condition.

Finding: 4B An excessive moisture condition exists due to leakage at the main drain line.

Finding: 4C Loose cellulose debris (wood scraps/paper) were found in the substructure area. This may lead to Subterranean termite infestation.

Recommendation: Seal the structure and fumigate with a gas lethal to Drywood Termites (Sulfuryl Fluoride). All occupants and pets must vacate the structure until the fumigation is complete. This company will exercise reasonable caution, but cannot be held responsible for damage to plants, TV antennas or roofing due to the fumigation. Further terms and instructions will be supplied upon request or upon scheduling of the fumigation. Information may also be obtained from the fumigation page on our website at [www.keytermite.com](http://www.keytermite.com)  
**\*\*\*Fumigations are guaranteed for 5 years from the date completed\*\*\***

Recommendation: Remove and replace the damaged portions of the heater closet floor as needed to eliminate the fungus infection and damage.

Recommendation: Remove and replace the damaged portions of the interior bedroom ceiling as needed.

Recommendation: Make the necessary corrections to eliminate the leakage at the main drain line.

Recommendation: Remove and dispose of all loose cellulose debris from under the dwelling of such size that it will not pass through an ordinary garden rake.
