WOOD DESTROYING PESTS AND ORGANISMS INSPECTION REPORT

Building No. 27013	Street Springcreek Road	City Rancho Palos Verdes	Zip 90275	Date of Inspection 04/11/2024	Number of Pages 7
  <p>964 E. Badillo Street, Suite 237 Covina, California 91724 Off: 310.482.0720 / Tel: 818.482.7306 www.dabtermite.net <i>email: paul.guzman4@verizon.net</i></p>					Report # 106744 Lic. Registration # PR 6216 Escrow #

COMPLETE REPORT <input checked="" type="checkbox"/>	LIMITED REPORT <input type="checkbox"/>	SUPPLEMENTAL REPORT <input type="checkbox"/>	REINSPECTION REPORT <input type="checkbox"/>
General Description: 1 story single family residence, attached garage, composition roof, raised foundation, vacant		Inspection Tag Posted: Garage	
		Other Tags Posted: None Noted

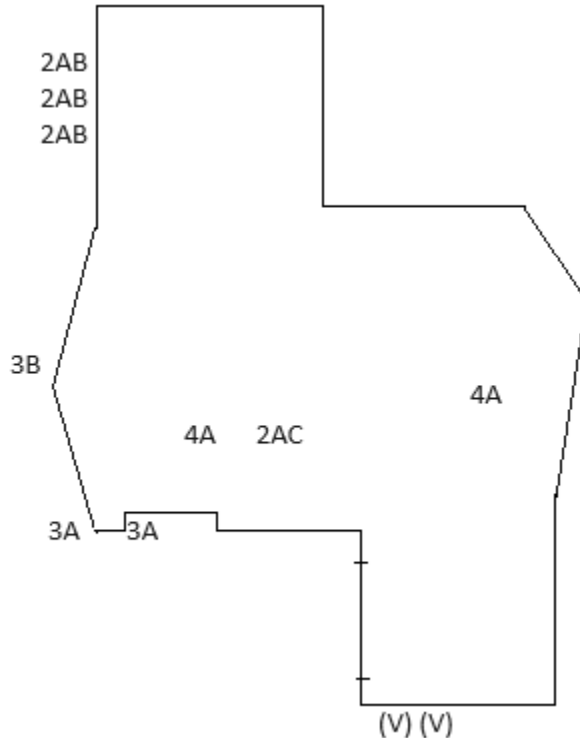
This Diagram is not to Scale

- 2A (Section I)
FINDING – Evidence of drywood termites noted at fascia and attic.
RECOMMENDATION – Locally treat area(s) for the control of drywood termites. Cover or remove accessible termite pellets. Treated areas have a one year warranty.
PRICE: \$500.00

- 2B (Section I)
FINDING – Termite damage wood noted at fascia.
RECOMMENDATION – Repair termite damage. DAB Termite & Pest Solution will prime area repaired with one coat of primer.
PRICE: \$750.00

- 2C (Section I)
FINDING – Evidence of drywood termites noted at attic.
RECOMMENDATION – Apply Timbor to accessible unpainted timbers at area(s) marked on diagram. Treated areas have a one year warranty. **NOTE:** *To insects, the borate compound in Timbor acts as a slow-acting stomach poison. When the treated wood is ingested by termites, for example, the compound prevents the insects from metabolizing their food, which, in turn causes death. Also, during grooming, the topical presence of Timbor is ingested, producing the same results.*
http://www.ehow.com/about_5117836_timbor.html
PRICE: See item 2A

- 3A (Section I)
FINDING – Fungus damaged wood noted at beam and roof sheathing, which appears to have been caused by moisture.
RECOMMENDATION – Cut out fungus damage and repair area(s) noted on the diagram.
PRICE: See item 2B

- 3B (Section I)
FINDING – Minor fungus damage noted at beam, which appears to have been caused by moisture.
RECOMMENDATION – Dig or cut out fungus from infected wood, treat area with a registered fungicide, fill area with water resistant wood filler and prime area with one coat of primer.
PRICE: See item 2B

- 4A (Section II)
FINDING – Cellulose debris in earth contact noted in the sub area.
RECOMMENDATION – Remove cellulose debris of size that can be raked.
PRICE: Bid on request

Heavy vegetation at areas of exterior noted (V) on diagram did not allow for a thorough inspection of area(s)
