**From:** Cristopher O'Hern <criso@terrapac.net>  
**Date:** Tuesday, November 5, 2024 at 3:18 PM  
**To:** Sam Stone <samstone@udvs.net>  
**Subject:** 22-089 Stone - 1703 Castellana Updated Bluff Review October 2024

As requested, I visited the Stone – 1703 Castellana property for a follow up review of the bluff adjacent to the driveway. The following are my observations and notes from a conversation with one of the tenants:

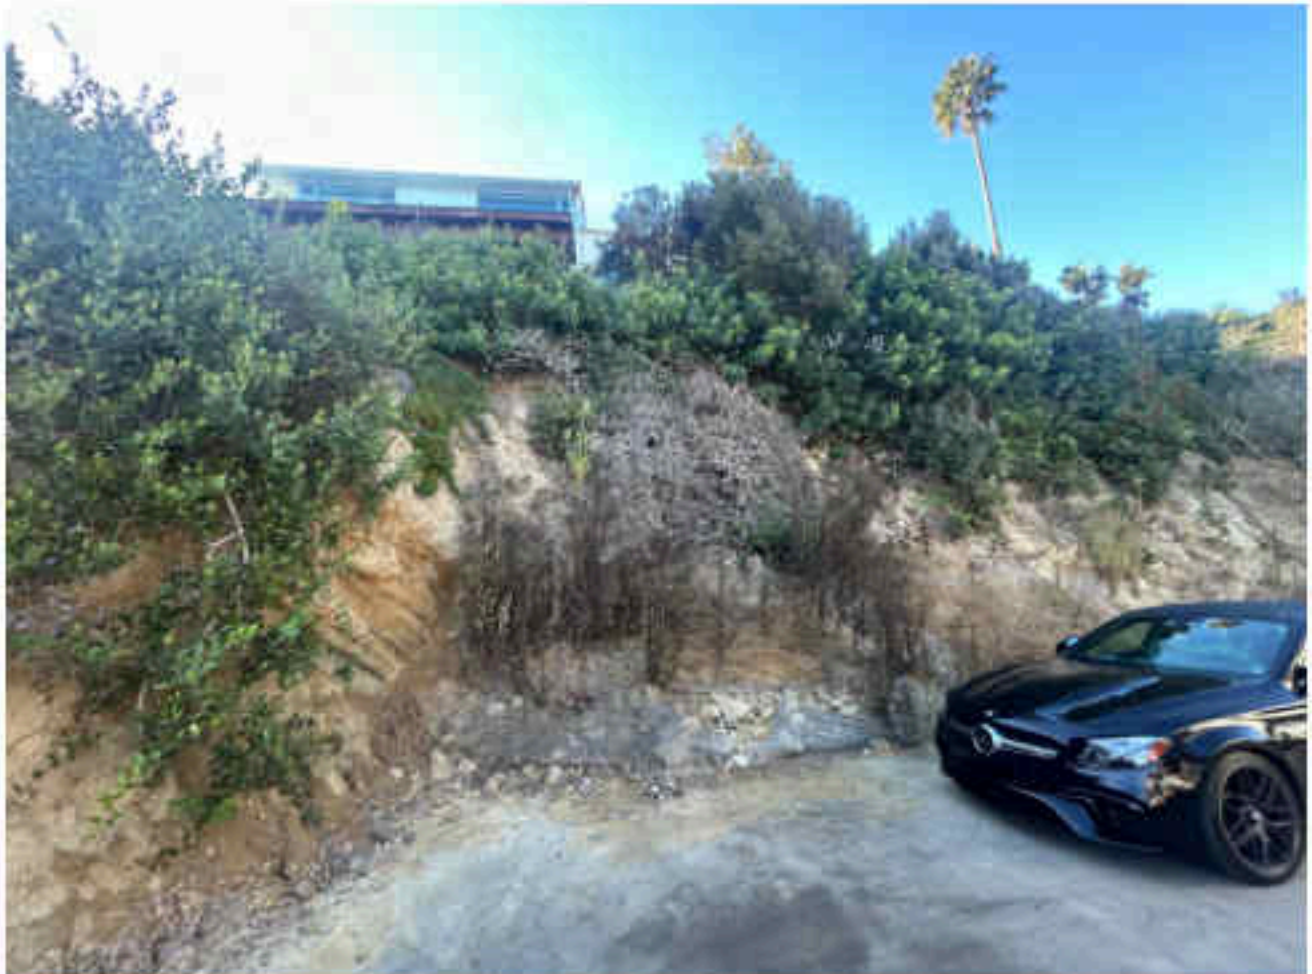
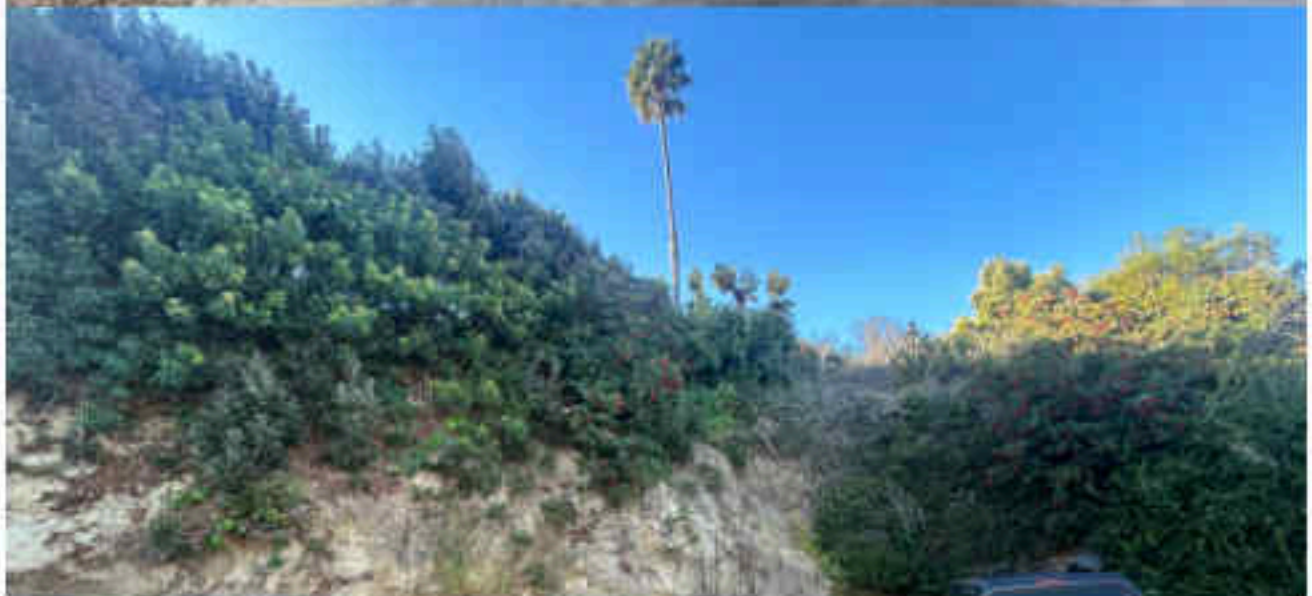
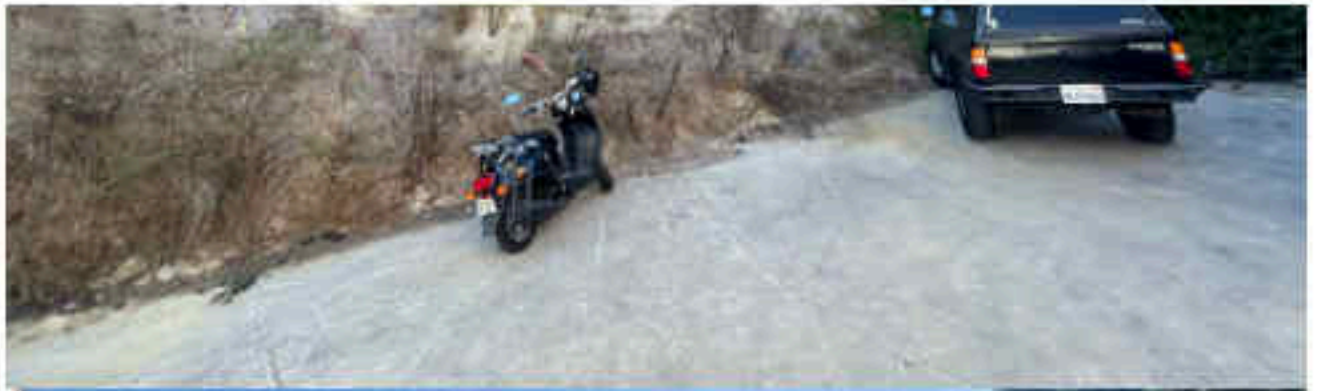
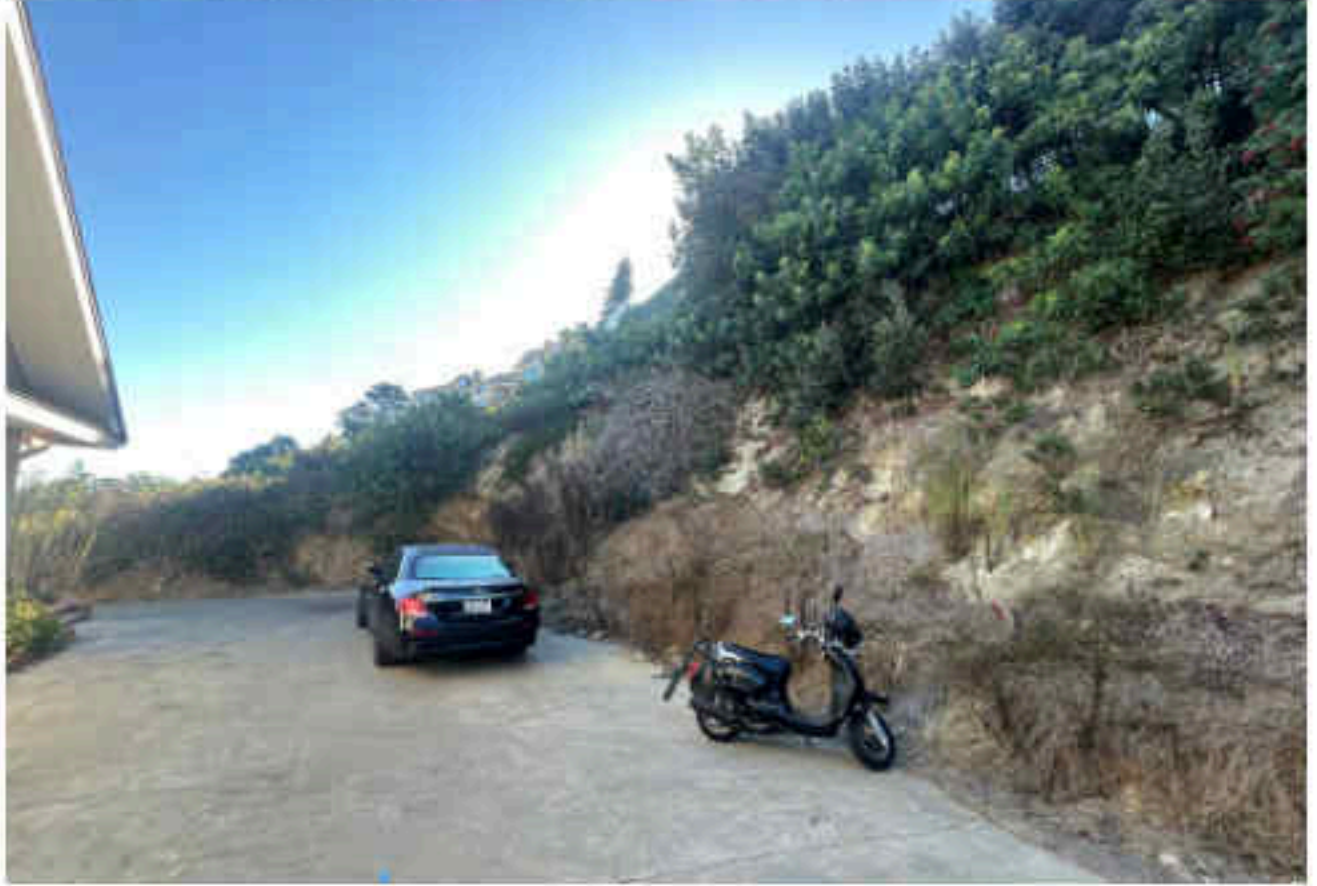
- There are indications of on-going erosion and surficial failures with additional debris (i.e. sediment, rocks, blocks of sandstone) that have collected at the base of slope.
- An old concrete fence post foundation that was on the slope face reportedly fell onto the driveway during the winter of 2023/2024.
- The previously installed jute netting and straw waddles along the debris pile at the base of slope are weathered and deteriorating and are no longer effective for limiting erosion at the bluff base.

Temporary maintenance recommendations include removing some of the loose soil and erosional debris from the base of slope and installing new jute netting and straw waddles. The top of bluff neighboring property should also be made aware of the on-going erosion of the bluff face and top of bluff area and the on-going impacts to the 1703 Castellana property. Maintenance including proper drainage, irrigation and landscaping control should be enacted and monitored for the top of bluff property.

Longer term recommendations include removing a majority of the loose soil and erosional debris from the base of bluff and installing a cmu block wall, K-rail, debris fence, at the base with free-board to help catch any debris, rock or soil that may erode on or near the bluff both on and off-site. A permanent soil nail/tie back wall or shoring wall can also be considered. Additional recommendations can be provided upon request for these items or other options can be discussed.
