WOOD DESTROYING PESTS AND ORGANISMS INSPECTION REPORT

Building Address: 15349 Highland Valley Rd., Escondido, CA 92029		Date of Inspection 02/04/2025	Number of Pages 6
ABC Termite and Pest Control 1835 S Centre City Pkwy #216 Escondido CA 92025 Phone: (855) 263-7378 Fax: (619) 798-4589		Report # W10407	
		Lic. Registration # PR 8126	
		Escrow # 22544-PR	
Ordered by: A Team Real Estate Veronica Ramirez	Property Owner and/or Party of Interest: Arnufo Quintero 15349 Highland Valley Rd. Escondido, CA 92029	Report Sent to: Oakwood Escrow Pam Reifeiss	
COMPLETE REPORT <input checked="" type="checkbox"/> LIMITED REPORT <input type="checkbox"/> SUPPLEMENTAL REPORT <input type="checkbox"/> REINSPECTION REPORT <input type="checkbox"/>			
General Description: 1 STORY, SFR, STUCCO EXTERIOR, SLAB, TILE ROOF, OCCUPIED		Inspection Tag Posted: Water Heater	
		Other Tags Posted: None Found	
An inspection has been made of the structure(s) shown on the diagram in accordance with the Structural Pest Control Act. Detached porches, detached steps, detached decks and any other structures not on the diagram were not inspected.

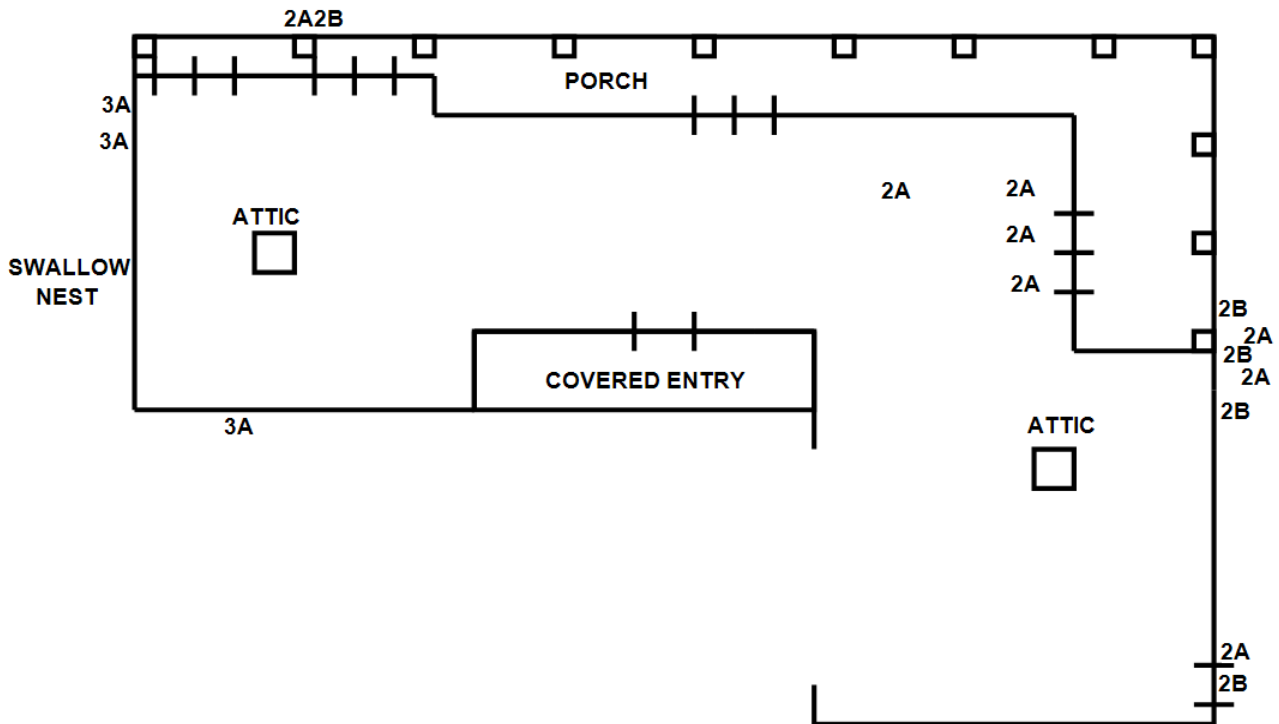
This Diagram is not to scale

2A PRICE: \$4,125.00 (Section I)
FINDINGS: Evidence of drywood termite infestation in the attic, rafter tails, porch beam and stucco molding as indicated on the diagram.
RECOMMENDATION: Vacate the premises and seal the structure for fumigation with a registered fumigant. Remove or cover accessible evidence of infestation. Fumigation awareness notice must be signed prior to fumigation. See fumigation notice for terms and liabilities. ABC Termite & Pest Control. assumes no responsibility for damage to any plant life or roofing caused by fumigation operation.
** NOTE: THIS COMPANY IS NOT RESPONSIBLE FOR DELAYS OR SCHEDULE CHANGES DUE TO INCLEMENT WEATHER OR OTHER AGENCIES. ABC Termite & Pest Control. USES SUBCONTRACTORS TO PERFORM FUMIGATIONS. **
*** Fumigation guarantee is for Three (3) years from the date of the fumigation against drywood termites only.***

2B PRICE: \$2,345.00 (Section I)
FINDINGS: Evidence of drywood termite damaged wood members noted to rafter tails, porch beam and stucco molding in the areas as indicated on the diagram.
RECOMMENDATION: Correct and repair all termite damaged wood members noted in the above finding in the most practical way. Primer painting only is included in this estimate.
** Our wood repairs are guaranteed for 1 year from the date of completion. **

- 3A PRICE: See 2B (Section I)
FINDINGS: Dry-rot/Fungus damaged wood members found to fascia at the water heater closet and blocking as indicated on the diagram.
RECOMMENDATION: Correct and repair all dry-rot/fungus damaged wood members noted in the above finding in the most practical way. Primer painting only is included in this estimate.
** Our wood repairs are guaranteed for 1 year from the date of completion. **
